WMSC Commissioner Brief: W-0117 - Improper Roadway Worker Protection - C&A Connector - June 5, 2021

FINAL REPORT OF INVESTIGATION A&I E21229

Date of Event:	06/05/2021
Type of Event:	Improper RWP Protection
Incident Time:	0625 hours
Location:	Farragut North, Track 2 C&A Connector Foggy Bottom to McPherson Square
Time and How received by SAFE:	0640 hours SAFE On-call Phone
WMSC Notification Time:	0809 hours
Responding Safety Officers:	WMATA SAFE: No WMSC: No Other: N/A
Rail Vehicle:	None
Injuries:	None
Damage:	None
Emergency Responders:	None
SMS I/A Incident Number:	20210817#95074

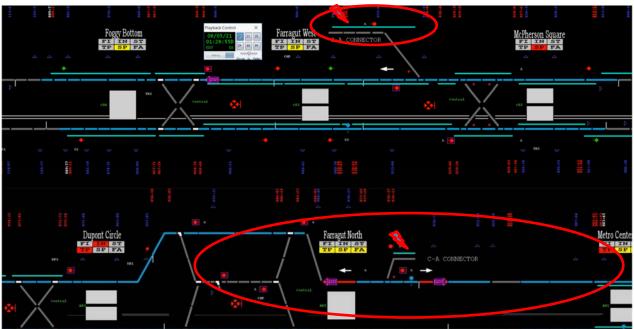
Diagram 2 (Ops 1) – Shows third rail power energized on the A-Line at 0126 hours; however, the C&A connector is deenergized

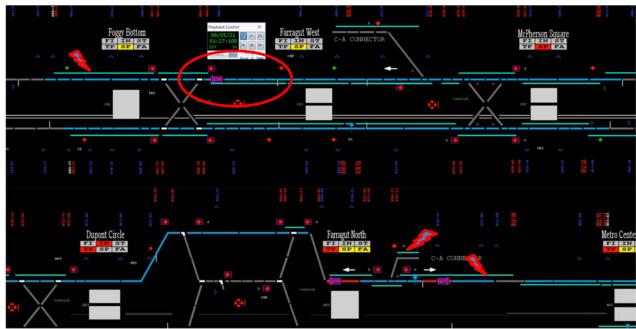
Diagram 3 – Shows Senior RWIC moving on PM 54 beginning to set up their work location on the Foggy Bottom end. ROCC de-energized third rail power in Junior RWIC's work location on the lower half between Farragut North and Metro Center at 0127 hours. Lightning bolt indicates third rail power locations are illuminated green for clarification purposes.

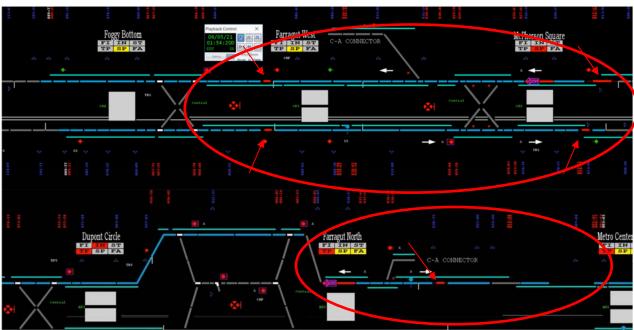
Diagram 4 – Shows both work crews setting up their work location and installing shunts (red blocks) in tandem within the same time parameters. Senior RWIC on the C-Line is notated above, and Junior RWIC on the A-Line is notated below. The Arrows indicate shunt placement.

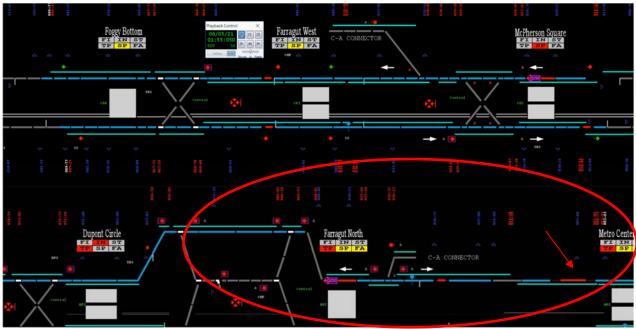
Diagram 5 – Shows Junior RWIC installed their last shunt at approximately 0155 hours.

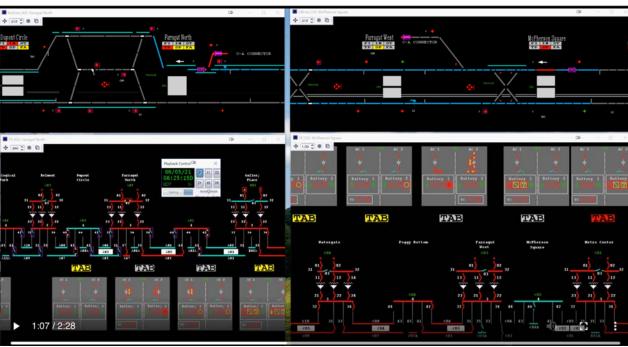
Diagram 6 – ROCC commanded breakers closed for the C&A connector at 06:25:15 hours.

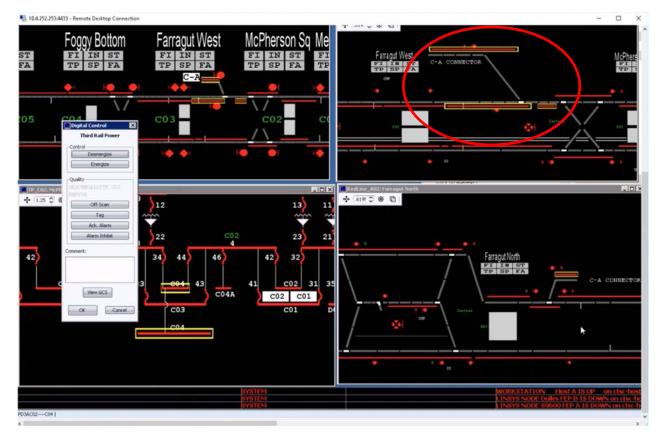
ROCC and SAFE requested a change to the power schematic and third-rail power indications at McPherson Square Station and the C&A connector on the AIMS screen. The diagram below indicates a future state view of the C&A Power Indication that highlights all associated areas of third rail power for the location. The power bar C50 (C&A connector) is connected to power bar C04 (track #2 McPherson) by way of power configuration; both bars will highlight when clicking on one or the other to indicate that power operations control both sections of third rail.

As of the date of this report, only one power indication bar will illuminate when selecting either bar. Once the update is completed, both bars in the power schematic and third rail bars layers will illuminate as shown above with the selection of either one because they are configured together when restoring and de-energizing third rail power.

A contributing factor to the improper power restoration was an engineering control within the AIMS display. During the investigation, it was observed that when selecting the power bar in the power schematic for the C&A connector via the AIMS screen, the connecting power bar that indicates the area to be energized did not illuminate for the C&A connector. Additional contributing factors to this event included inadequate communication between the work crews during the shift and between RTC controllers during power restoration procedures. The ROCC Ops 2 RTC received communication from the Button RTC on Ops 1 to not reenergize third rail power but did not state that the Junior RWIC was still in the work location. Based on a review of training records, SAFE interview, and tenor, the Ops 2 RTC responded to the Ops 1 Button RTC that they were not reenergizing third rail power; however, they energized third rail power in the C&A connector several minutes later.

Metrorail will change power schematics and third-rail power indications in the AIM system to show power status and allow for blue block human form indications at all points in connector tracks.
