WMSC Commissioner Brief: W-0118 – Near-Miss/Red Signal – West Falls Church Yard – February 1, 2021

Washington Metro Area Transit Authority
Department of Safety and Environmental
Management (SAFE)
FINAL REPORT OF INVESTIGATION A&I E21042

West Falls Church Yard – Red Signal Overrun

February 1, 2021

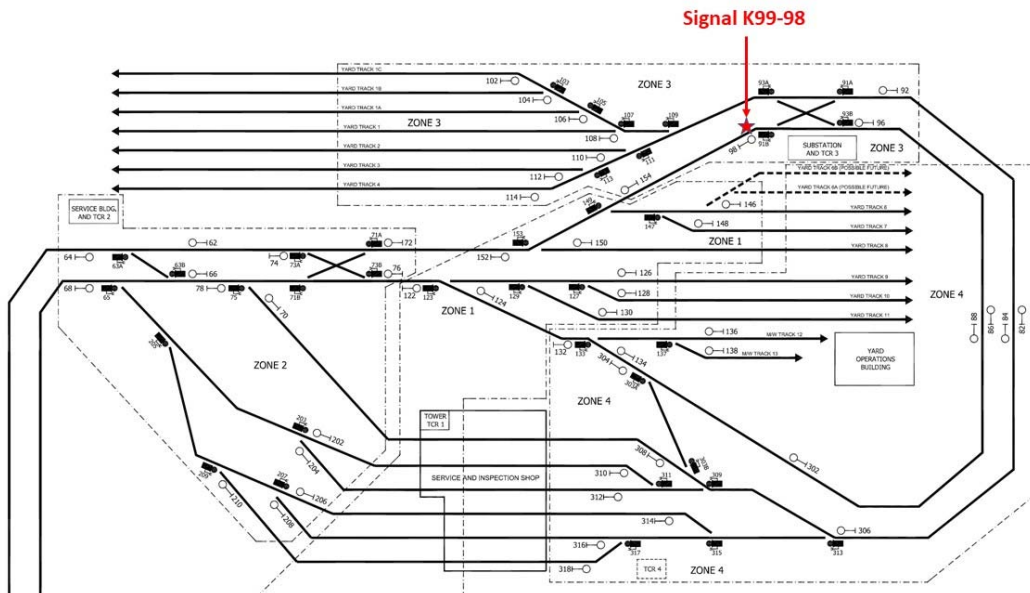
Field Sketch/Diagram

West Falls Church, Signal K99-98

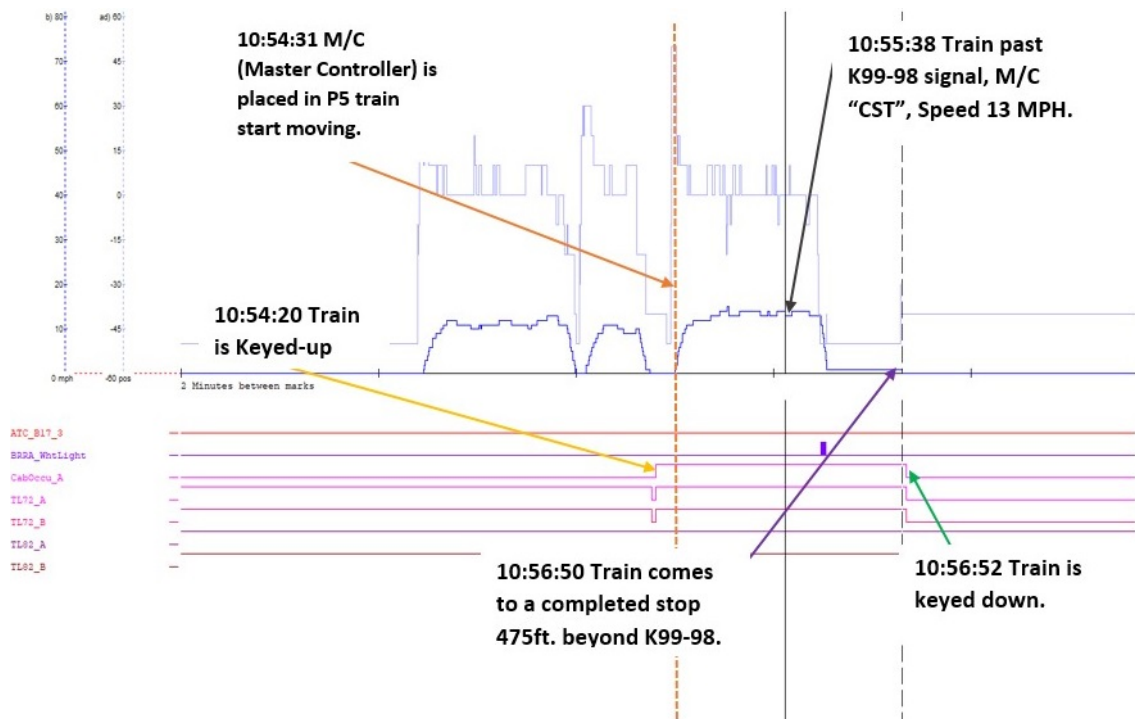
Graph #1 – Office of Vehicle Program Services (CENV) reported no propulsion or brake faults were observed that could have contributed to the incident.

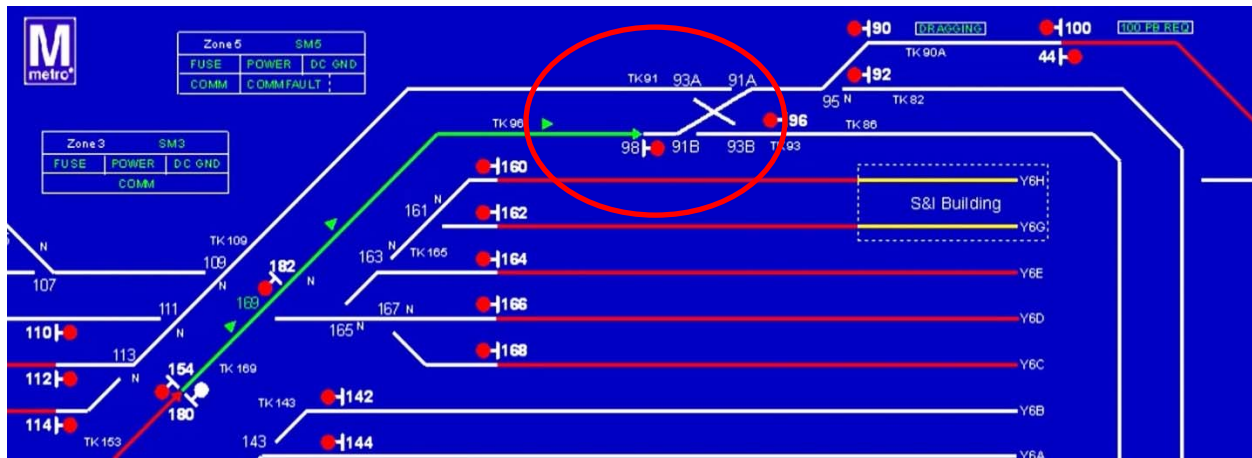
The preliminary ATCE analysis revealed that Signal K99-98 was displaying a red aspect as Train ID 851 traversed the interlocking.

Diagram #1 – Graphical playback depicts the Train Operator had a red signal at K99-98 when they passed it.

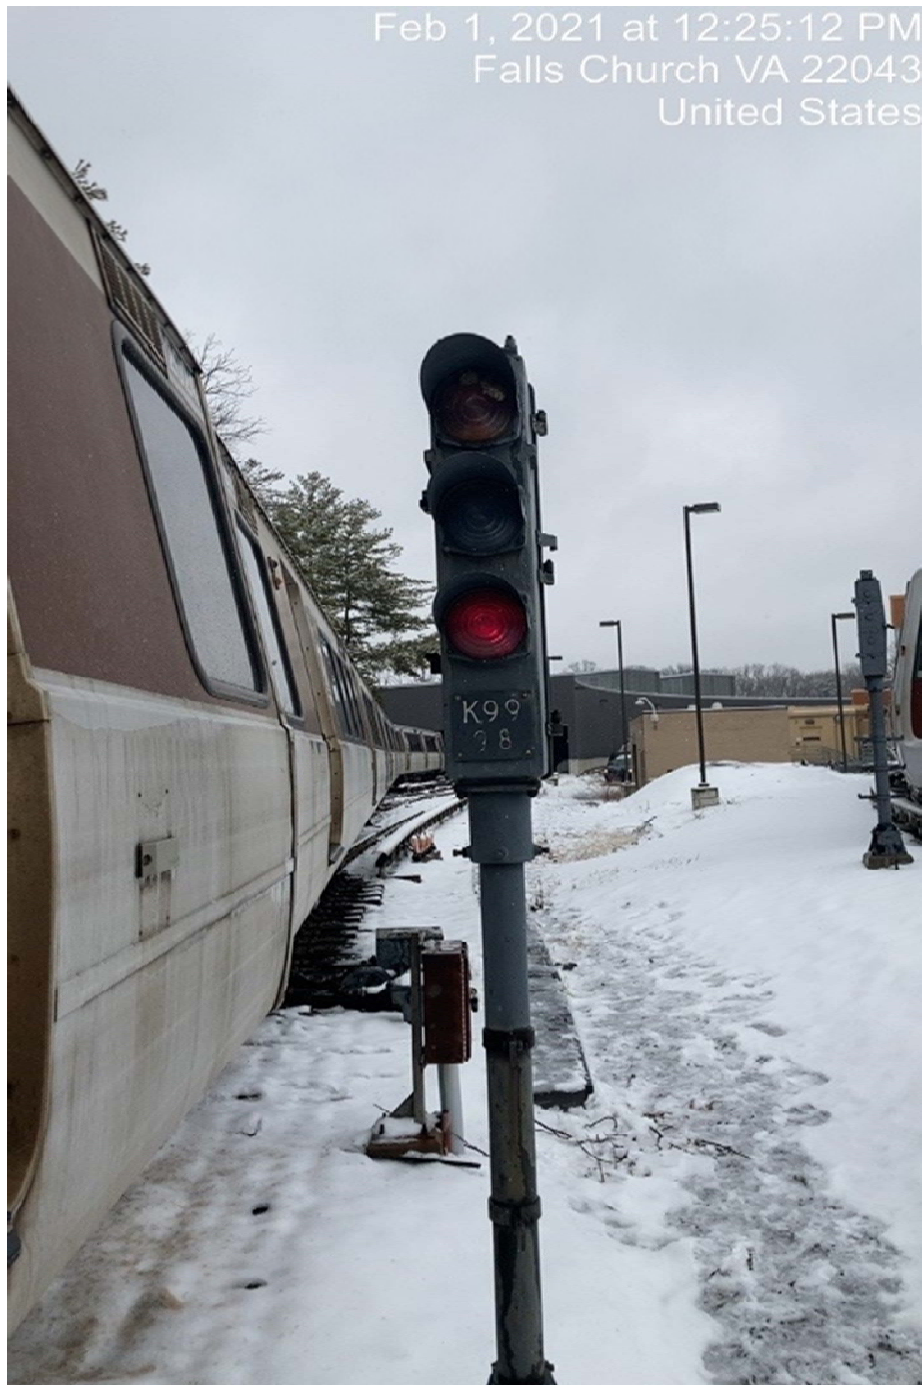
Photo #1 – Train ID #851, approximately 475 feet past Signal K99-98 (Red).

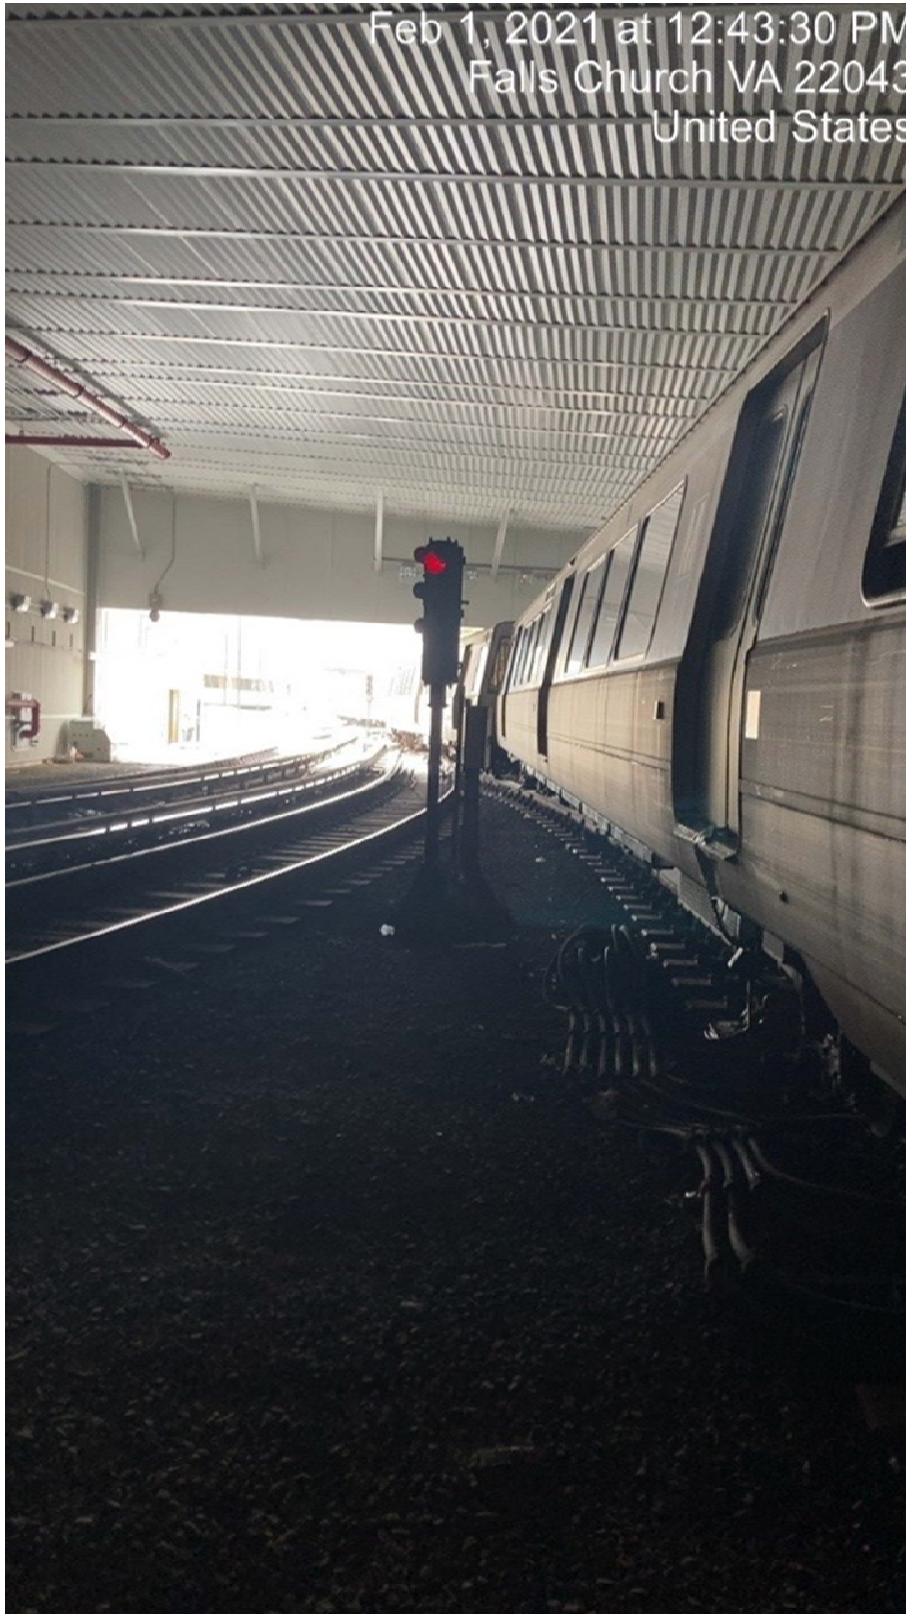
Photo #2 – Train ID #851, approximately 475 feet past Signal K99-98 (Red) [View from lead car].
