WMSC Commissioner Brief: W-0120 – Improper Door Operation – Glenmont Station – June 4, 2021

Washington Metro Area Transit Authority
Department of Safety and Environmental
Management (SAFE)
FINAL REPORT OF INVESTIGATION A&I E21228

Glenmont Station – Improper Door Operation

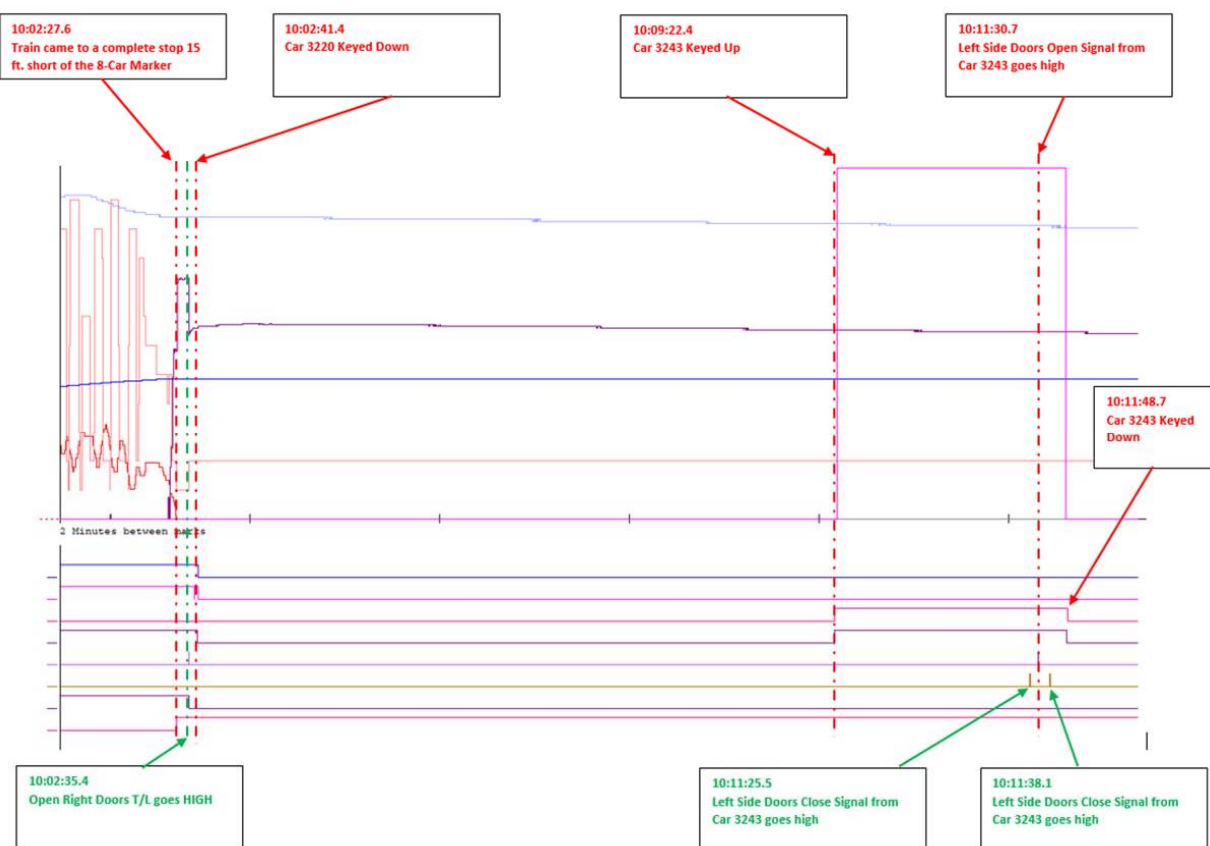
10:02:27.6	Train comes to a complete stop 15 ft. short of the 8-Car Marker
10:02:35.4	Right Open Door Manually activated and Right Door Open Trainline energized

***This diagram shows the speed the consist entered Glenmont Station, the distance it stopped from the 8-car marker, when the doors were opened manually, and when the doors were closed.*

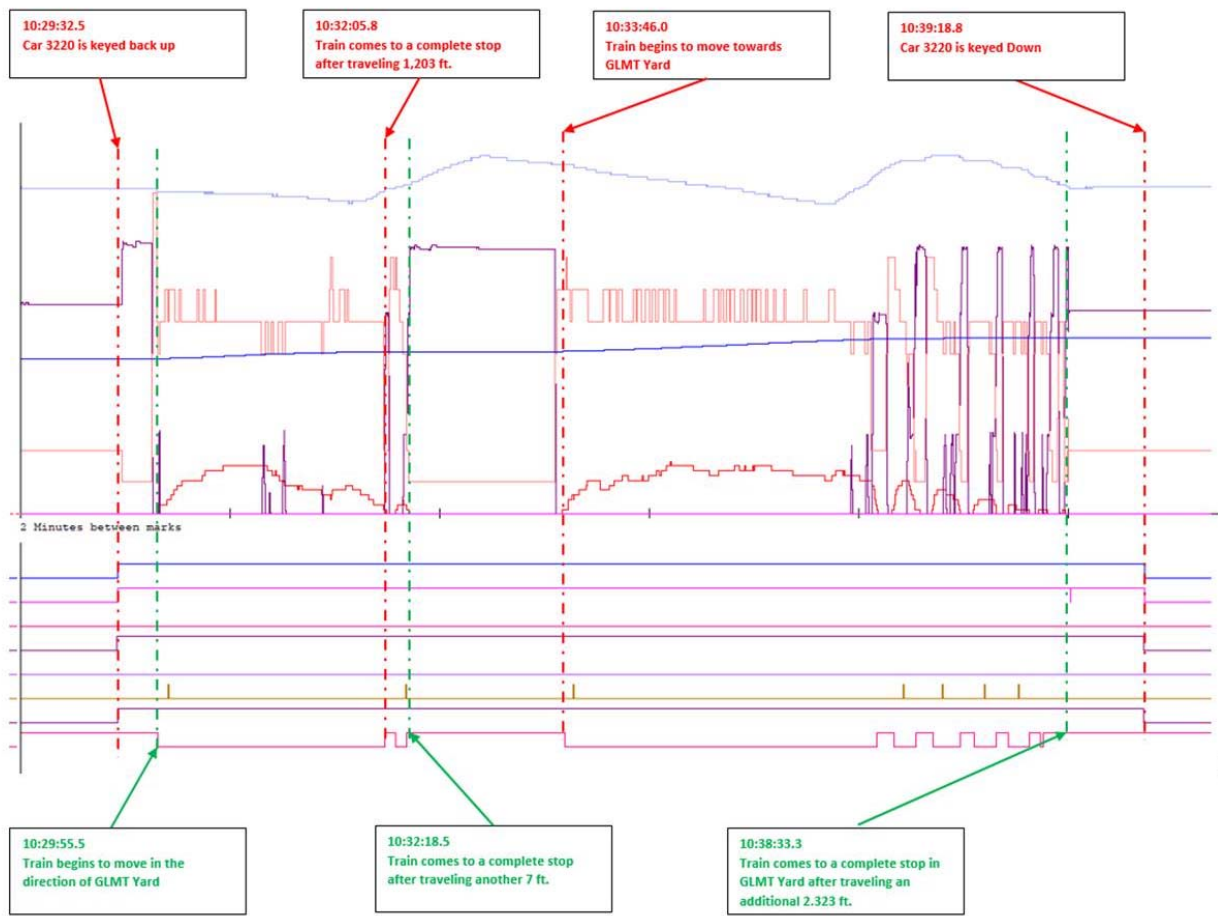
***This diagram shows the activity of the consist when the RTRA Supervisor removed the consist from the platform.*

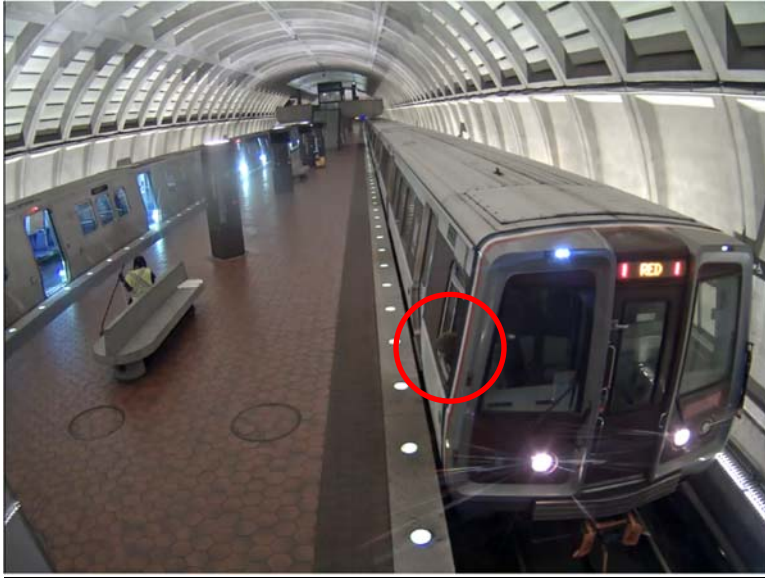
***This image shows Train ID #115 Operator looking out of the cab window noticing they were short of the 8 car-marker.*

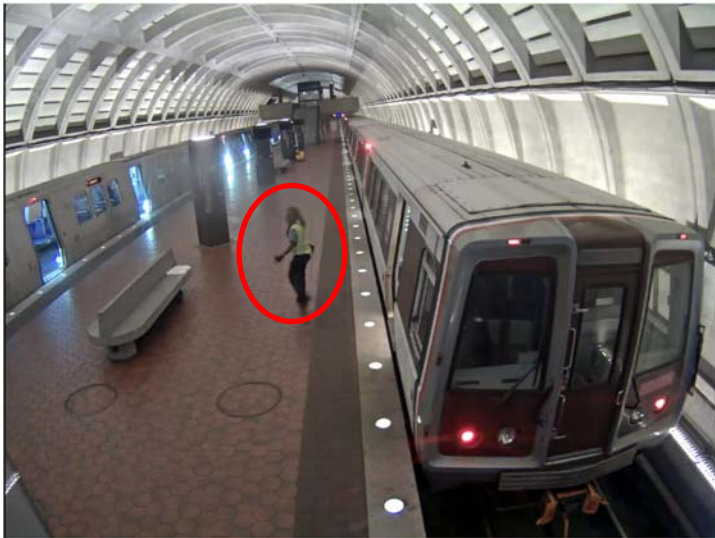
***This image shows Train ID #115 Operator looking back outside of the consist seeing it was short of the 8 car-marker.*

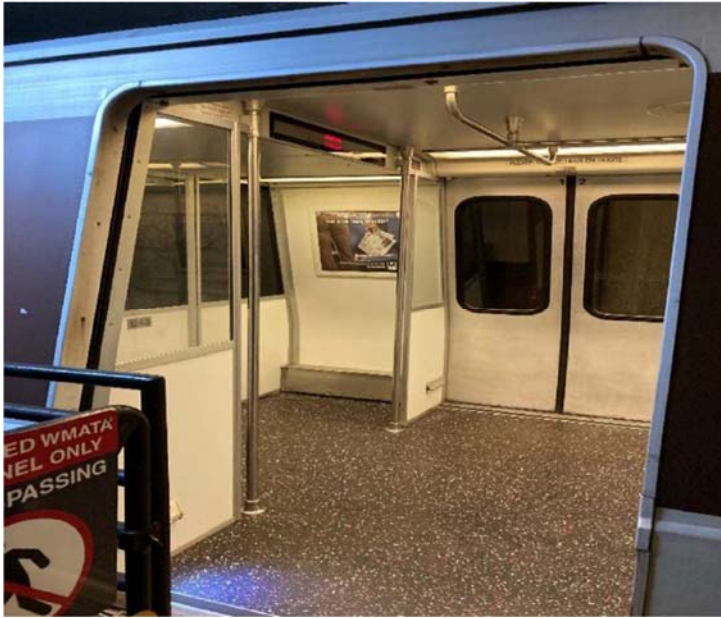
*** This image shows the trailing car door of Train ID #115 opened against the platform gate.*

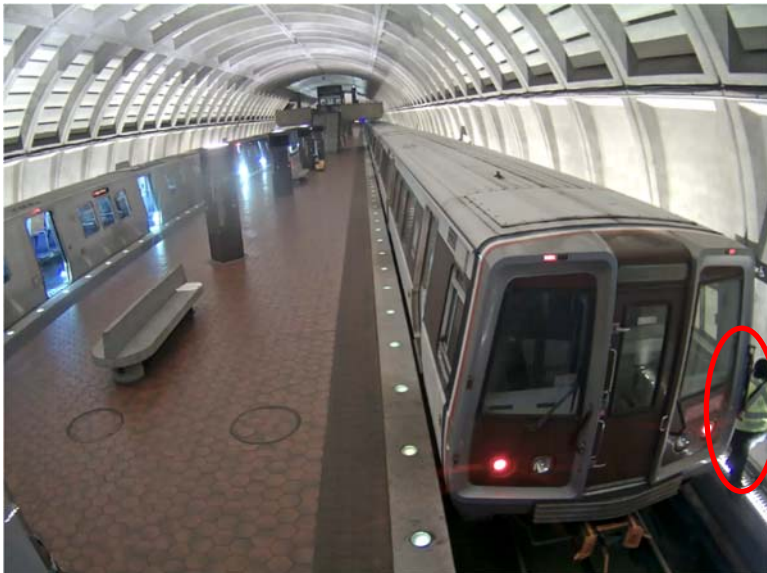
***This image shows a RTRA Supervisor conducting a ground walk around.*

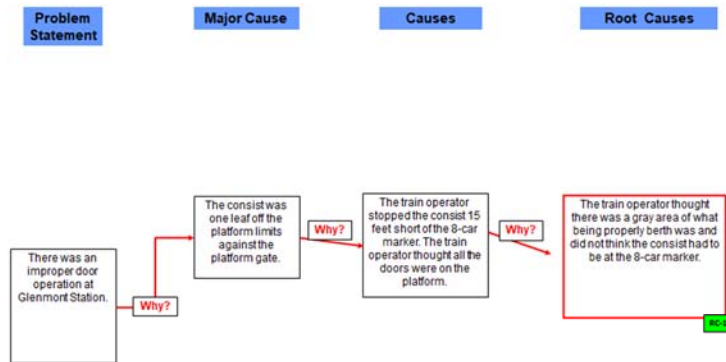
Appendix D - Root Cause Analysis

This incident's root cause was complacency and failure to follow the proper door opening procedures as outlined in SOP #40, requesting permission to operate doors manually, and waiting 3-5 seconds before initiating the
