## **WMSC Commissioner Brief: W-0121 – Collision, Customer Fatality – Union Station – June 23, 2021**

*Prepared for Washington Metrorail Safety Commission meeting on October 26, 2021*

**FINAL REPORT OF INVESTIGATION A&I E21255**

<b>Date of Event:</b>	6/23/2021
<b>Type of Event:</b>	Person Struck by Train
<b>Incident Time:</b>	12:29 hours.
<b>Location:</b>	Union Station, Track 1
<b>Time and How received by SAFE:</b>	13:39 hours. SAFE On-call Phone
<b>WMSC Notification Time:</b>	13:54 hours.
<b>Responding Safety Officers:</b>	WMATA SAFE: Yes WMSC: No Other: N/A
<b>Rail Vehicle:</b>	Train ID 118, <b>L7442-7443</b> . 7325-7324. 7284-7385. 7403-7402T
<b>Injuries:</b>	Fatality
<b>Damage:</b>	Train-to-Wayside Communication Antenna
<b>Emergency Responders:</b>	Office of Rail Transportation (RTRA), Metro Transit Police Department (MTPD), District of Columbia Fire and Emergency Services (DCFEMS), Office of Car Maintenance (CMNT), Emergency Response Team (ERT), and Office of Plant Maintenance (PLNT).
<b>SMS I/A Incident Number:</b>	20210623#94044MX

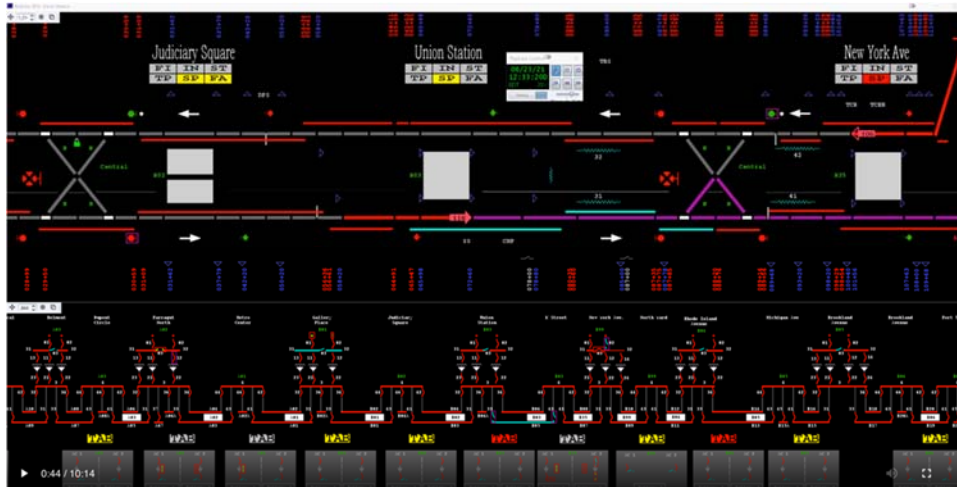
Based on AIMS Playback, at approximately 12:33:20 hours, the Button RTC de-energized third rail power on Track 1.

*Diagram 1 - ROCC commanded Third rail power circuit breakers open after Train ID 118 reported striking a person at 12:33:20 hours.*

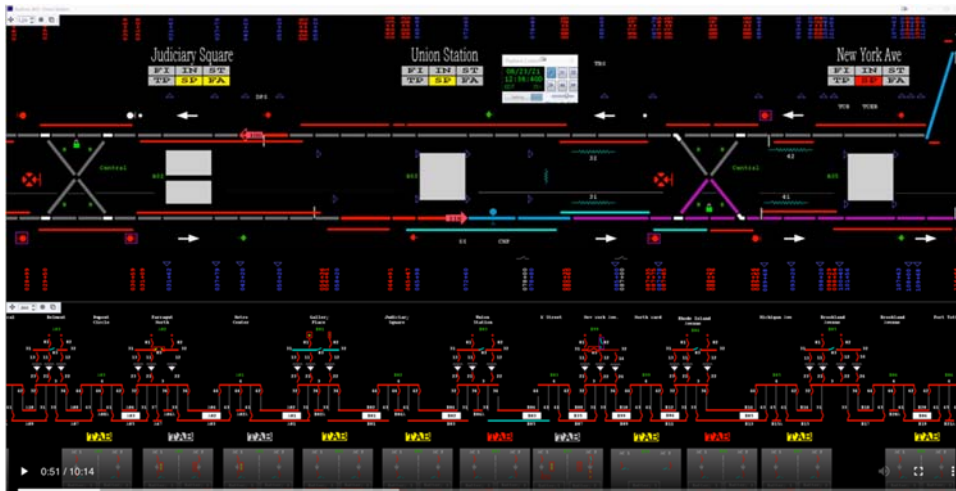
Diagram 2 – ROCC setup FT Protection for RTRA Supervisor Unit 4 at 12:36:40 hours.

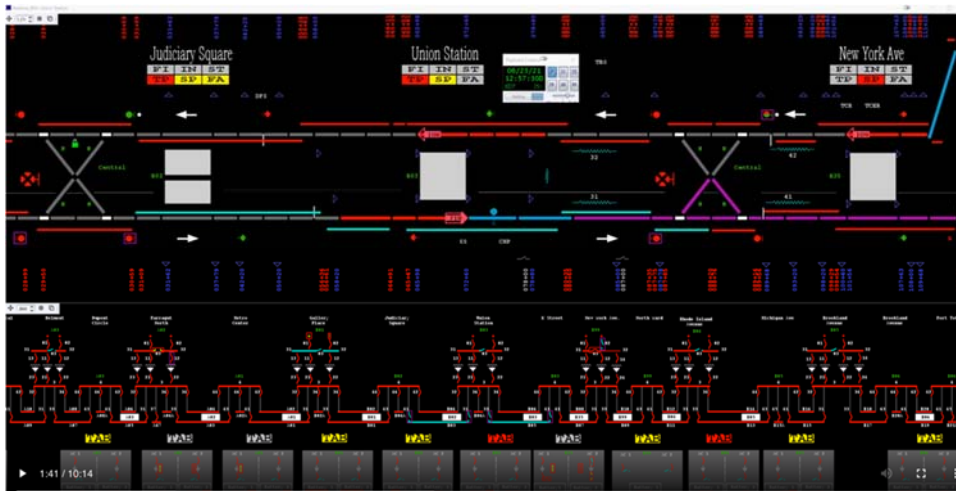
A review of Open MHz DCFEMS tactical channel revealed Safety Truck 4 notified the ICP that third rail power was still energized 300 feet from the Union Station platform limits on Track 1 at approximately 12:55 hours. The Safety Truck 4 notified the ICP they were located at C1-62+00 and activated the Electronic Trip Station (ETS) box to de-energize third rail power.

Diagram 4 – Third rail power circuit breakers commanded open at Judiciary Square via ETS trip station by the DCFEMS at approximately 12:57:30 hours.

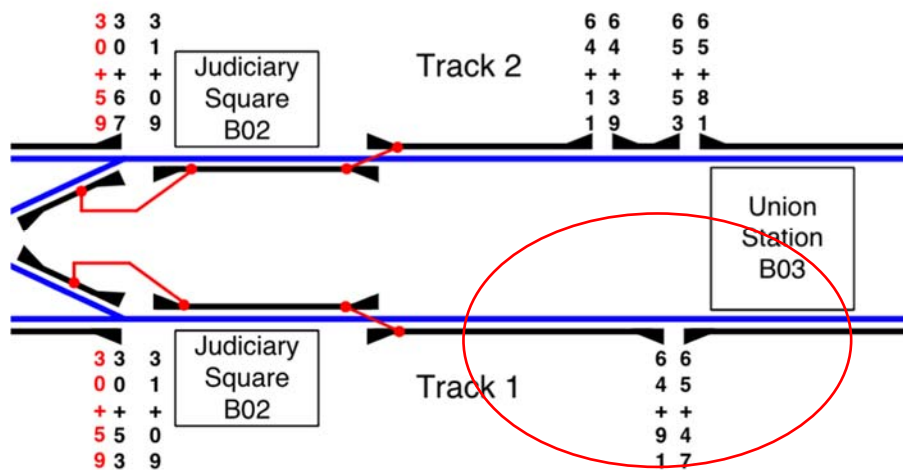
A review of the track schematic and train data shows the incident train came to a complete stop approximately 370 feet from the eight-car marker at Union Station with three rail cars in the station. An eight-car consist is approximately 600 feet in length in relation to the platform limits. This would indicate that 370 feet of the incident train, approximately five rail cars, were outside the platform limits within the tunnel on energized rail based on DCFEMS reported CM C1-62+00.

Diagram 5 - Contact rail schematic indicating CM and the affected third rail outside Union station.

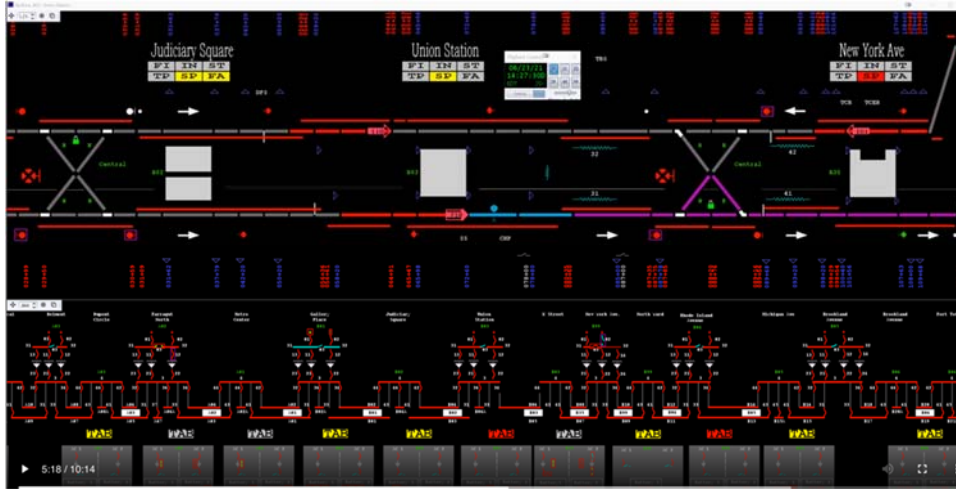
*Diagram 6 – ROCC commanded, third rail power circuit breakers closed at Judiciary Square and Union Station at approximately 14:27:30 hours to move Train ID 718.*

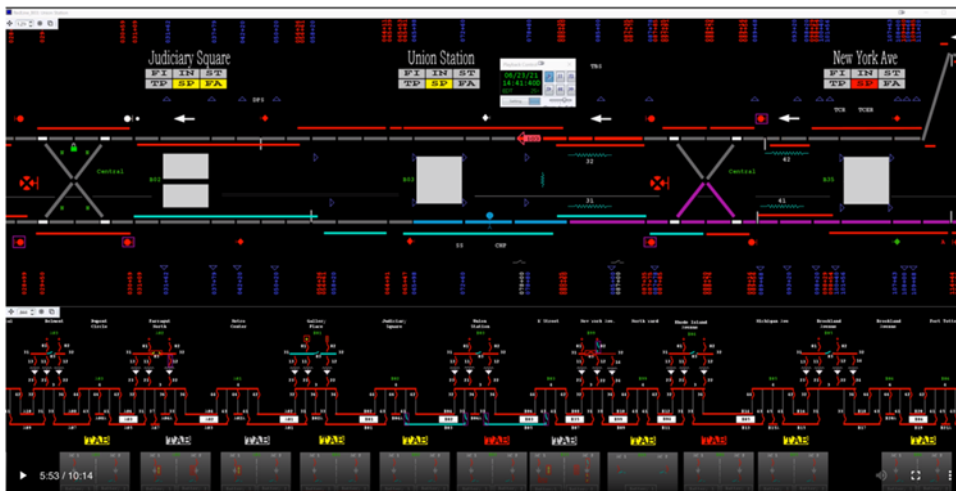
*Diagram 7 – ROCC Commanded Third rail power circuit breakers commanded open at Judiciary Square and Union Station at approximately 14:41:40 hours.*

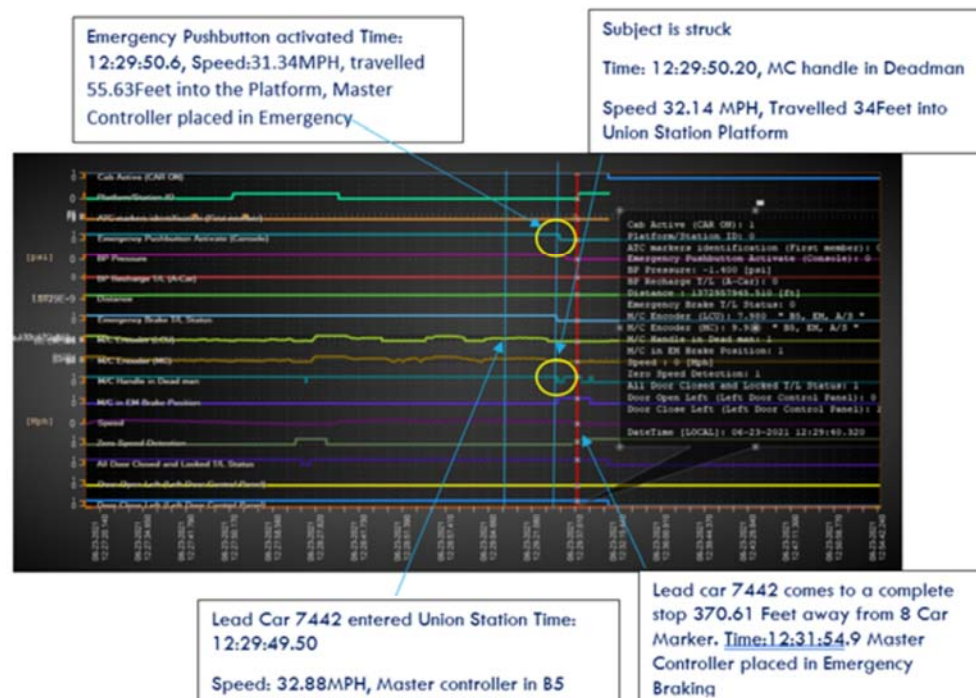
Diagram 1 - Event Recorder Graphical Analysis

Based on the VMDS and ER data, all the subsystems' safety components such as Automatic Train Control (ATC), brakes, and propulsion acted as designed, and there were no faults with the train that contributed to this event.
