WMSC Commissioner Brief: W-0122 – Improper Roadway Worker Protection – Near Grosvenor-Strathmore Station – June 23, 2021

FINAL REPORT OF INVESTIGATION A&I E21256

Grosvenor-Strathmore Station – Improper Roadway Worker Protection

June 23, 2021

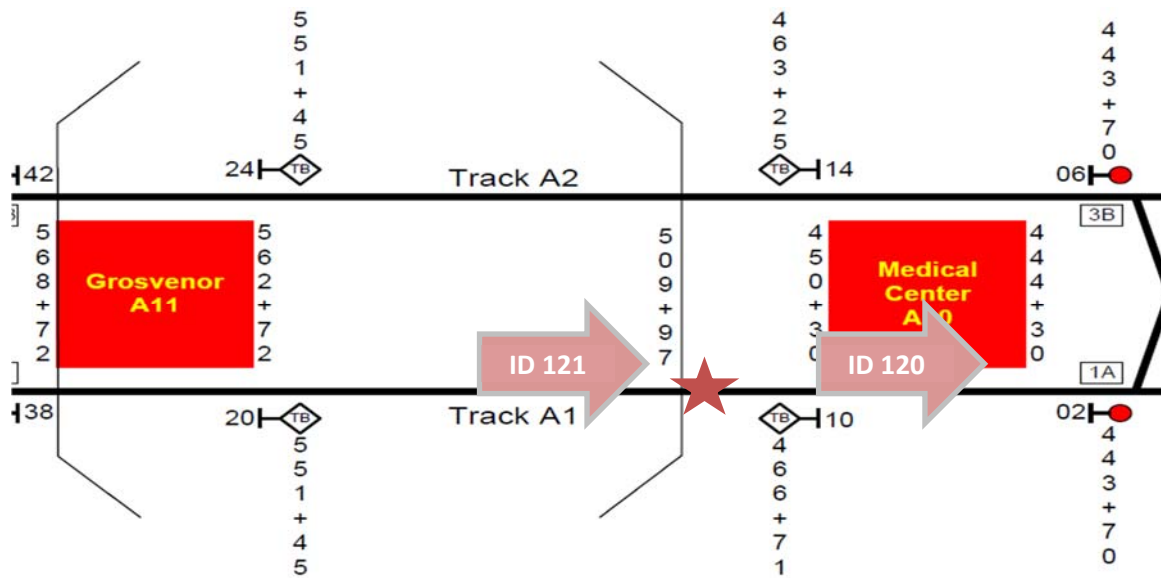
Field Sketch/Schematics

Rail Right-of-Way at Drainage Pumping Station located between Grosvenor-Strathmore Station and Medical Center Station. Approximate Chain Marker - A1 510+98.

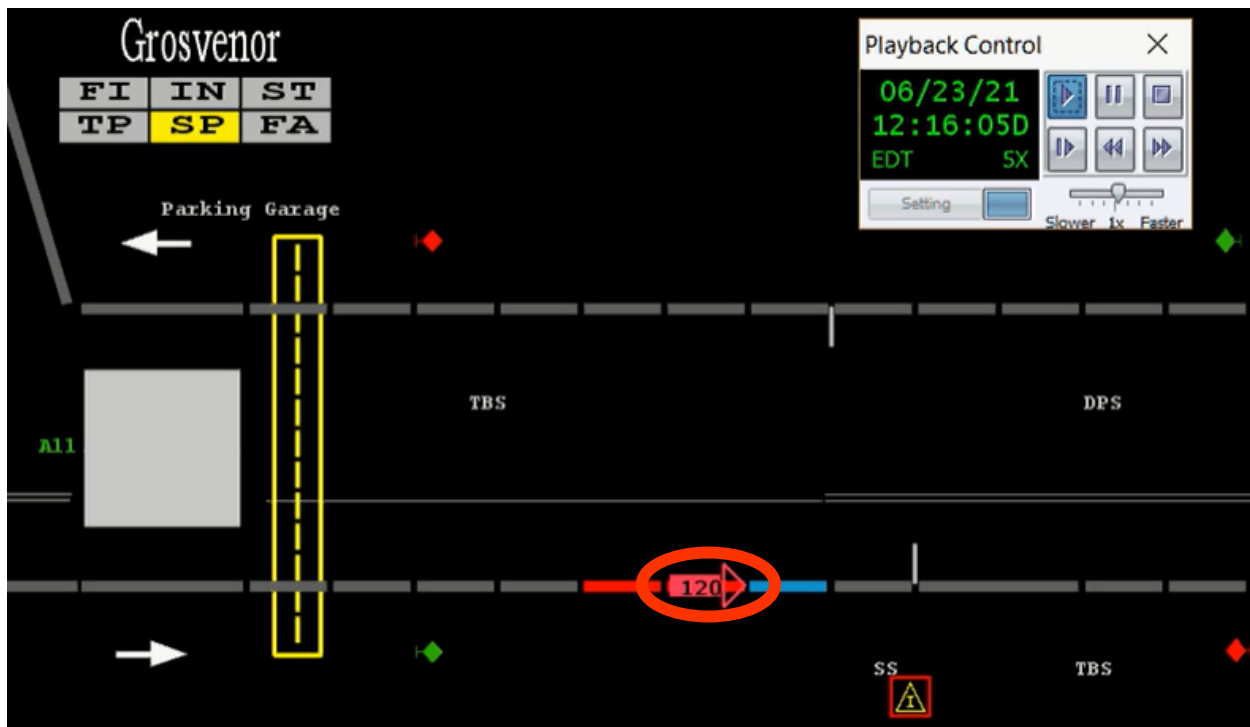
Figure 1 - Based on the AIMS, at 12:16:05 hours, Train ID 120 was stopped to align PLNT Units at DPS, CM A1 510+98.

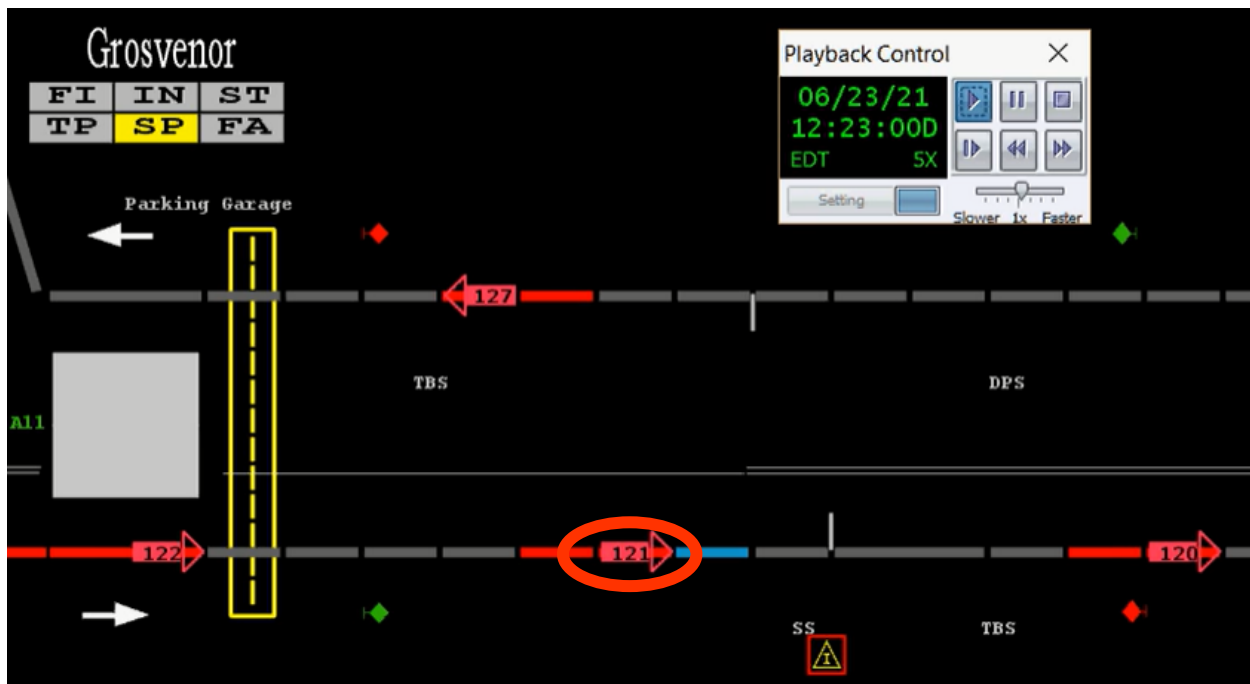
Time	Description
	<u>Train ID 121 Train Operator</u> : Contacted ROCC and advised that there are personnel visible on the roadway.
12:23:28 hours	<u>ROCC Radio RTC</u> : Request Unit #1 to contact ROCC.
12:23:39 hours	<u>ROCC Radio RTC</u> : Contacted, Train ID 121 inquired if they saw personnel on the roadway. <u>Train ID 121 Train Operator</u> : Responded, they went back into the room; they were on the roadway when I came around the corner.
12:23:56 hours	<u>ROCC Radio RTC</u> : Request Unit #1 to contact ROCC.

Figure 2 - Based on the AIMS, at 12:23:00 hours, Train ID 121 was stopped at DPS, CM A1 510+98.

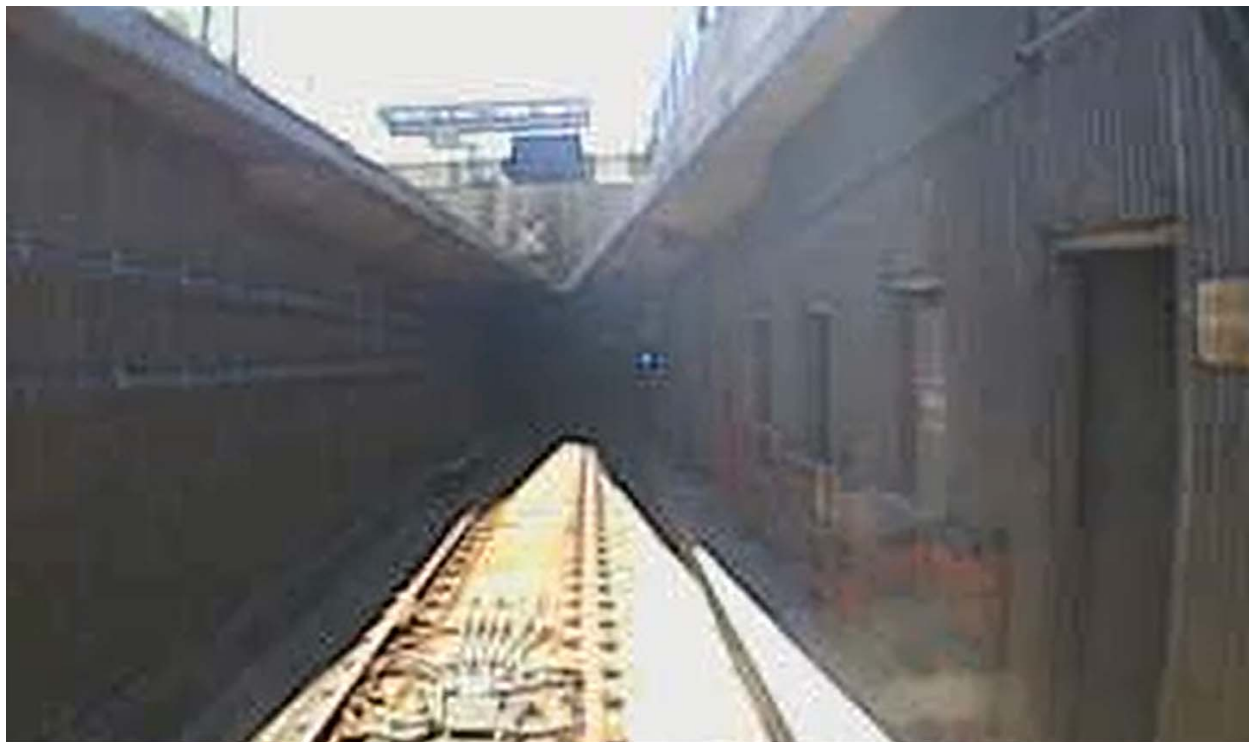
Figure 3 - Based on the CCTV, Train ID 121 was stopped at DPS, CM A1 510+98.
