WMSC Commissioner Brief: W-0123 – Improper Roadway Worker Protection – Ronald Reagan Washington National Airport Station – June 21, 2021

Washington Metro Area Transit Authority
Department of Safety and Environmental
Management (SAFE)
FINAL REPORT OF INVESTIGATION A&I E21252

National Airport Station – Roadway Worker Protection (RWP) Violation

June 21, 2021

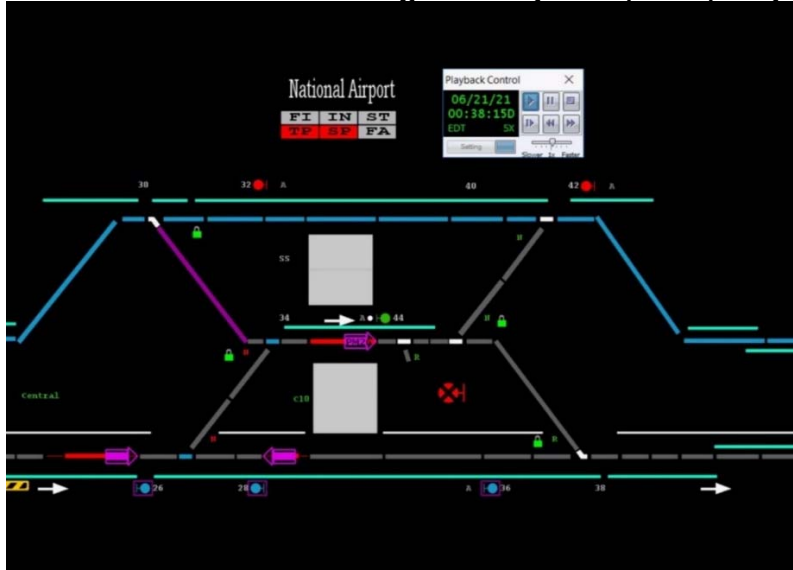
Photo #1 – PM 26 crossing over from Track 2 to Track 3. PM 26 Vehicle Operator noticed and reported personnel on the roadway to ROCC at approximately 00:38:15 hours.

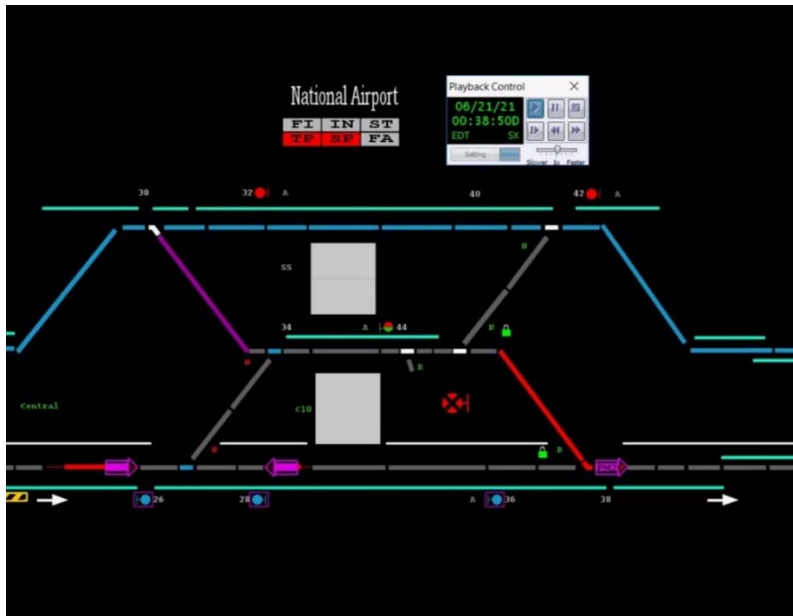
Photo #2 – PM 26 crossing over from Track 3 to Track 1 at Signal C10-38. PM 26 clears personnel on the roadway at approximately 00:38:50 hours.
