WMSC Commissioner Brief: W-0125 – Improper Vehicle Movement – Woodley Park Station – June 21, 2021

Washington Metro Area Transit Authority
Department of Safety and Environmental
Management (SAFE)
FINAL REPORT OF INVESTIGATION A&I E21251

Woodley Park Station – Improper Rail Vehicle Movement

June 21, 2021

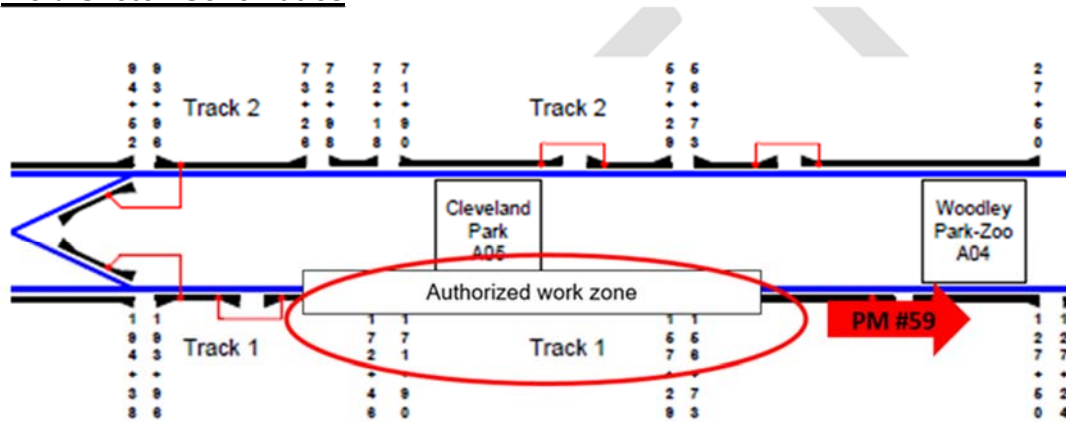
Field Sketch/Schematics

Note: Authorized Work Zone block is approximate.

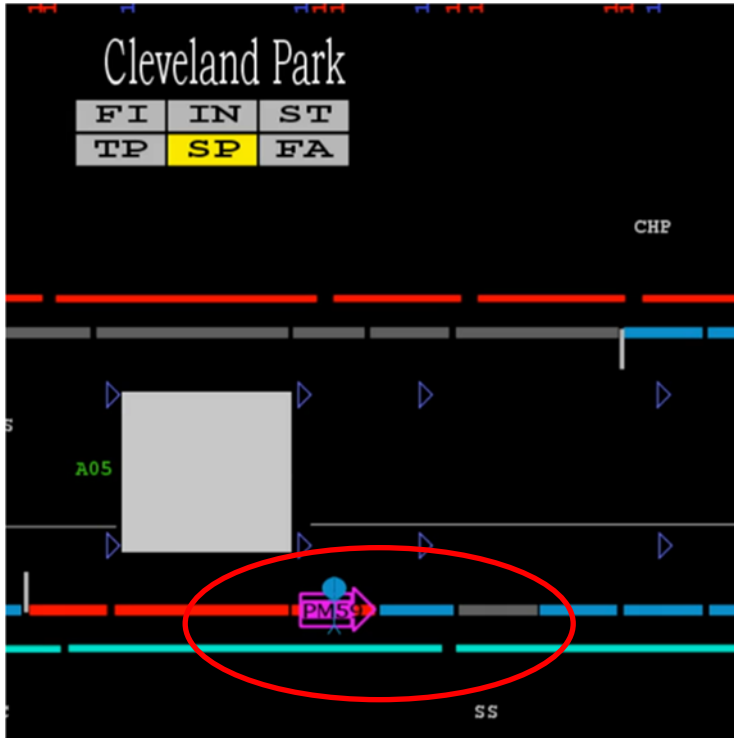
Figure 1: This image shows PM 59 holding the work zone where the RWIC placed the first shunt.

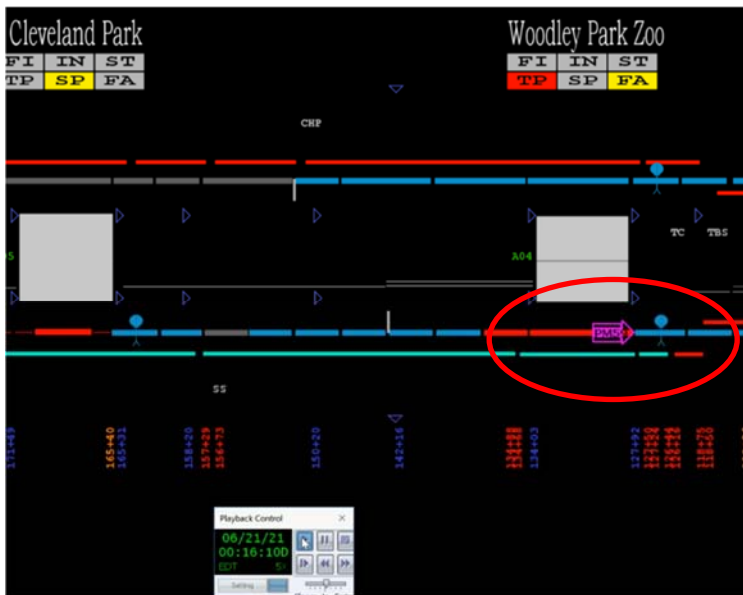
Figure 2: This image shows PM 59 outside of the work zone.

- PLNT RWIC stated incorrect work zone CMs to the ROCC RTC when they requested permission to establish their work area.
- ROCC RTC repeated back the correct CMs per the GOTRS documentation.
- ROCC RTC and PLNT RWIC used inconsistent language when communicating Chain Markers to each other during work zone set up.
- PLNT RWIC performed work in the same area the previous days, however the Protected Limits on the incident date involved a smaller area.
- PLNT RWIC received the first page of GOTRS rights, which included the Protected Working Limits, before entering the roadway.

Corrective Action Code	Description
95142_SAFECAPS_PLNT_001	PLNT should continue their program of requiring supervisors to perform Quality Checks of Work Zones until further notice. One check per week should be roadway-based.
9512_SAFECAPS_CENV_001	CENV and CMNT should identify solutions to capture video playback of interior, forward- and rear-facing viewpoints for Class II rail vehicles.

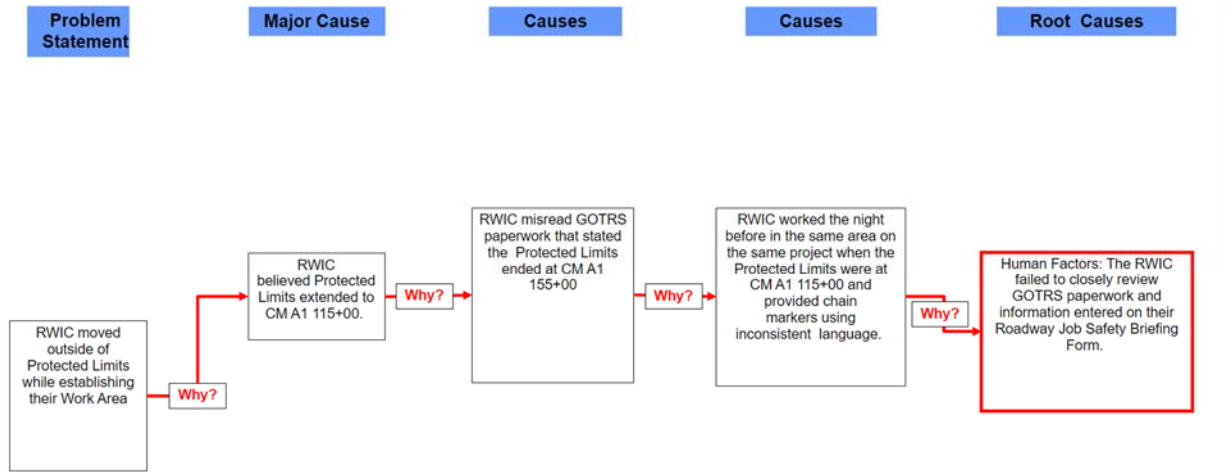
Appendix C - Root Cause Analysis

The probable cause of the Improper Rail Vehicle Movement violation event on June 21, 2021, was human error and lack of procedural adherence with Metrorail Safety Rules and Procedures Handbook (MSRPH) section 5.10.2 detailing the responsibilities of the RWIC. The investigation also identified several communication errors, employee non-adherence to written procedures and processes within the MSRPH as contributing factors in this event.
