WMSC Commissioner Brief: W-0070 – Red Signal Overrun – U Street Station – November 27, 2020

FINAL REPORT OF INVESTIGATION A&I E20469

Date of Event:	11/27/2020
Type of Event:	Red Signal Overrun
Incident Time:	12:47 hrs.
Location:	U Street Station, Track 2 (E03-08)
Time and How received by SAFE:	12:47 hrs. SAFE On-Call Phone
WMSC Notification Time:	14:33 hrs.
Responding Safety Officers:	WMATA SAFE: Yes WMSC: No Other: N/A
Rail Vehicle:	L7062.7063X7201.7200X7016.7017X7155 7154T
Injuries:	None
Damage:	None
Emergency Responders:	ATCM, MTPD, RTRA, SAFE and TRST.

U. Street Station – Red Signal Overrun

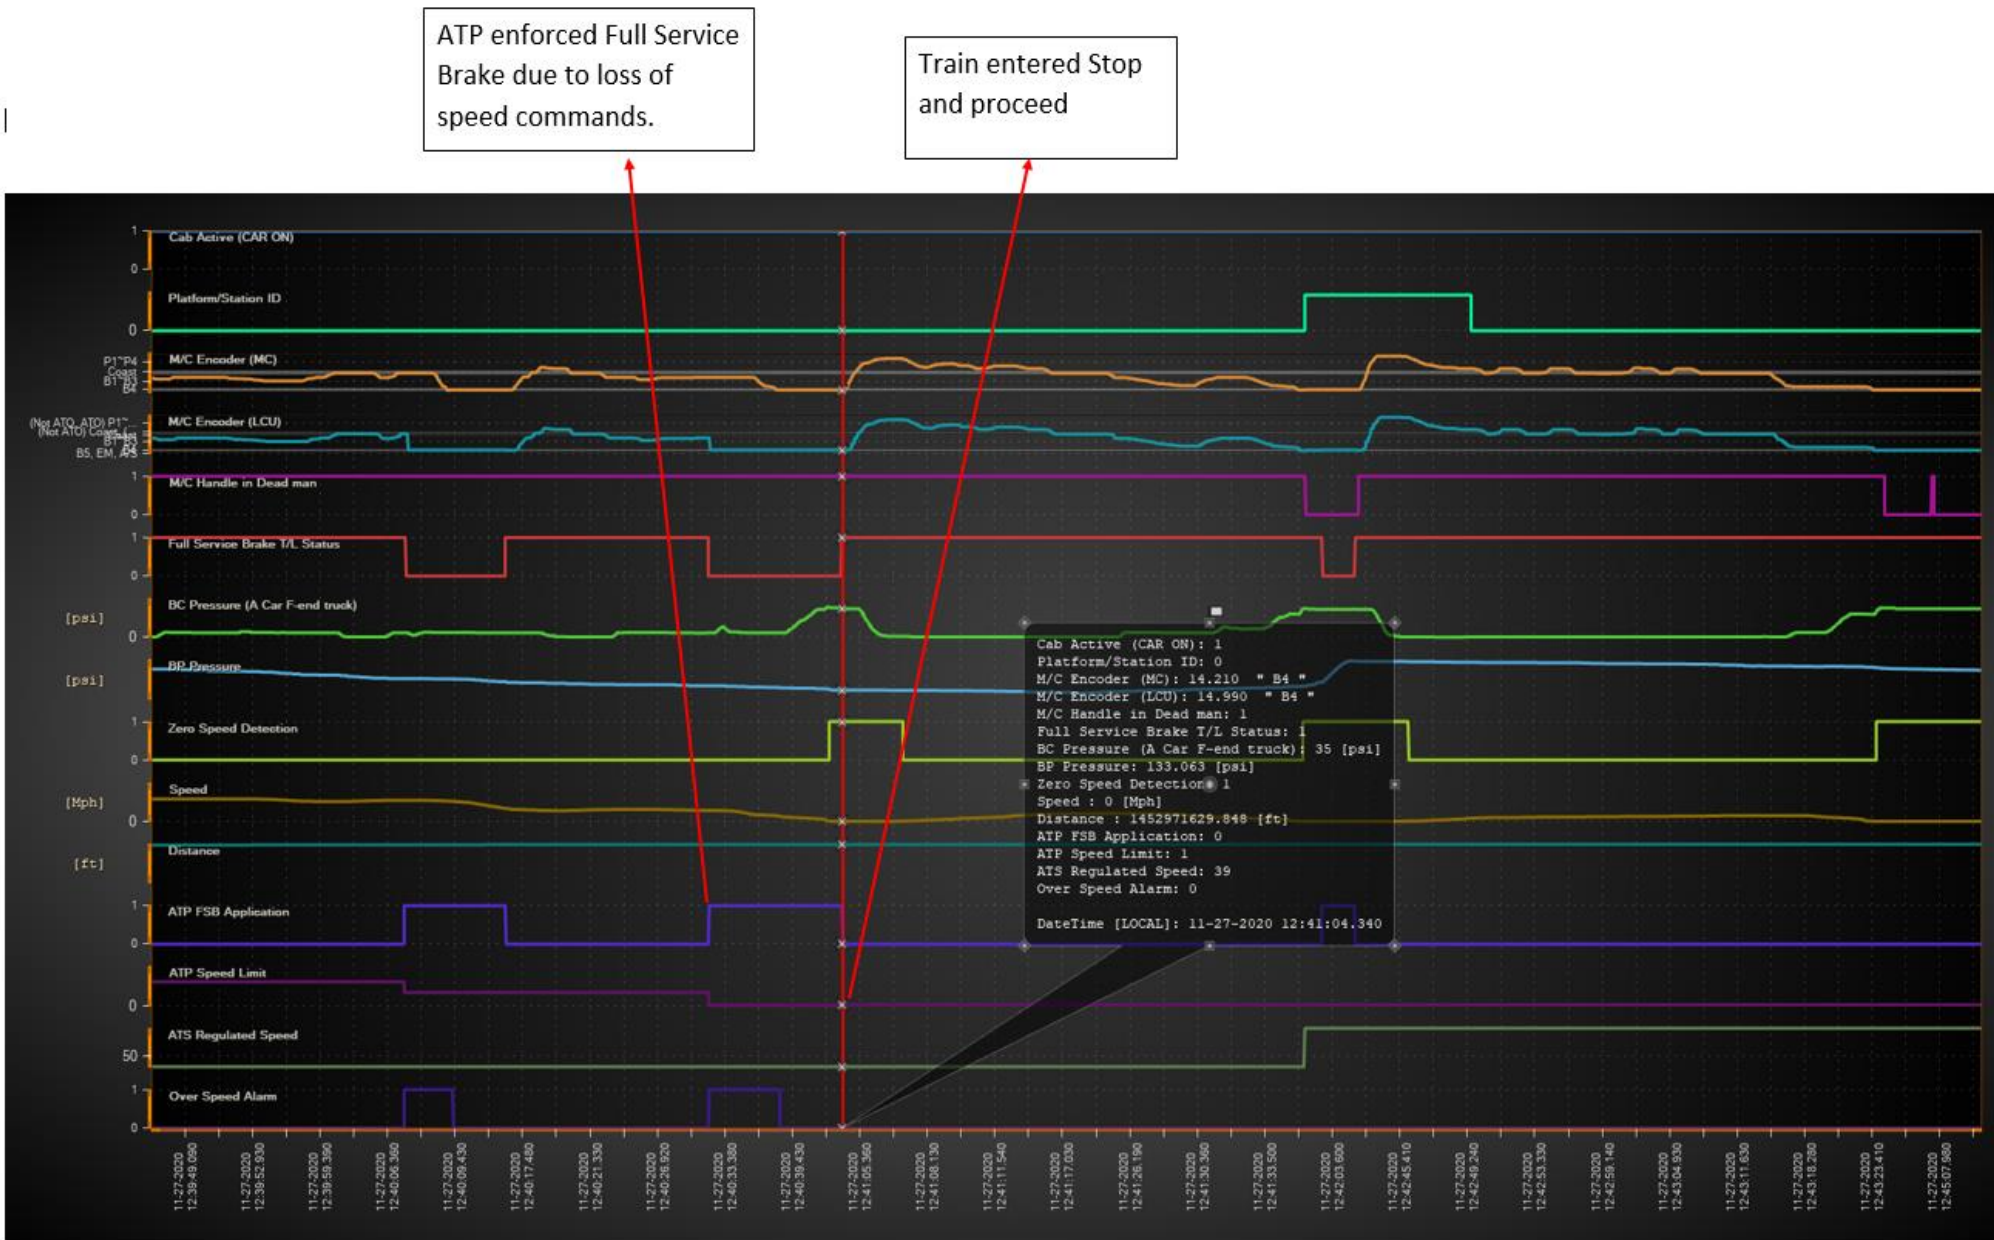
Diagram 1- ER Graphical Analysis prior to servicing the station.

Train 308 leaves U street
at 12:42:55 with Master
Controller on P1-P4

12:42:57 Train 308 traveled 100
feet from the end of U Street
Platform and Overran Red Signal
with the Master Controller Placed
in CST and Speed of 7mph.

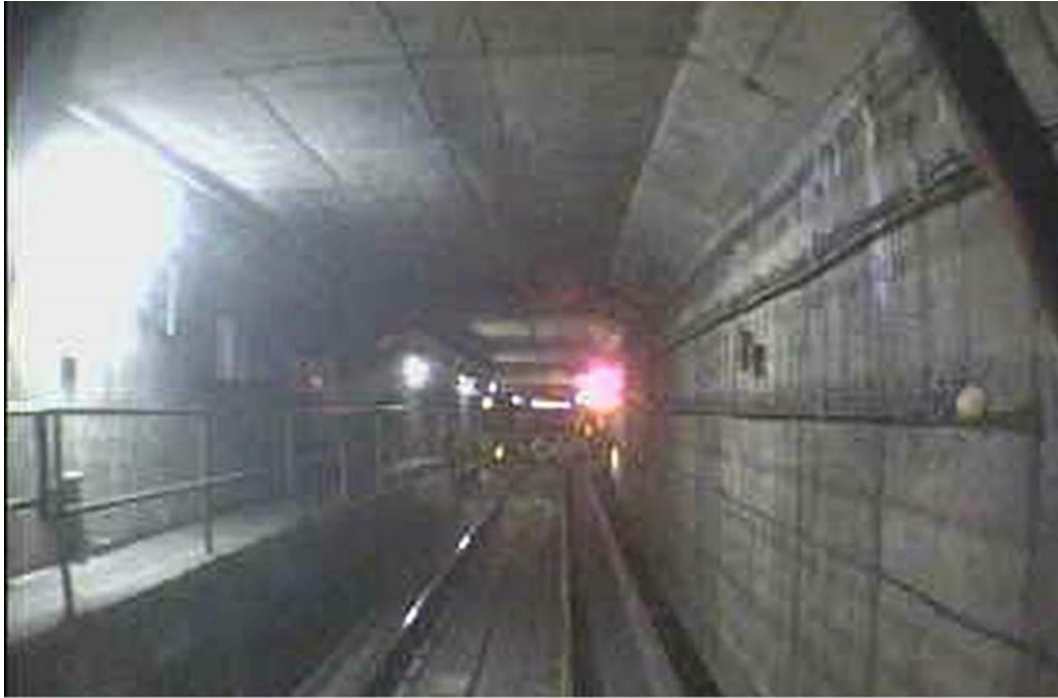
Photo 1 – E03-08 signal displaying a red aspect as seen from the 8-car marker.

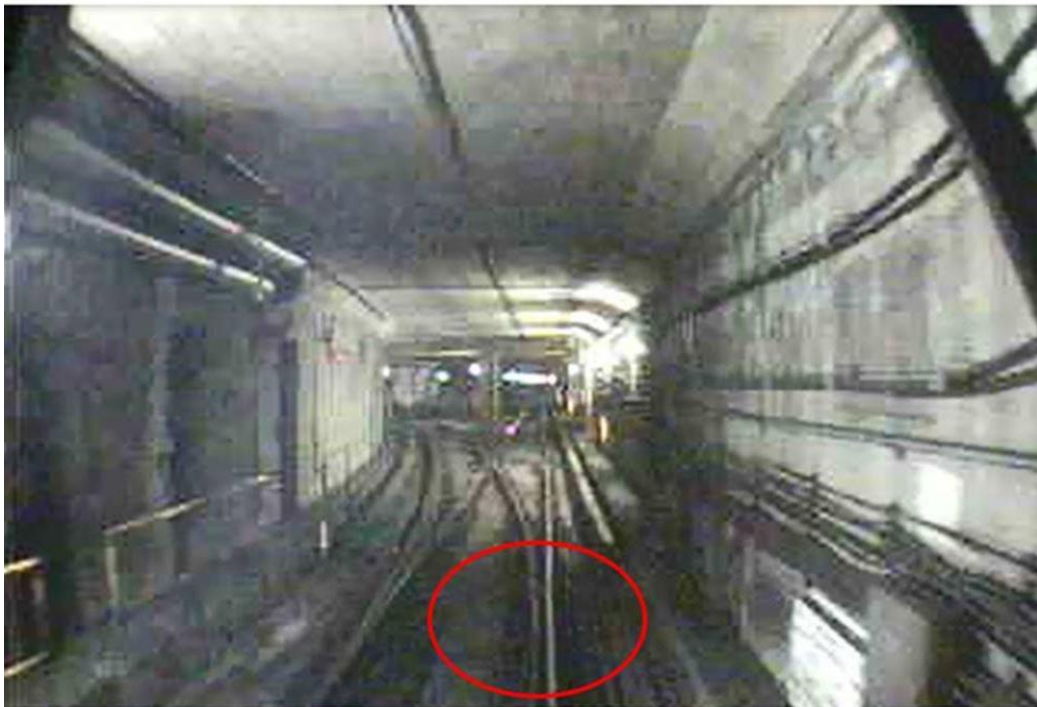
12:42:58 hrs.	The consist straddled switch 1B at Chain Marker (CM) E2-76+80 [switch was in the normal position] with the Master Controller on coast and speed of 8 mph.

Photo 2 – E03 Switch 1B in the normal position.

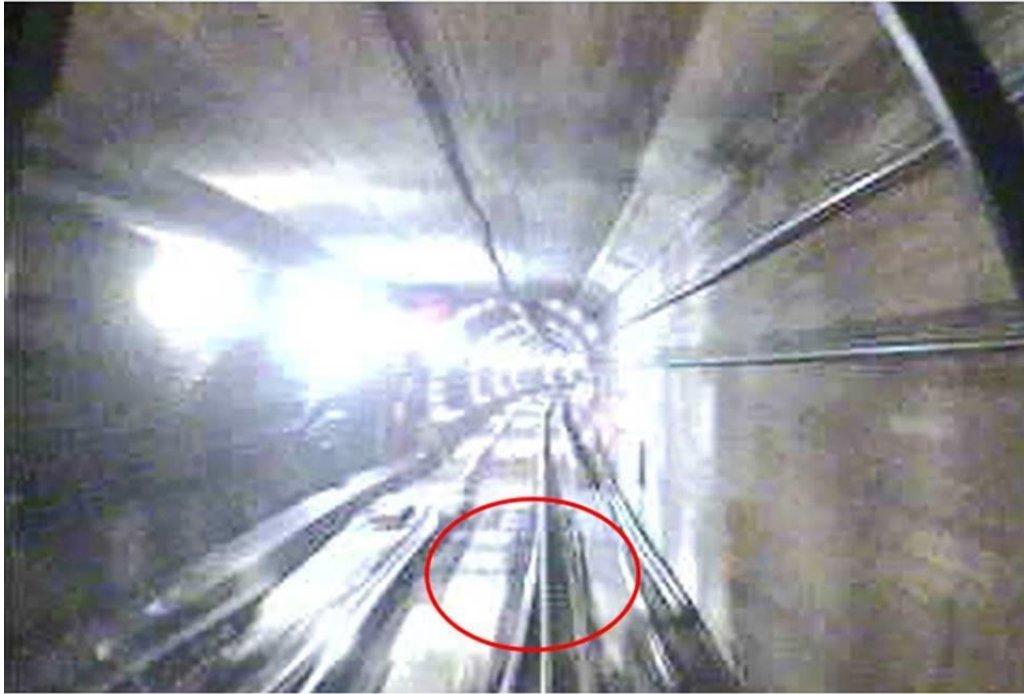
13:06:30 hrs.	The RTRA Supervisor reported that the train jumped the E03-3B switch; however, the train remained on the rails. The Supervisor reported minor damage to the E03-3B switch point. [Radio]

12:43:18 hrs.	The consist straddled switch 3B at CM E2-73+04 [switch positioned in reverse] with the Master Controller on B1-B3 and speed of 10 mph.
12:43:23 hrs.	Master Controller stayed on B1-B3 after straddling the second switch and eventually stopped approximately 27 ft past the second switch.

Photo 3 – E03 Switch 3B in the reverse position.

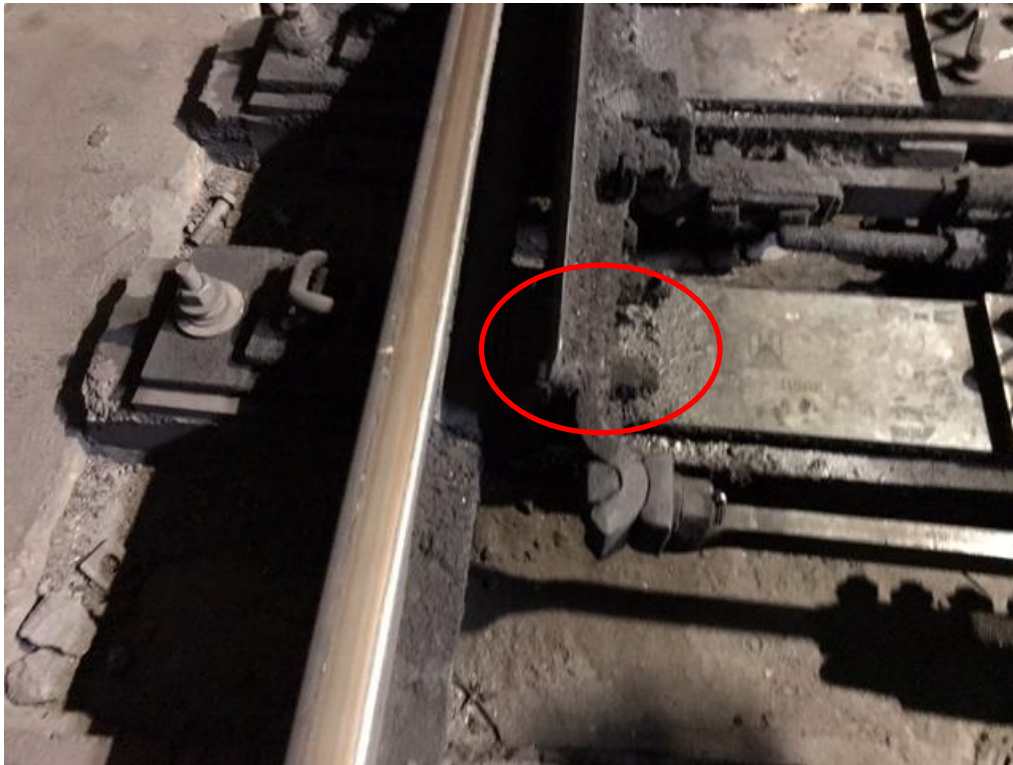
Photo 4 – Minor chip in the E03-08 switch point.

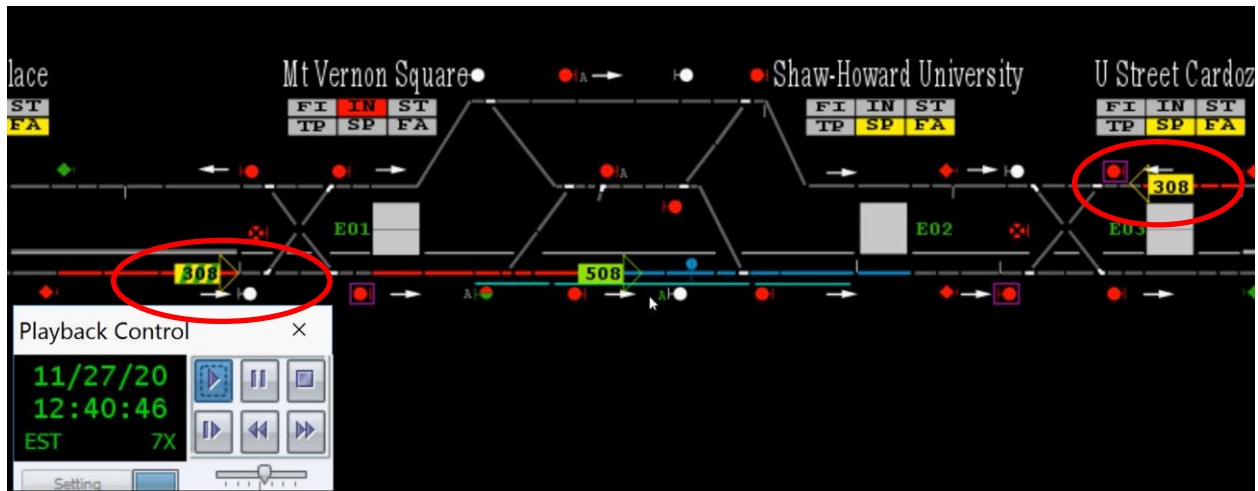
Diagram 4 – AIMS indication displays two trains with identical IDs; one located on Track 1 in approach to Mt. Vernon Square in preparation to enter the single-track area and the second train located at U Street Station, Track 2.

- AIMS displayed two trains with identical Train IDs [Train ID 308]. One train was located at Mt. Vernon Square Station, Track 2 and the second train was located at U Street Station, Track 2.
- The Radio RTC did not specify which Train Operator they were communicating with by not providing the Train ID number, location and track. The Radio RTC was in direct violation of MSRP General Rule 1.78, which states: "Employee shall, when communicating with ROCC, provide train/unit number or name/title and location (including track number when appropriate). ROCC shall acknowledge employee by repeating train number, location and track."

Metrorail has raised the notification level of the duplicate train ID alarm in the AIM system in the ROCC to a “super major alarm” as of July 2021, and is training ROCC personnel on actions to be taken, including changing the train ID to a new number.

Metrorail has begun revisions to its scheduling plans intended to avoid duplicate train IDs. Generally, these revisions will provide for odd numbered trains moving in one direction (east or northbound) and even numbered trains moving in the other direction (west or southbound). The development of these scheduling software adjustments began in October 2021 after additional WMSC follow-up. The adjustments are expected to be implemented in 2022.

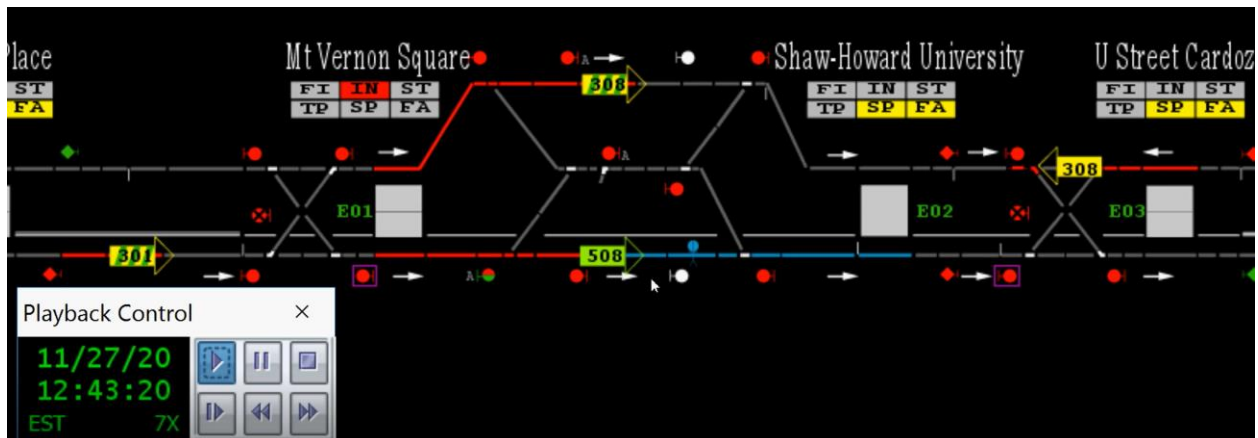
Diagram 5 – Train ID 308 traversing the single-track area; an additional train with an identical Train ID located at U Street Station, track 2 passed E03-08 signal while displaying a red aspect.
