WMSC Commissioner Brief: W-0084 – Customer Evacuation – near Fort Totten & Georgia Ave.-Petworth stations – December 13, 2020

FINAL REPORT OF INVESTIGATION A&I E20488

Date of Event:	December 13, 2020
Type of Event:	Customer Evacuation
Incident Time:	21:03 hrs.
Location:	Fort Totten Station, Track 2
Time and How received by SAFE:	21:03 hrs. – SAFE On-Call Phone
WMSC Notification Time:	22:41 hrs.
Responding Safety Officers:	WMATA SAFE: No WMSC: No Other: No
Rail Vehicle:	Train ID 308 and Train ID 502
Injuries:	None
Damage:	None
Emergency Responders:	DCFEMS, MTPD, RTRA, TRPM
SMS I/A Incident Number:	SMS 20201213#90755

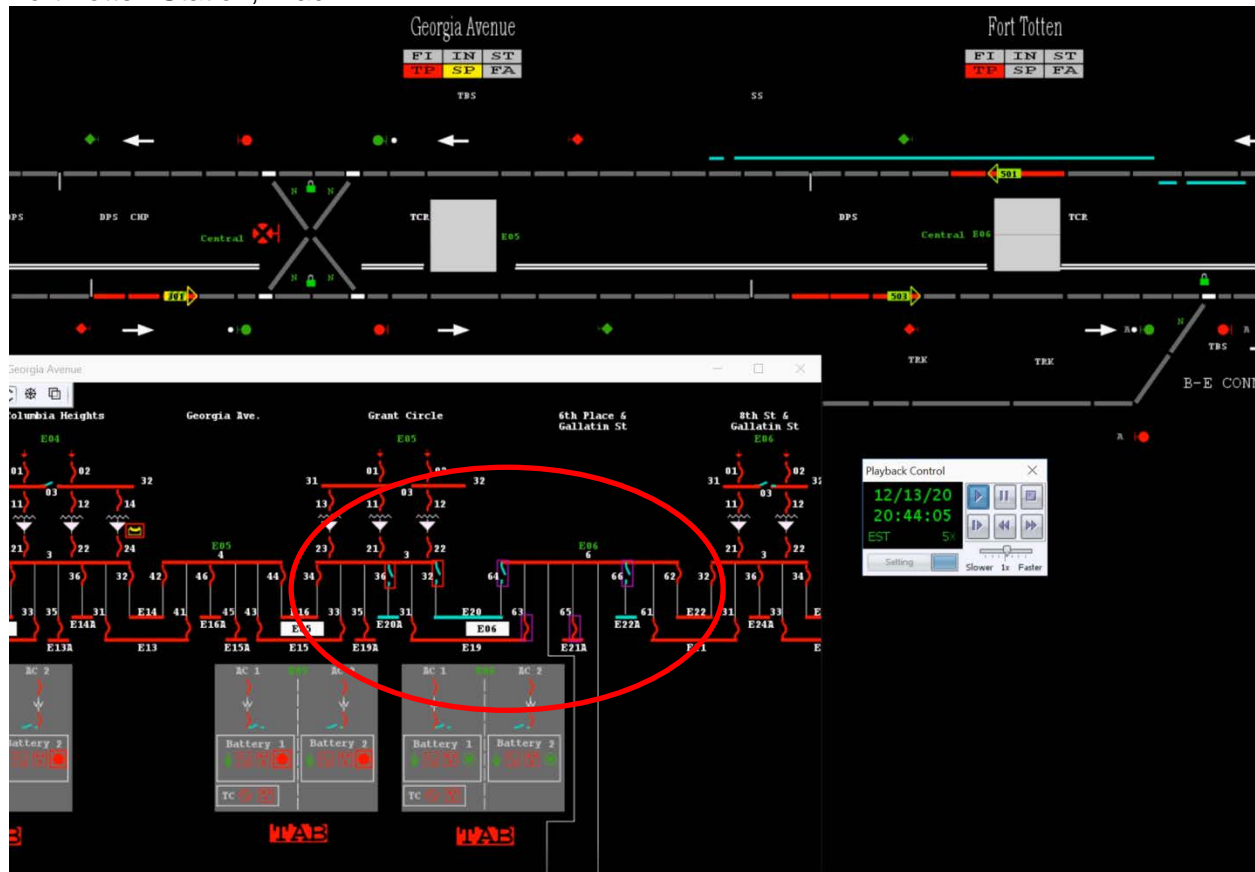
On Sunday, December 13, 2020, at a Time frame from approximately 20:42:55 hrs. to 20:44:15 hrs., the Train Operator of Train ID 501 [Green Line] serviced Fort Totten Station. During this time frame, AIMS playback indicated breakers 36, 32, 64, and 66 opened uncommanded and de-energized third-rail power briefly from 20:44:05 – 20:44:10 hrs., before Train ID 501 departed Fort Totten Station, Track 2.

Photo 1 – Time Frame from 20:42:55 hrs. to 20:44:15.

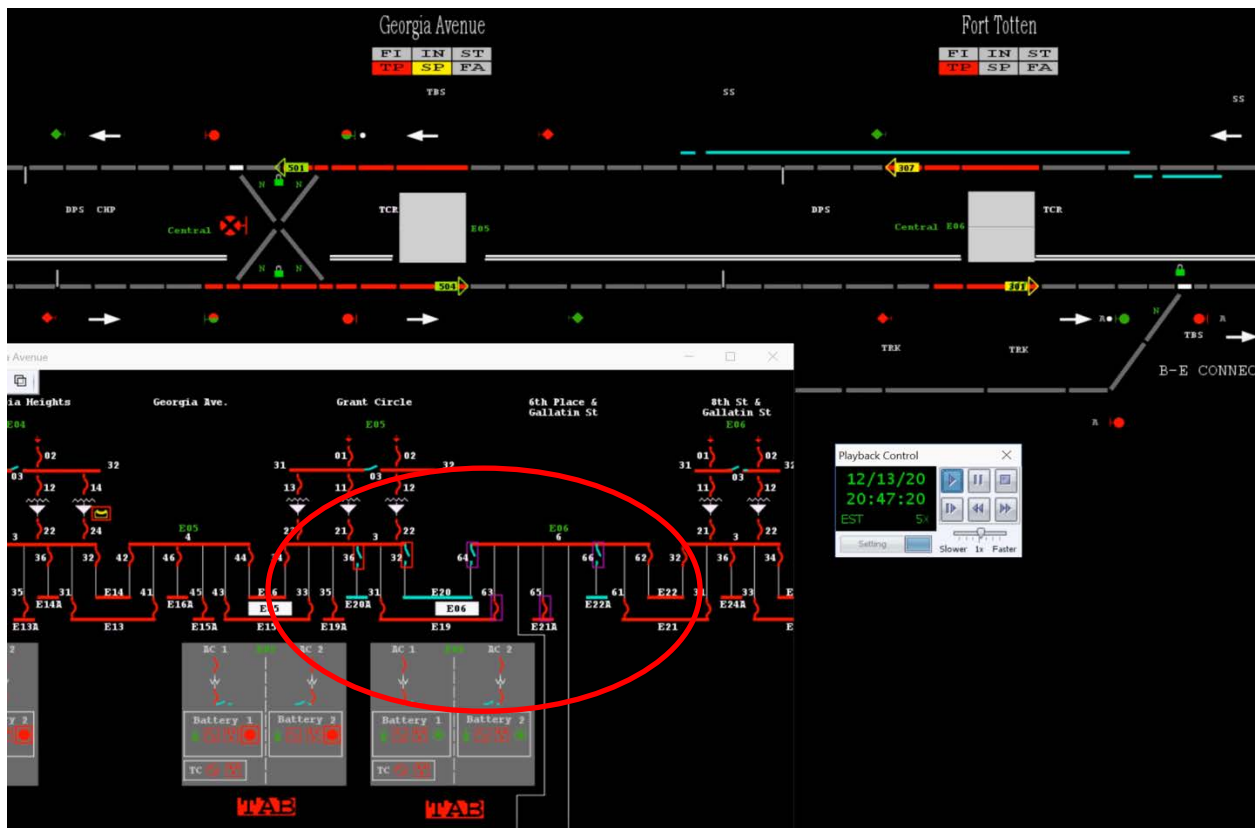
At a time frame from approximately 20:45:00 hrs. to 20:47:15 hrs., the Train Operator of Train ID 307 [Yellow Line] serviced Fort Totten Station and at 20:47:10 hrs. During this time frame, AIMS playback indicated breakers 36, 32, 64, and 66 opened uncommanded third-rail power de-energized again for a duration of 55 seconds from 20:47:20 hrs. - 20:48:05 hrs.]

Photo 2 - 20:45:00 hrs. to 20:47:20 hrs.

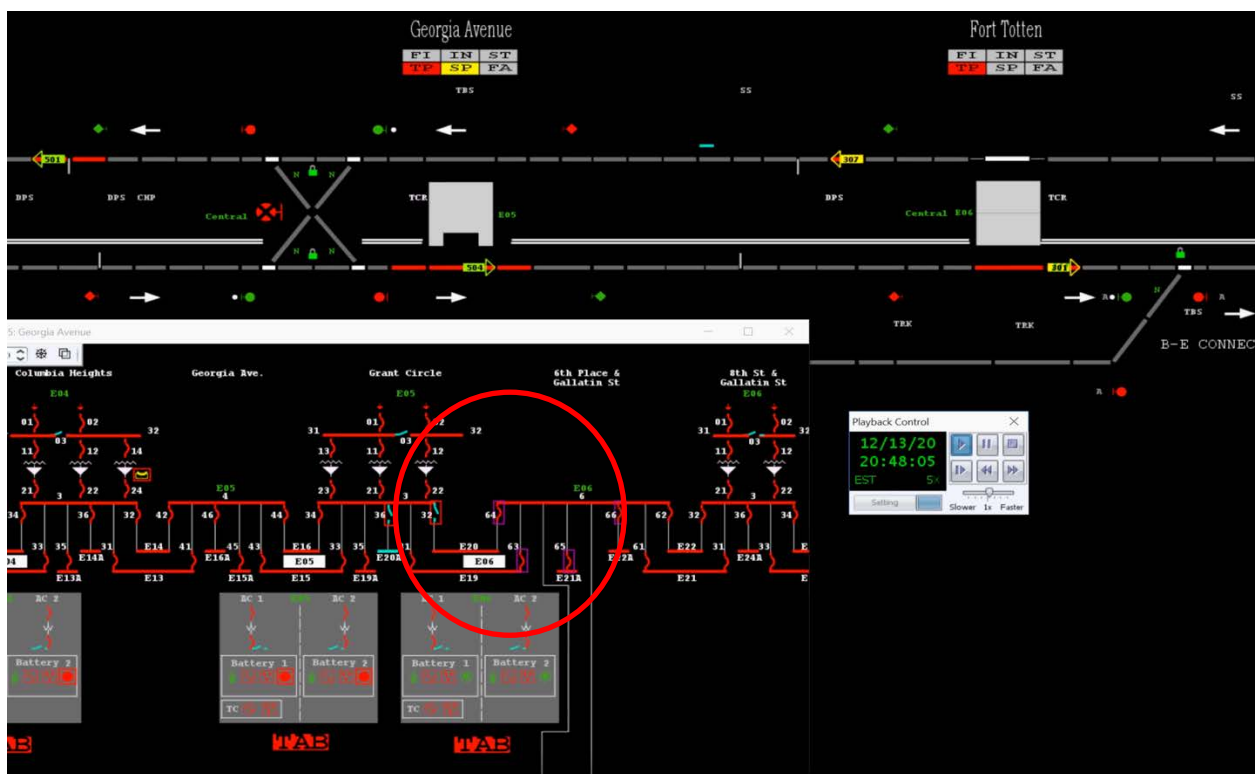
At approximately 20:48:05 hrs., ROCC remotely commanded Breakers 66 and 64 closed remotely, and third-rail power was reenergized.

Photo 3 – Power reenergized within Fort Totten platform limits

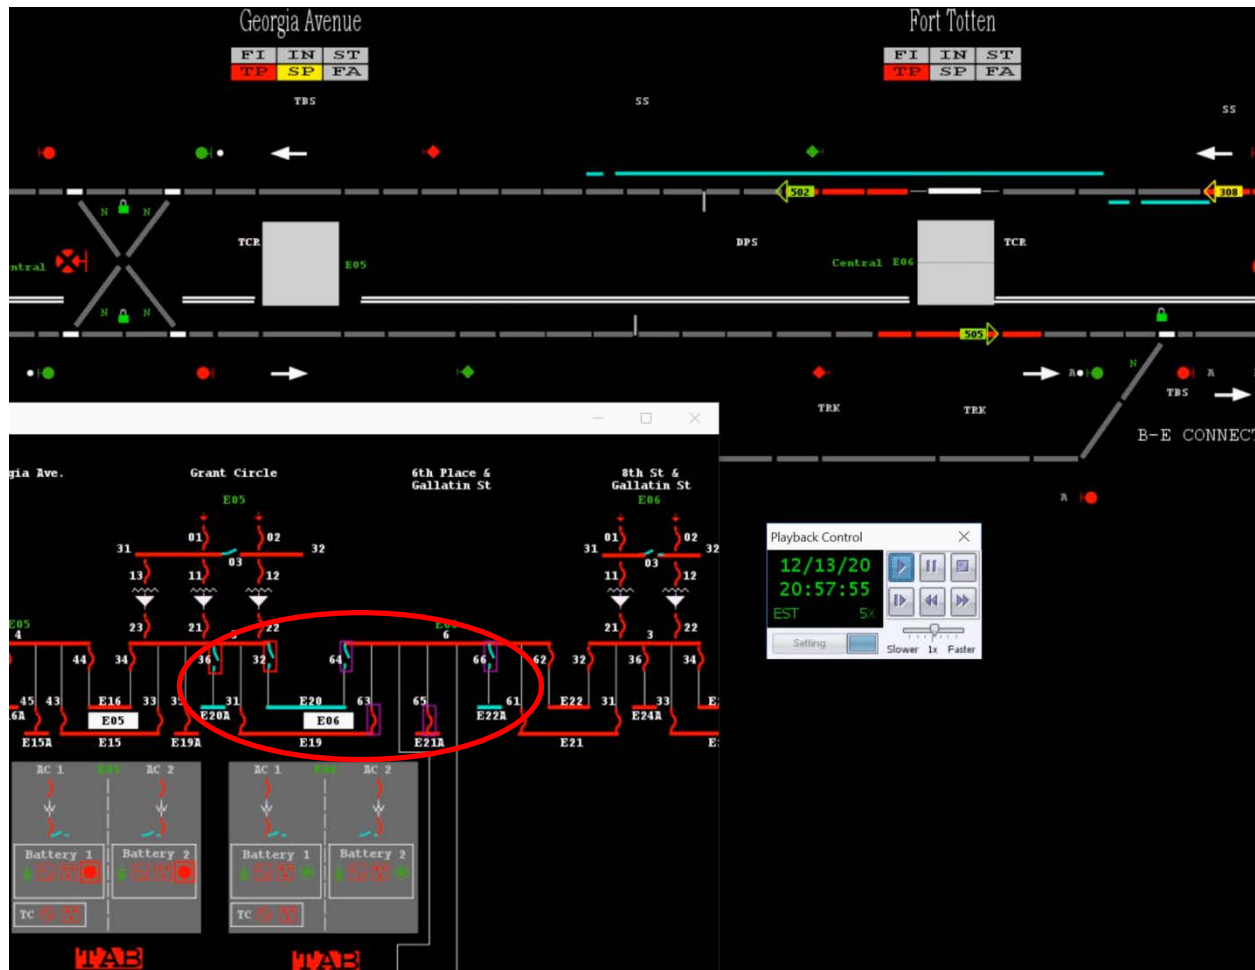
At approximately 20:57:55 hrs., breaker #36, 32, 64, and 66 open uncommanded and Third-rail power de-energized at Fort Totten Station, Track 2. After Train ID 502 [Green Line,] Train Operator departed Fort Totten Station, and Train ID 308 [Yellow Line] Train Operator approached Fort Totten Station, Track 2. Breaker #66 opened and de-energized a third-rail section before Fort Totten Station, Track 2.

Photo 4 – Breaker #36, 32, 64, and 66 showed open as Train ID 502 Train departed Fort Totten Station.

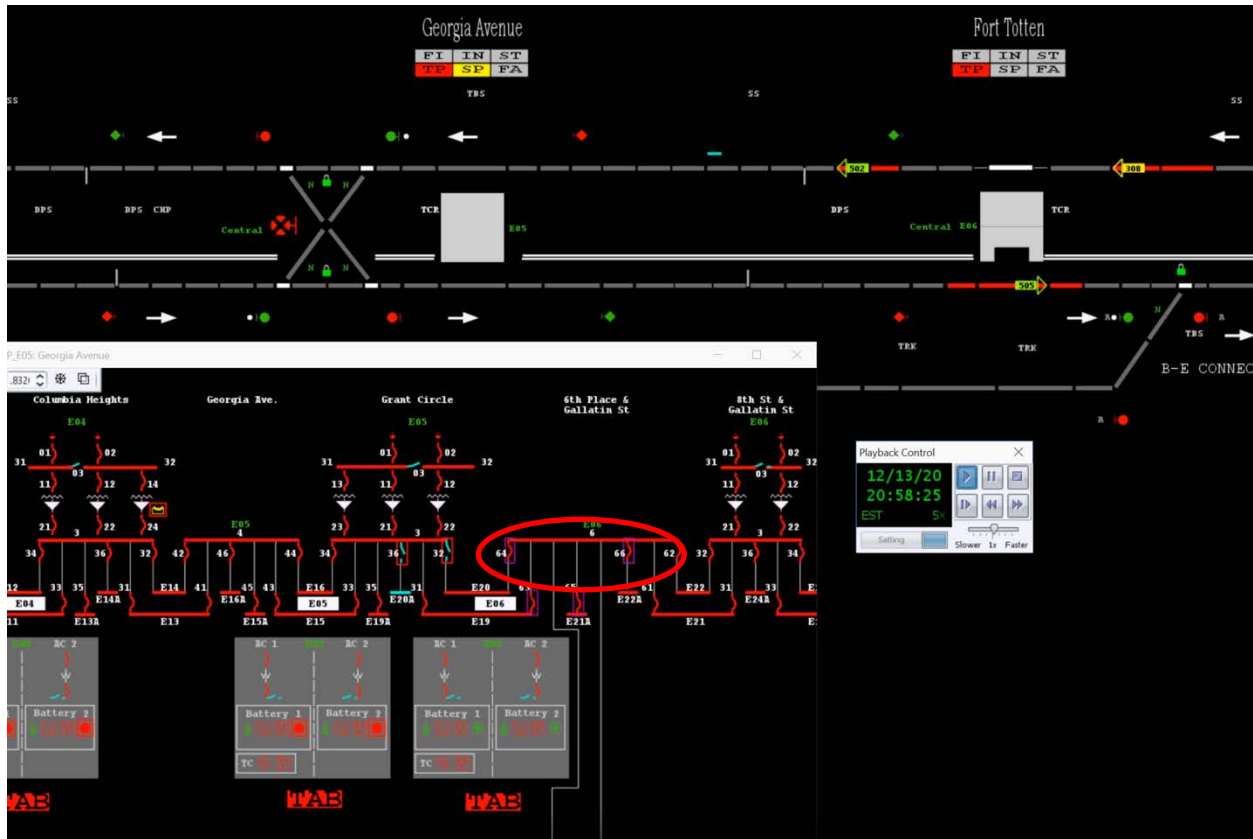
At approximately 20:58:25 hrs., ROCC remotely commanded breakers #64 and #66 closed, and third-rail power was reenergized briefly.

Photo 5 – Breakers #64 and #66

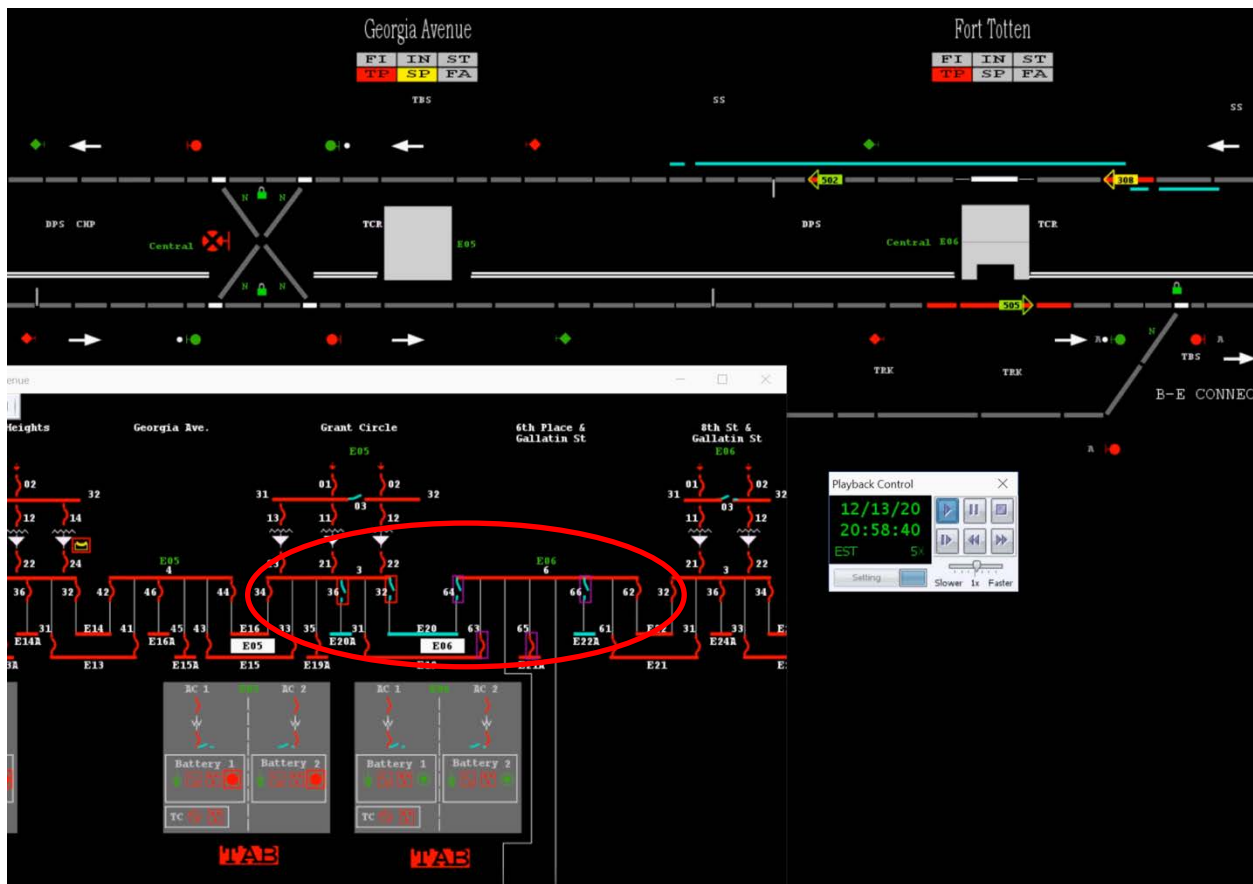
At approximately 20:58:40 hrs., the AIMS indicated breakers #66 and #64 opened [tripped] uncommanded at Fort Totten Station, TBS #2 resulting in third-rail power to de-energize once again. Train ID 502 [Green Line] and Train ID [Yellow Line] 308 moved slightly and stopped.

Photo 6 – Breakers #64 and #66 tripped uncommanded, and trains became stranded.

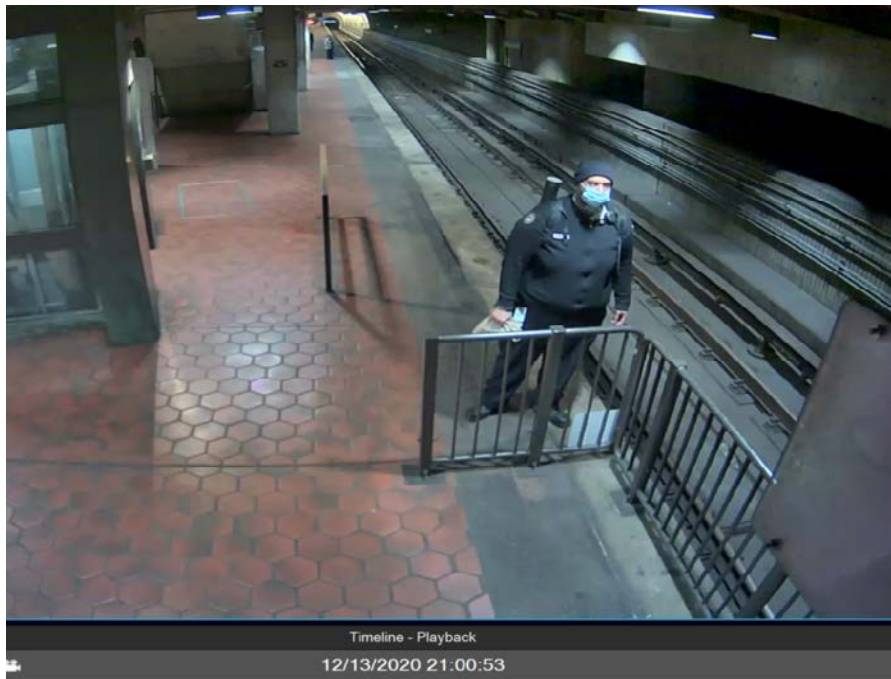
Photo 7 – At 21:00:53 hrs, an RTRA Supervisor was observing the disabled train.

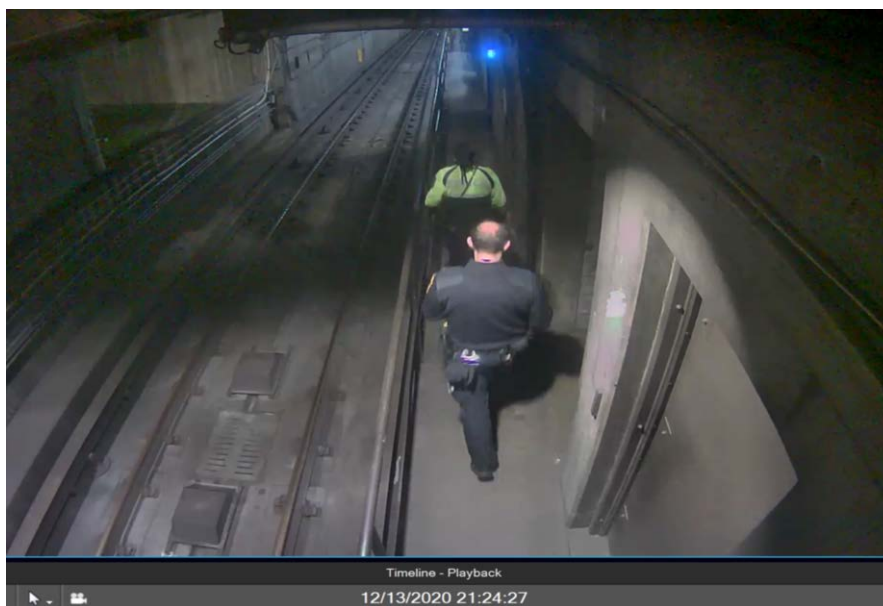
Photo 8 –At 21:24:27 hrs., MTPD Forward Liaison and MTPD Officer Fort Totten Station

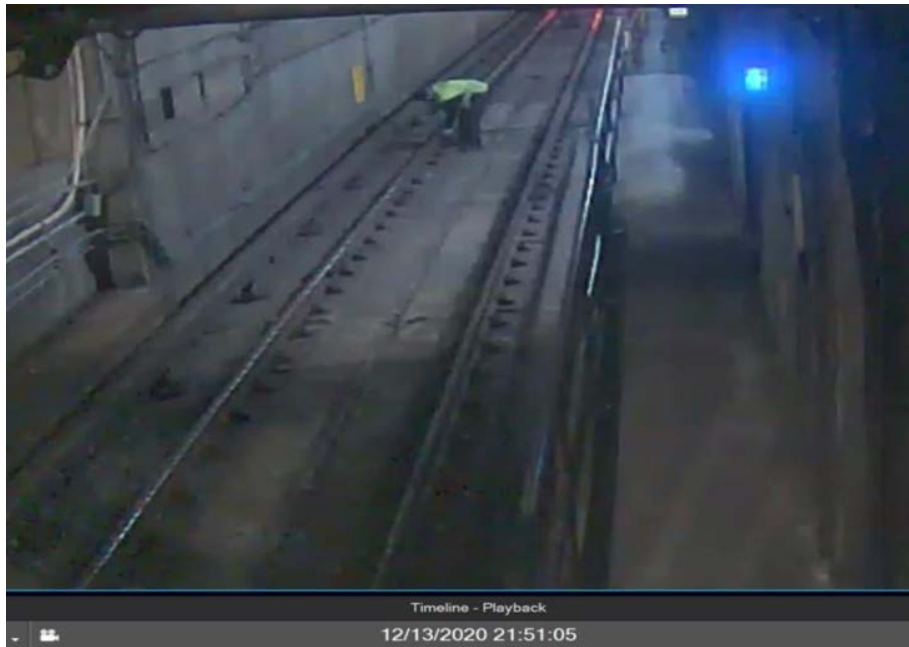
The RTRA Supervisor went beyond the end gate to hot stick and confirmed the third rail was de-energized. DCFEMS arrived on the scene with WSAD but remained on the platform.

Photo 9 – at 21:51:05 hrs., an RTRA Supervisor Hot Stick and confirming third rail power was de-energized Fort Totten Station.

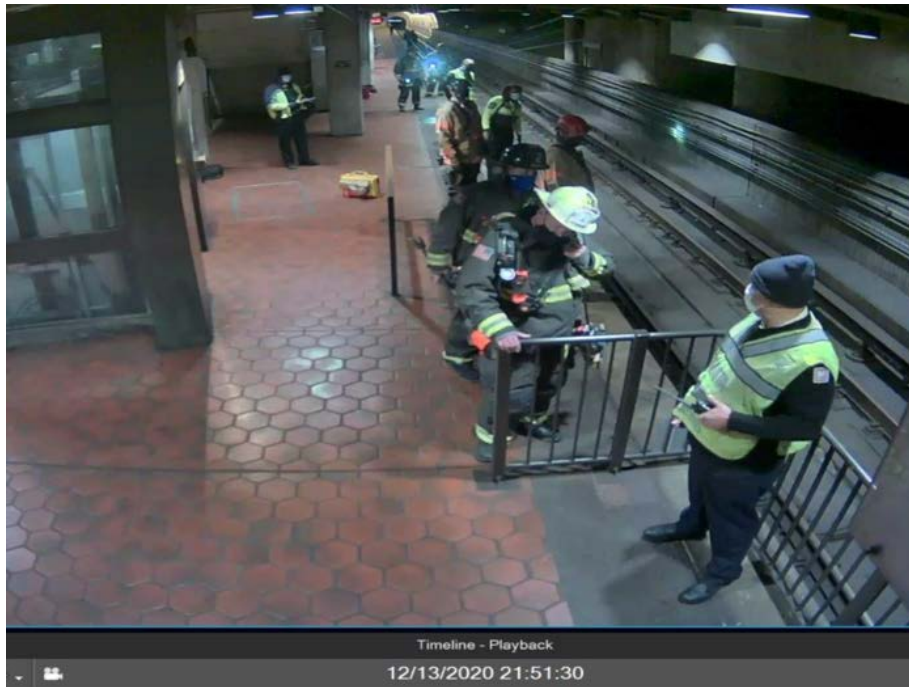
Photo 10 – DCFEMS Arrival at Fort Totten with WSAD at 21:51:30 hrs.

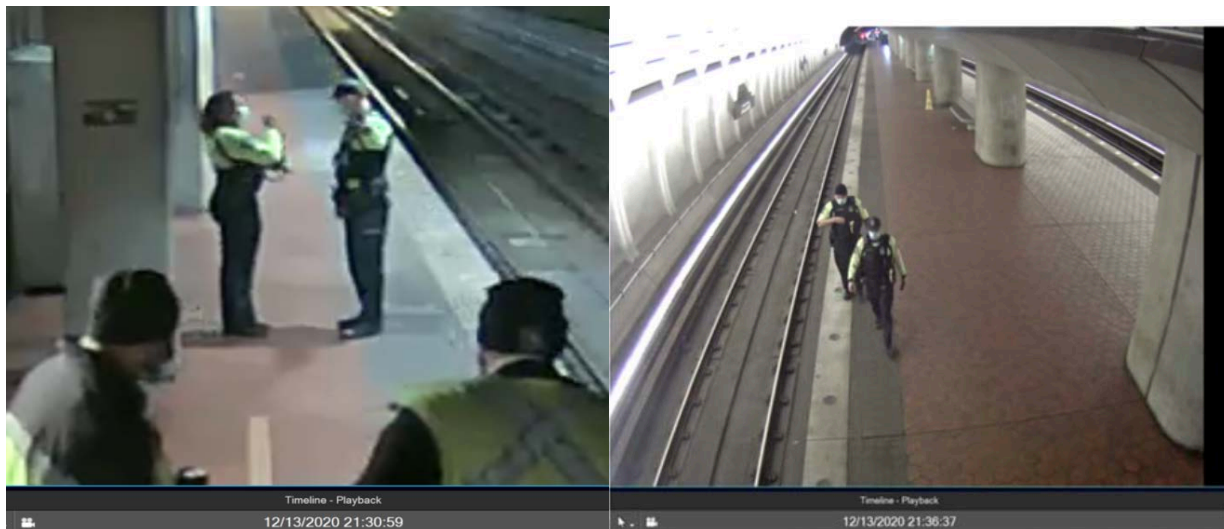
Photo 11 – MTPD Lieutenant [IC] and MTPD Sergeant #1 Photo 12 – MTPD Sergeant #1 with Officer

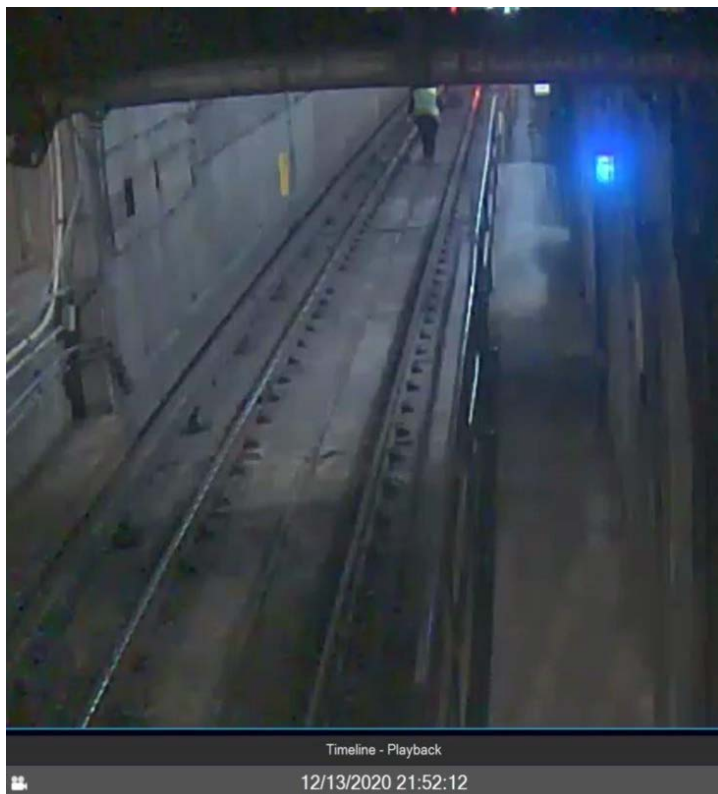
Photo 13 – RTRA Supervisor walks towards the down train at 21:52:12 hrs.

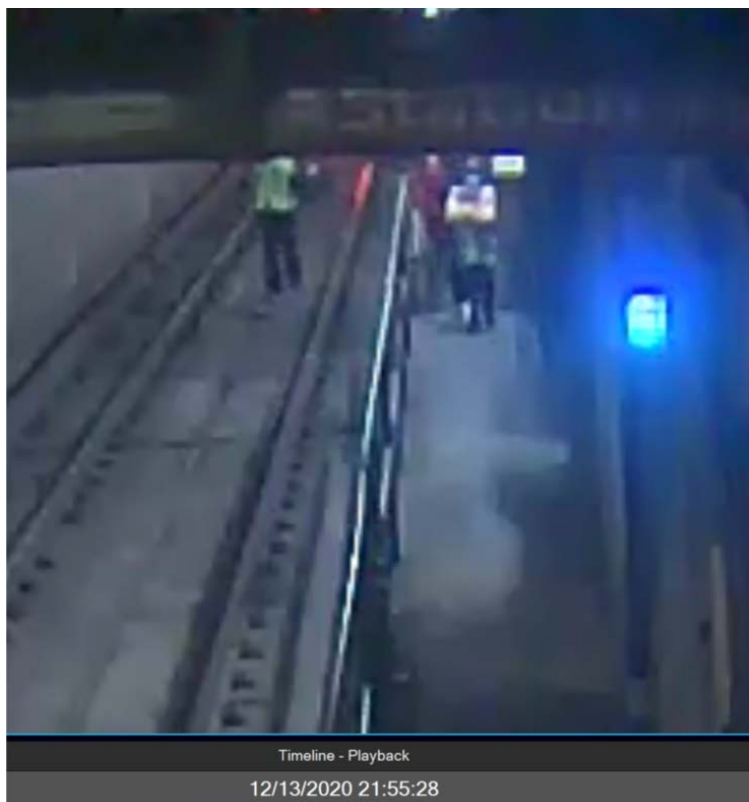
Photo 14 – Passenger evacuation began at 21:55:28 hrs.

At this time, no WSAD is deployed on the third rail. The evacuation started at approximately 21:51 hours and was completed at approximately 21:56 hours. Seven (7) Total passengers evacuated from Train ID 308, including one small child.

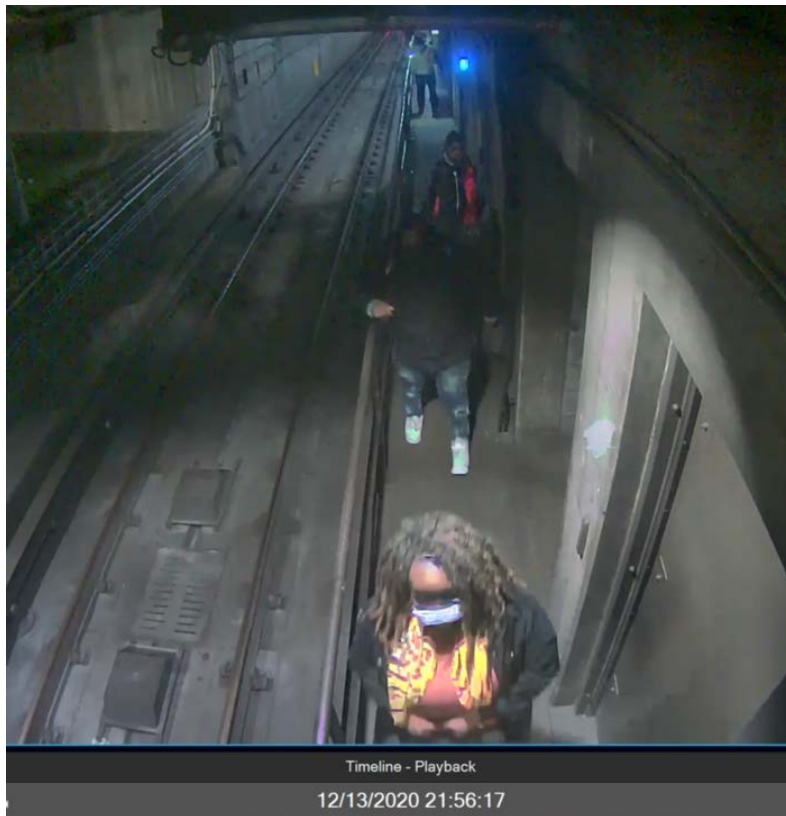
Photo 15 – At 21:56:17 hrs. Customers evacuating

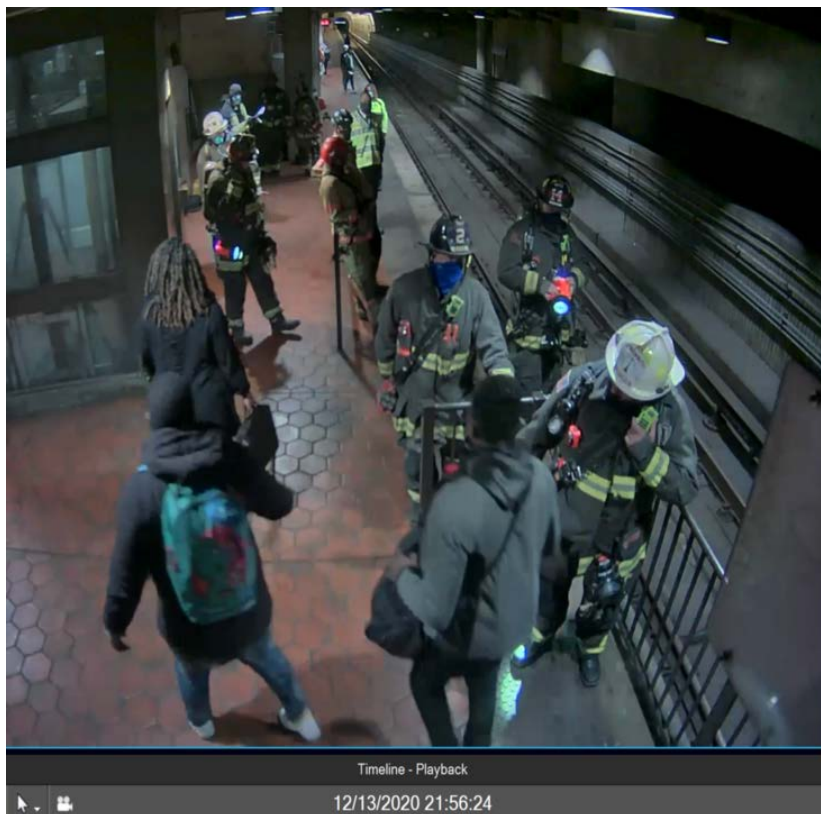
Photo 16 – At 21:56:24 hrs., the last customer evacuated to the platform limits

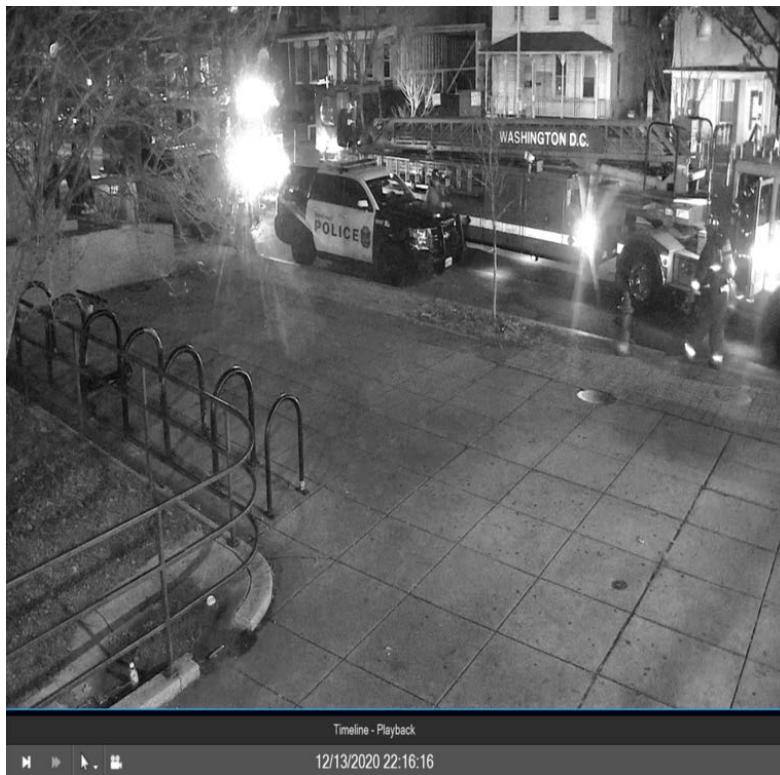
Photo 17 – DCFEMS and MTPD arrive at Georgia Ave Petworth at 22:16:16 hrs

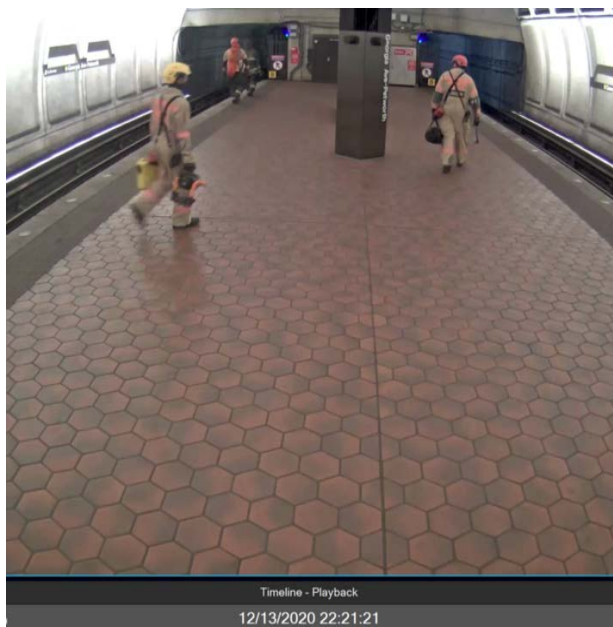
Photo 18 – DCFEMS with WSAD at 22:21:21 hrs.

The DCFEMS did not appear to assist in the evacuation process due to WMATA personnel not following safety procedures with WSADs. An OEM employee arrived on Georgia Ave-Petworth's

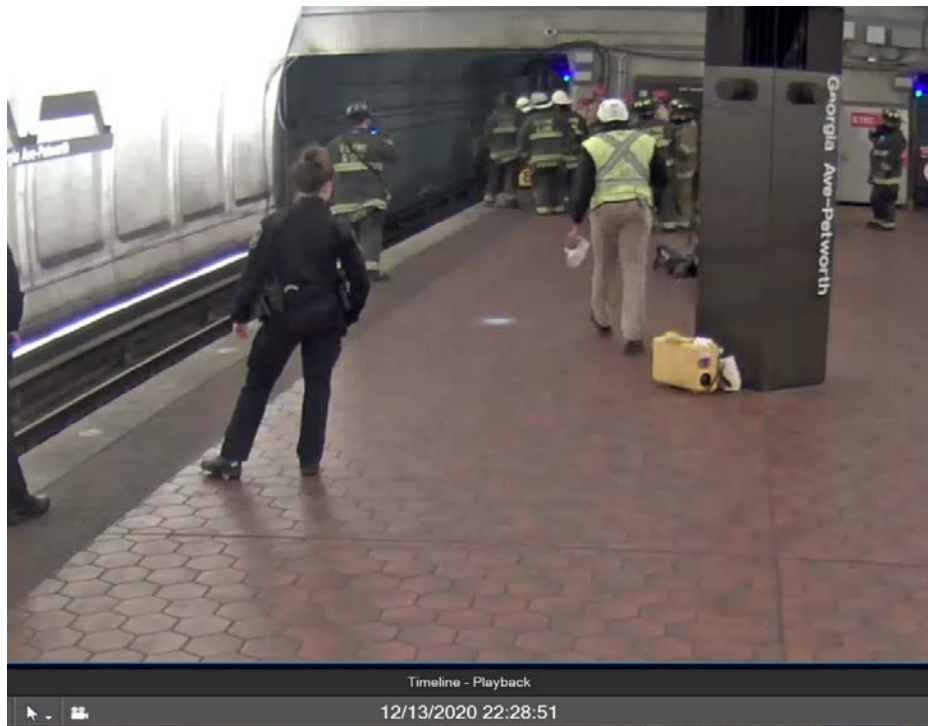
platform with another WSAD, hot stick, and HV Gloves. The OEM employee eventually goes beyond the end gate with HV gloves only, Sergeant IC, and one RTRA Supervisor.

Photo 19 – At 22:28:51 hrs. OEM employee with HV gloves

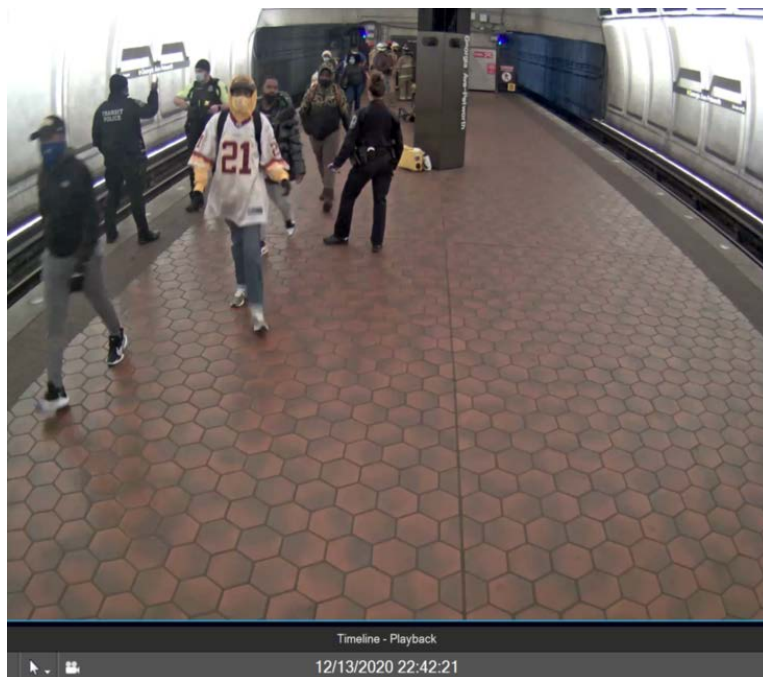
Approximately 16 minutes later, 13 customers evacuate to the platform via the end gate access area. MTPD Sergeant #1 from Fort Totten, MTPD Sergeant #3 IC at Georgia Ave-Petworth, one MTPD Officer from Fort Totten, an OEM employee, and one RTRA Supervisor return to the platform limits.

Photo 20 – At 22:42:21 hrs. Evacuated Customers

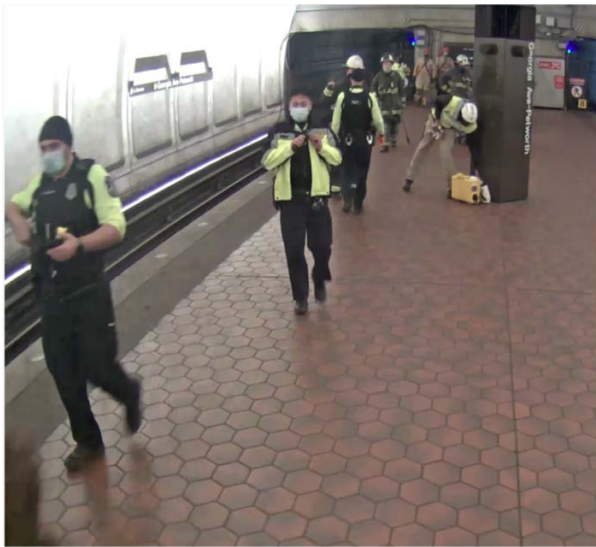
Photo 21 – Three MTPD Officers OEM and RTRA.

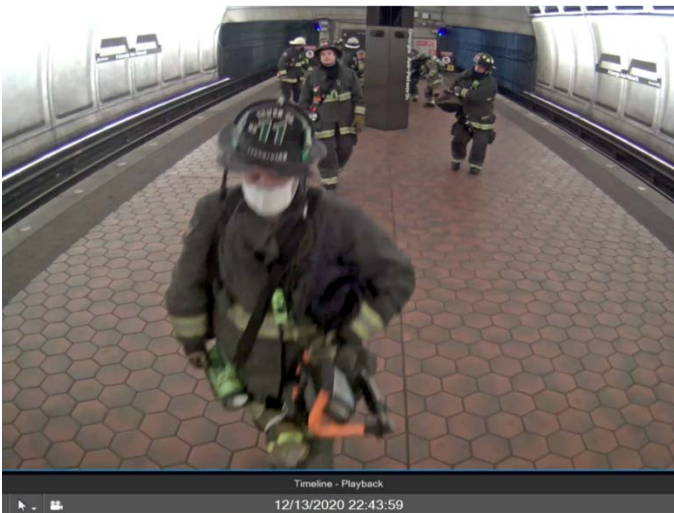
Photo 22 – At 22.43.59 hrs. DCFEMS began their departure.
