WMSC Commissioner Brief: W-0099 – Improper Roadway Worker Protection - Takoma Station - Jan. 18, 2021

FINAL REPORT OF INVESTIGATION A&I E21018

Takoma Station – Improper Roadway Worker Protection

January 18, 2021

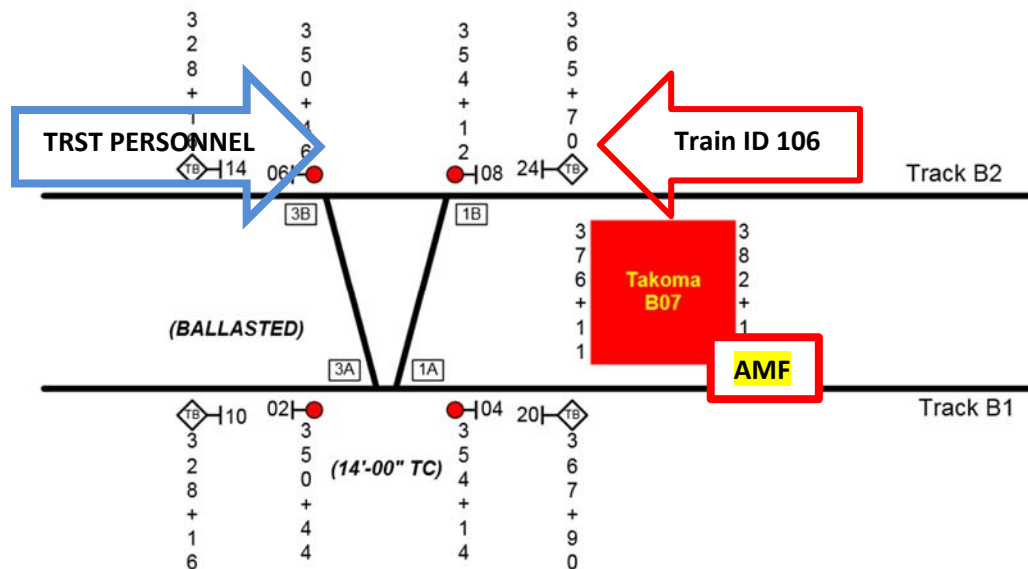
Figure 1 - Takoma Station (does not indicate the exact location of TRST personnel or Train ID 106).
