WMSC Commissioner Brief: W-0127 – Runaway Maintenance Vehicle – Southern Ave. Station – July 9, 2021

Prepared for Washington Metrorail Safety Commission meeting on December 7, 2021

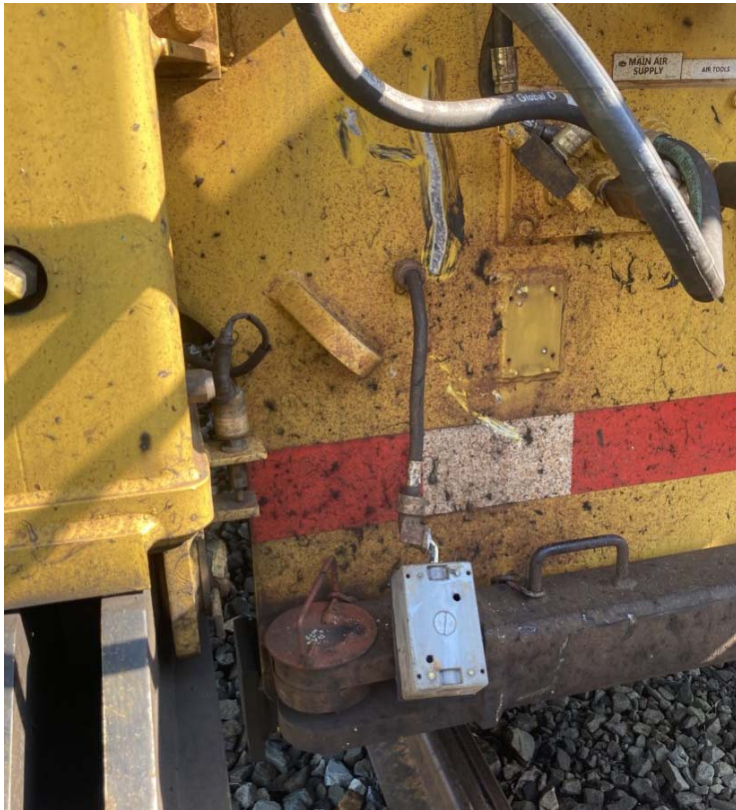
Figure 2 – Damaged electrical box on the left rear of PM65.

- CTEM Mechanics identified a damaged electrical box on the left rear of PM65 and the Geismar Track Torqueing Machine damaged.
- During the post-incident inspection performed at Branch Avenue Yard, CTEM identified a 15-second delay between the full parking brake application and the brake indicator light activation.

000-400-ABB BRAKE SYSTEM; PRIME MOVER										
Component:	FLEET	Work Accomp:	INSPECTED	Reason:	INSPECTION	Status:	CLOSE	Position:		Warranty?:	N
30	B-end electrical receptacle box replacement										
	Installed electrical receptacles on rear of Prime mover - Damaged										
	Howlin - 7/12/21 - Finish electrical repairs on rear of PM65 - Repair and straighten Hydraulic lines that were damaged.										
Component:	000-400-ABH-D00 DISTRIBUTION WIRING	Work Accomp:	REPLACED NEW	Reason:	DAMAGED	Status:	CLOSE	Position:		Warranty?:	N
Planned Materials											
Task ID	Item	Description	Storeroom	Issue Unit	Quantity	Unit Cost	Line Cost				
	R23810047	VALVE,BRAKE,PARKING	300	EA	1	\$47.66	\$47.66				
	R23800021	DESICCANT: CONTAINER: CARTRIDGE, FITS: K13R 900-3 BR REGULATOR, TYPE: AIR DRYER	252	EA	2	\$56.94	\$113.89				
	R59750398	BOX,ELECTRICAL:WATERPROOF,1 GANG,2-3/4 IN WD X 4-1/2 IN LG X 1-7/8 IN DP,(5) 3/4 IN KO'S	300	EA	1	\$4.59	\$4.59

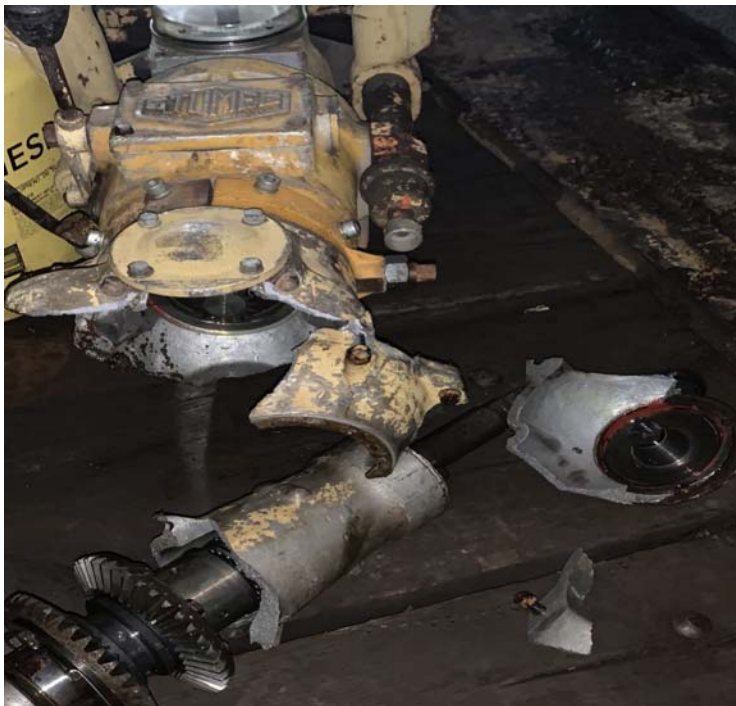
Figure 3 – Damaged Geismar Track Torquing Machine.

Inspection Fault Report:
<p>Parking brake failed to operate as designed. Unit rolled after brake was applied</p> <p>Also track wrench D41 received excessive damage from the impact sent unit to small equipment repair shop cost estimate</p>

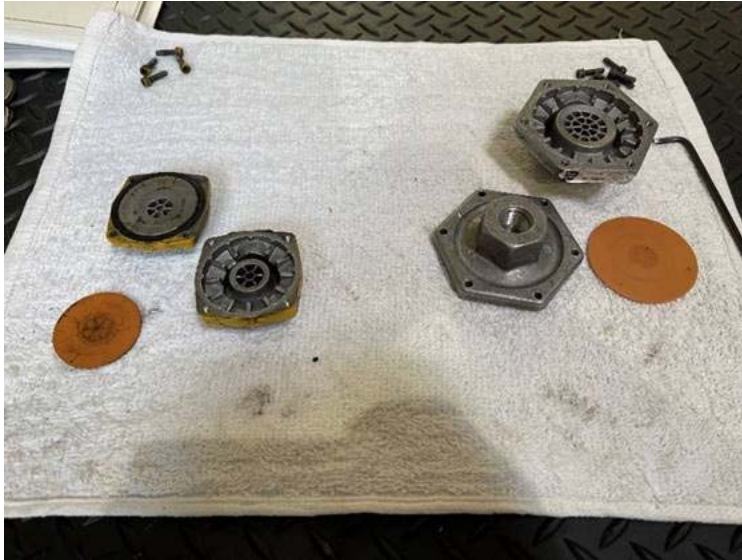
On July 12, 2021, SAFE observed CTEM perform a brake pneumatic system inspection to inspect for contaminants that could cause quick-release valve failure on PM65. CTEM took apart Quick Exhaust Valve 52 and Quick Exhaust Valve 77 on PM65 and identified that both valves contained a build-up of contaminants. CTEM determined that the contaminants caused both Quick Exhaust Valve Diaphragms to be stuck in the closed position, which likely caused the delay in full parking brake application. CTEM reported that when they changed both Quick Exhaust Valves on PM65, the application of the parking brakes engaged nearly instantaneously with simultaneous parking brake indicator light illuminations. CTEM installed a new anti-compounding valve and replaced the parking brake valve on PM65 as a preventative measure. CTEM performed an operational check after the necessary repairs, and all systems were functioning as designed per the Original Equipment Manufacturer (OEM) manual. **Note:** CTEM reported no contaminants were found in the quick release valves. See Addendum E. The brake system is pneumatic. All PMs were tested for immediate application, for both service and parking brake functions, immediately after the incident. One Plasser PM was found to have a leaking quick-release valve, however it did not impair the brake system. CTEM also conducted a campaign to replace all quick-release valves in all Plasser PMs as an additional measure to improve reliability and safety. See Addendum I. All valves have since been replaced.

Figure 4 – PM65 Quick Exhaust Valve 77 on the left and Quick Exhaust Valve 52 on the right both replaced.

- CTEM performed a brake pneumatic system inspection and identified that both valves contained a build-up of contaminants. CTEM replaced both valves on PM65, which corrected the delayed application of braking and indicator light illumination.

Total Actual Materials:									\$273.31
Failure Reporting									
Cause	Remedy				Supervisor		Remark Date		
1551 DEFECTIVE PART	0004	REPLACED							07/15/2021
Remarks: Replaced 2 OR50 and 1 OR37B quick release valves for front truck

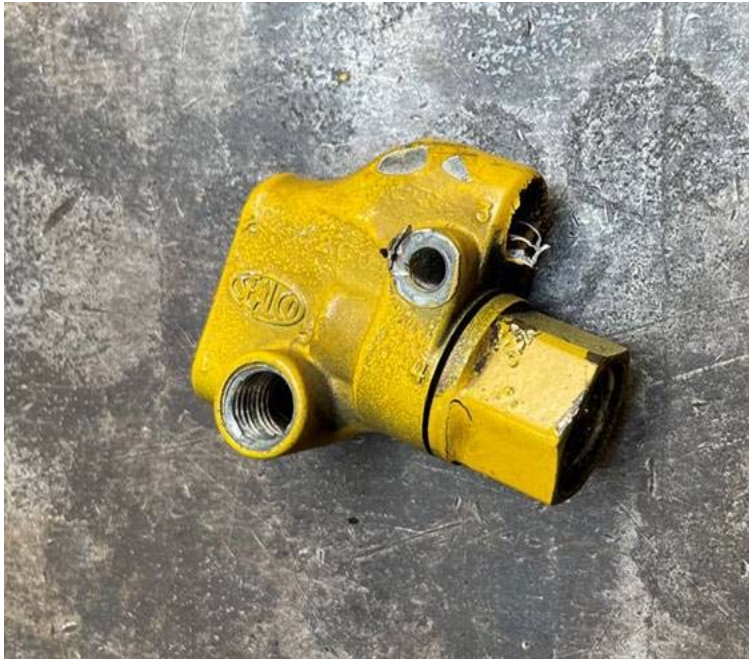
Figure 5 – PM65 Two Way Check Valve replaced.
