WMSC Commissioner Brief: W-0128 – Improper Vehicle Movement – Franconia-Springfield Station – July 16, 2021

Date of Event:	08/16/2021
Type of Event:	Improper Rail Vehicle Movement
Incident Time:	0600 hours
Location:	Franconia-Springfield, Track 2
Time and How received by SAFE:	0658 hours SAFE IMO
WMSC Notification Time:	0658 hours
Responding Safety Officers:	WMATA SAFE: No WMSC: No Other: N/A
Rail Vehicle:	Train ID 401, L7032-7033.7189-7188.7166-7167.7251-7250T
Injuries:	None
Damage:	None
Emergency Responders:	None
SMS I/A Incident Number:	20210830#95294

Franconia-Springfield – Improper Rail Vehicle Movement

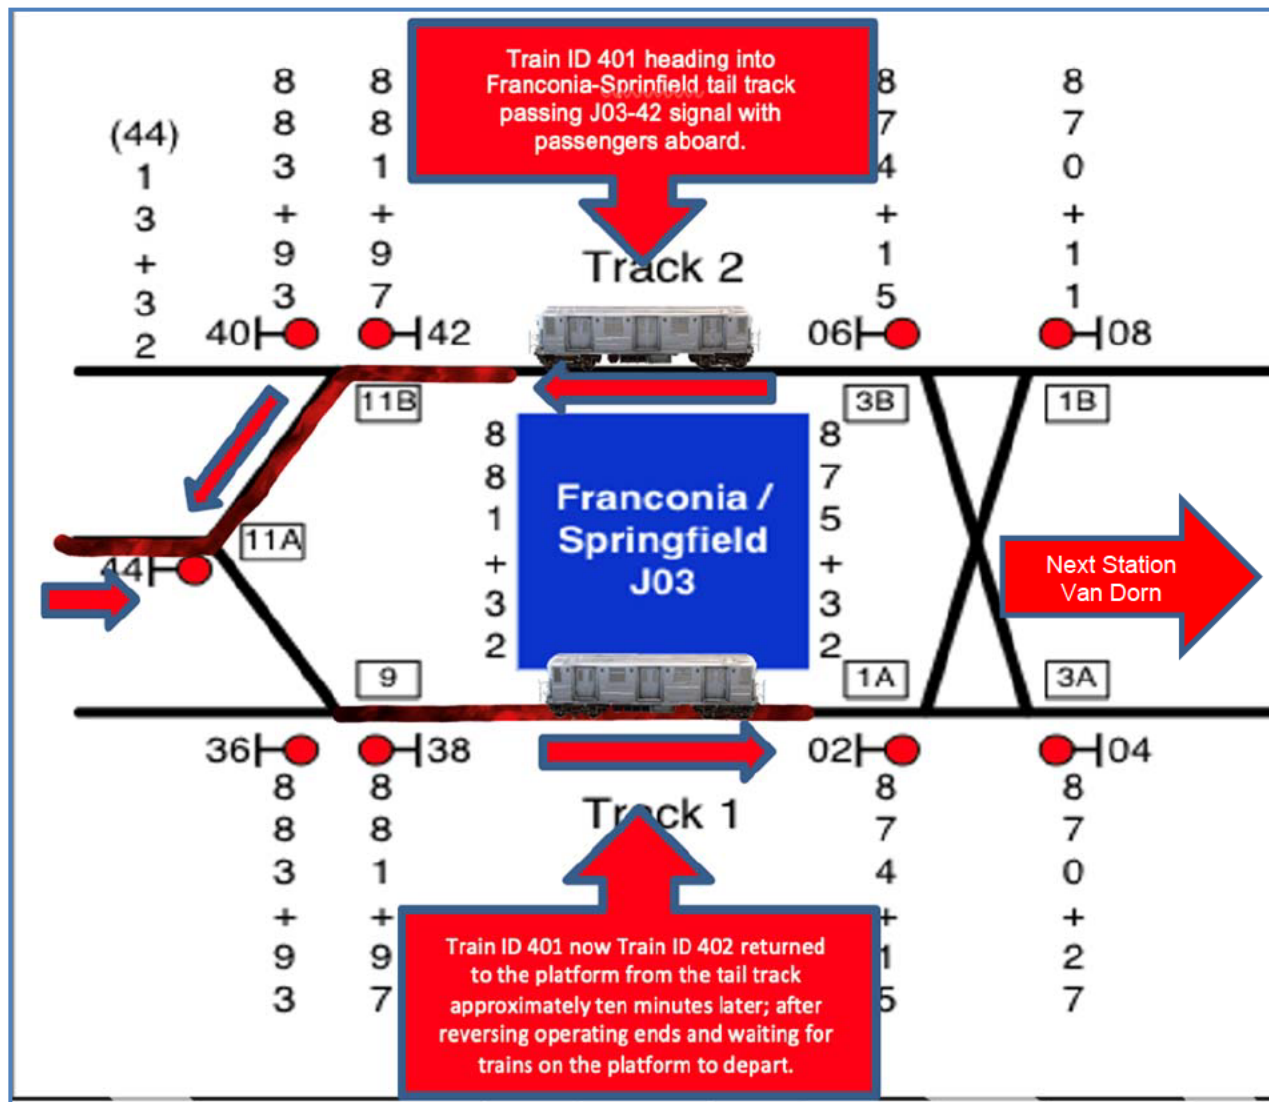
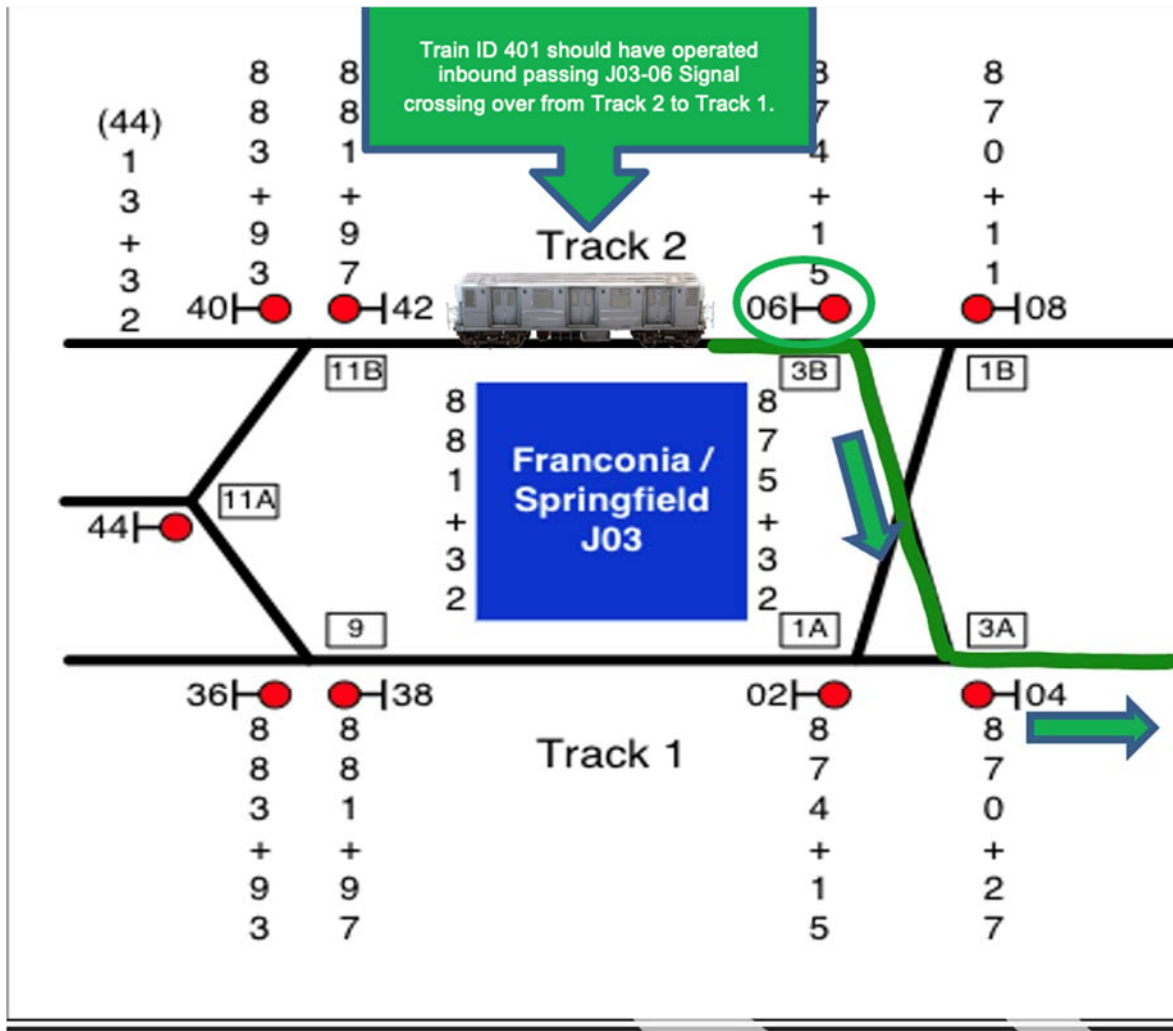
Field Sketch/Schematics

Franconia-Springfield Station, Track 2

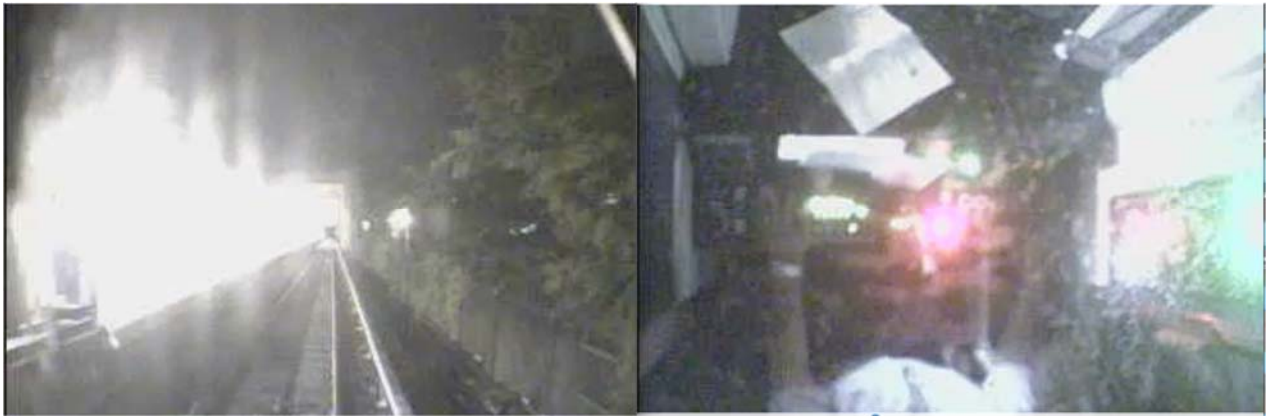
Figure 1- Train ID 401 Train Operator entering Franconia-Springfield Station, Track 2.

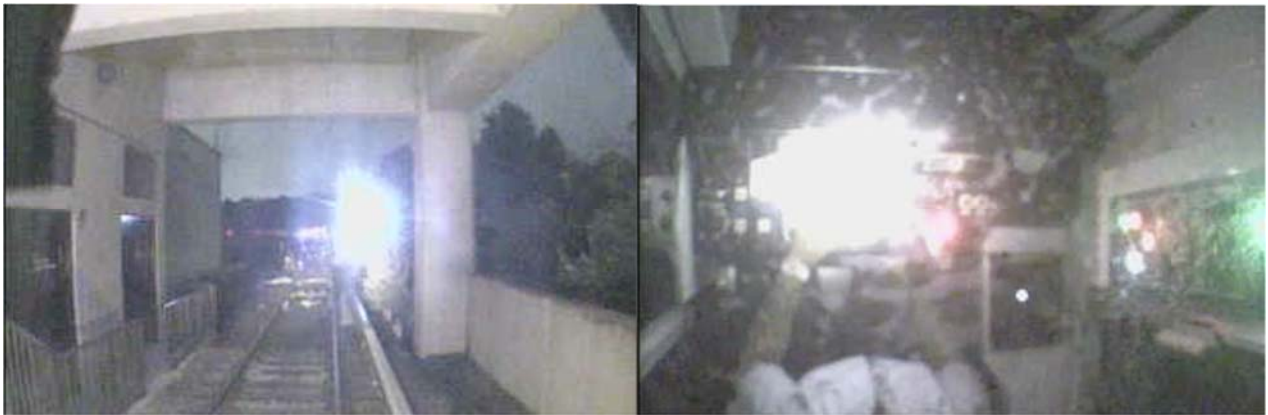
Upon arrival, Train ID 401 performed a left-side door operation, which allowed customers to board the train. After opening the doors, the Train Operator entered Stop-and-Proceed mode. While waiting at the station, Train ID 401 reviewed work-related documentation for approximately 14 minutes before departure.

Figure 2: Train ID 401 observed reviewing work-related train manifest from 0550 hours - 0558 hours while properly berthed at the 8-car marker.

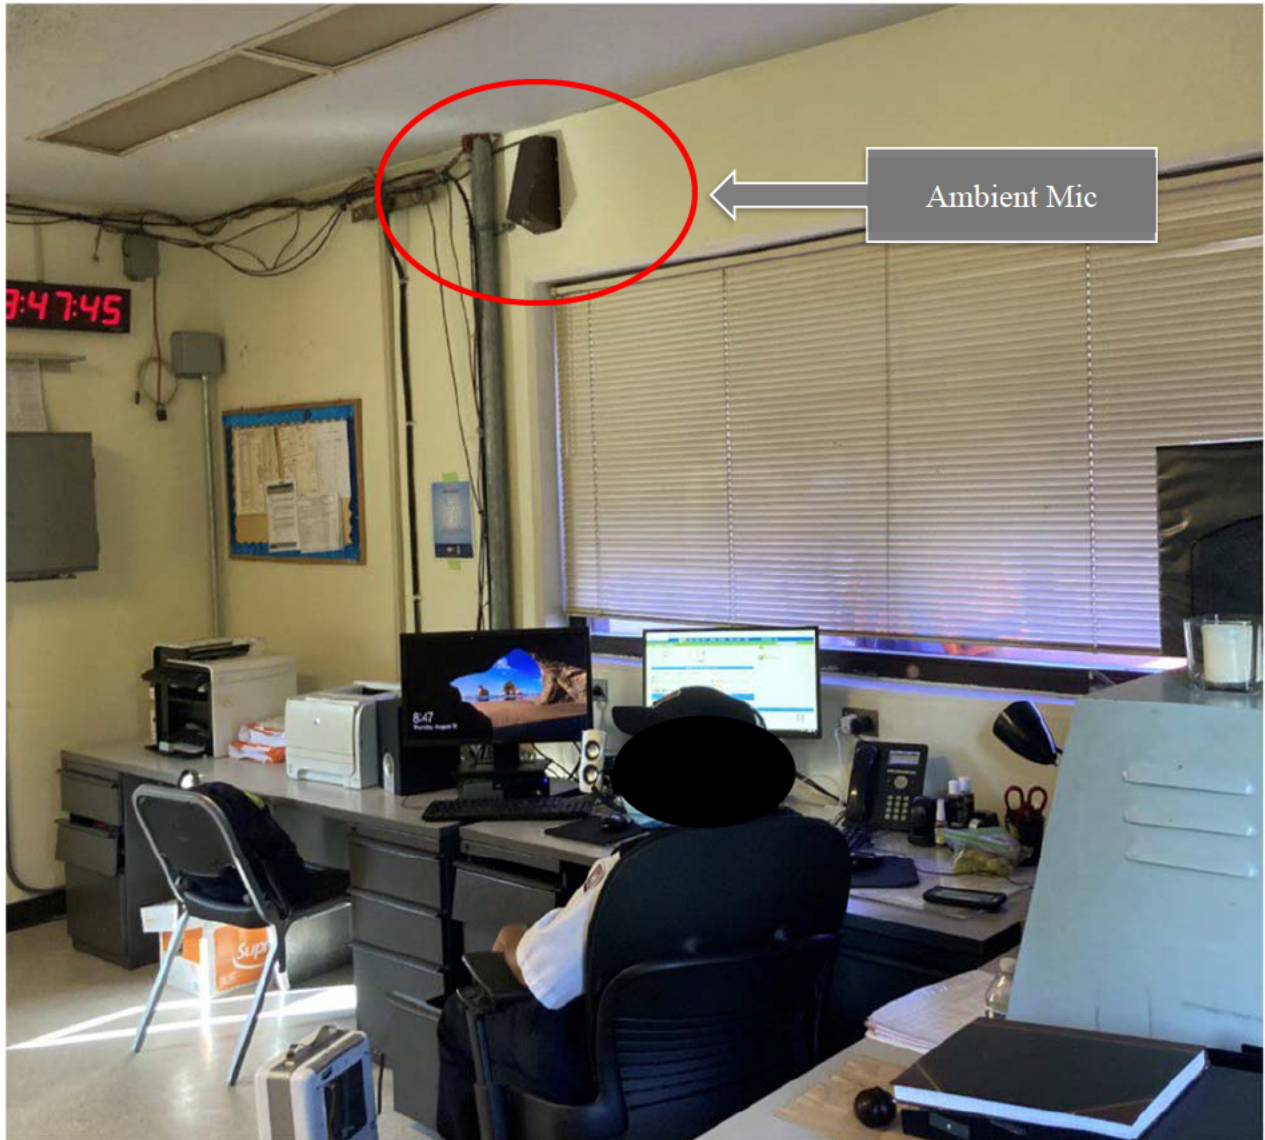
The ambient microphone in the Terminal Supervisor's work area is positioned directly above the Terminal Supervisor's desk. The television in the operator's lounge is approximately 30-35 feet away. The computer at the desk is equipped with speakers.

Figure 3 - Terminal Supervisor Desk and Ambient Mic location.

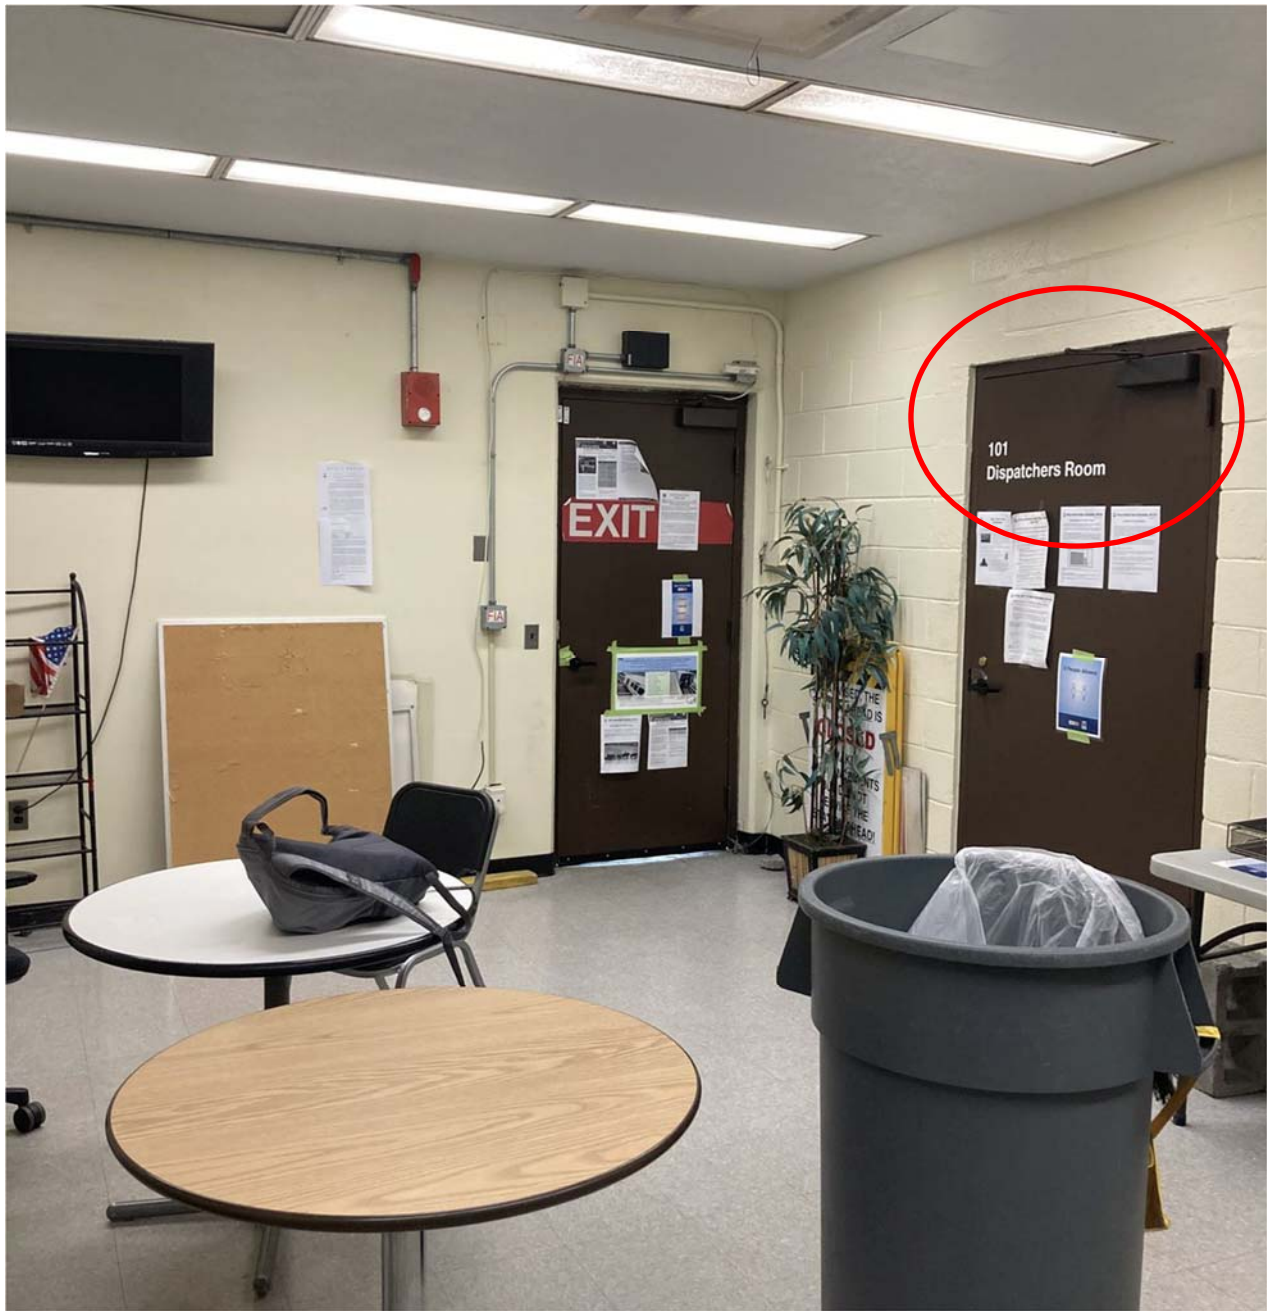
A site visit performed by SAFE identified that the break room adjacent to the Terminal Supervisor's work area is equipped with two televisions. The televisions are mounted on two walls on opposite ends of the break room. Neither television is mounted facing the Terminal Supervisor's work area. However, one television is positioned to the left of the door opening, and the other is not within the line of sight of the desk area. The dispatcher door is equipped with self-closing hinges.

Figure 4 - Operators lounge adjacent to Dispatchers Room (Terminal Supervisor work area).

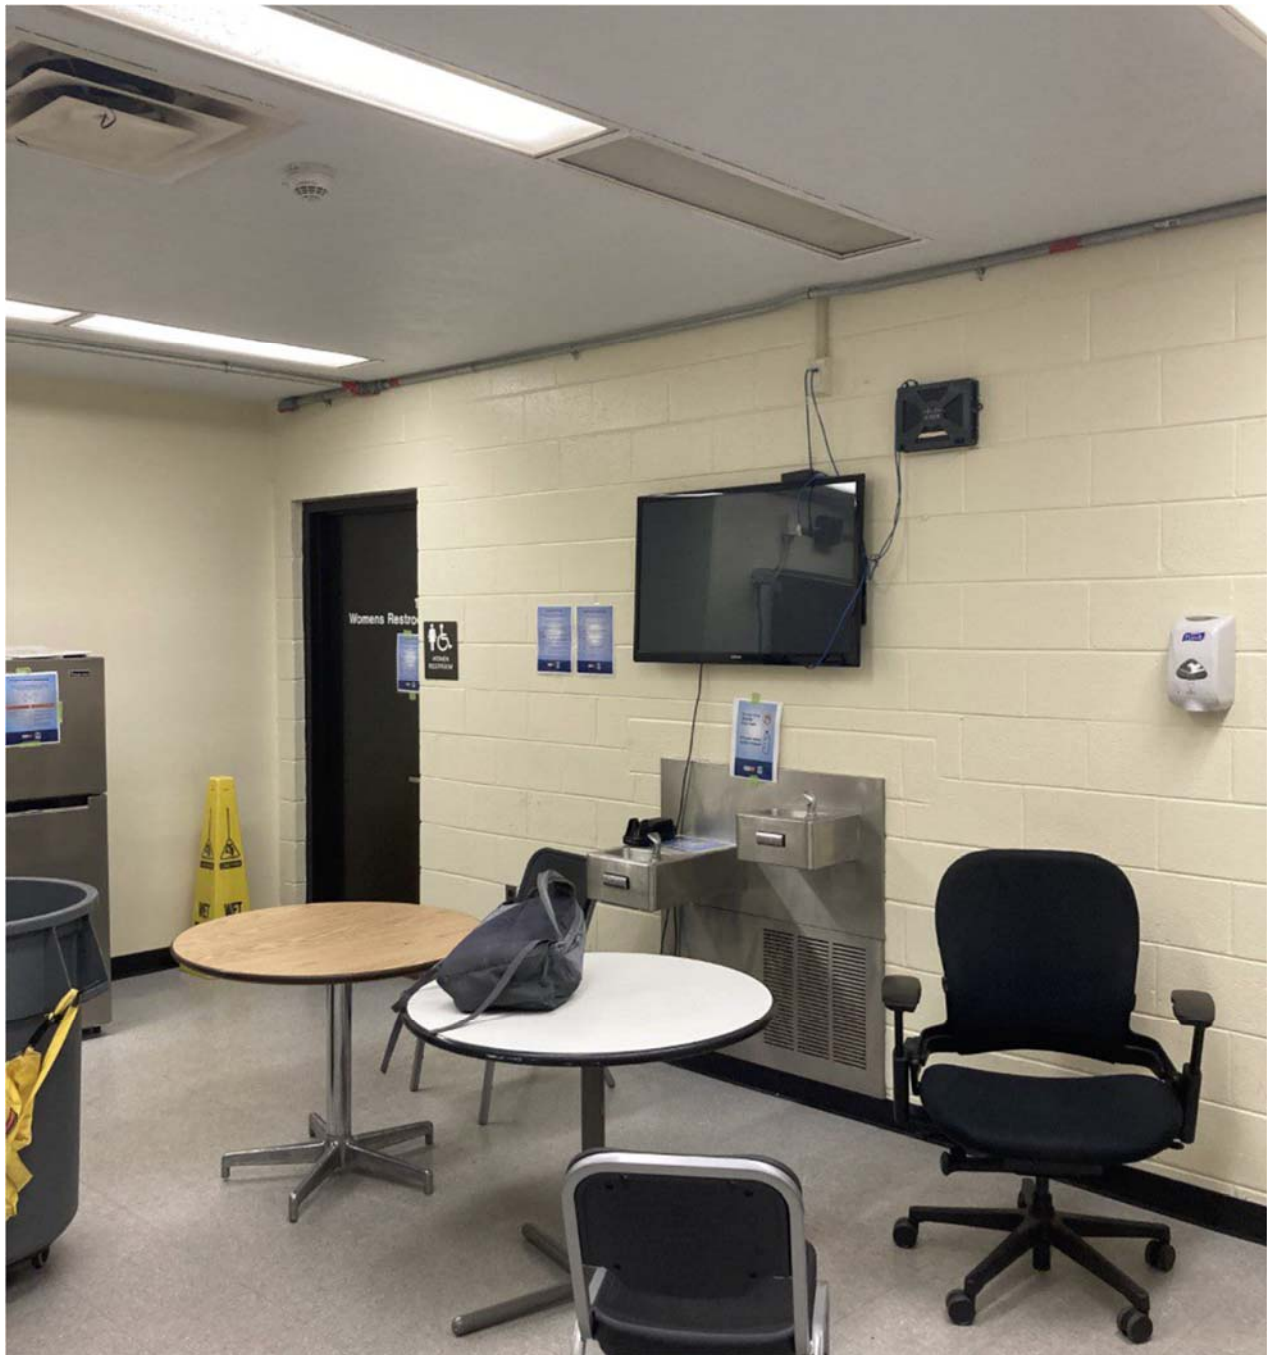
Figure 5 - This TV is positioned on the opposite end of the dispatcher's office door, out of their line of sight.

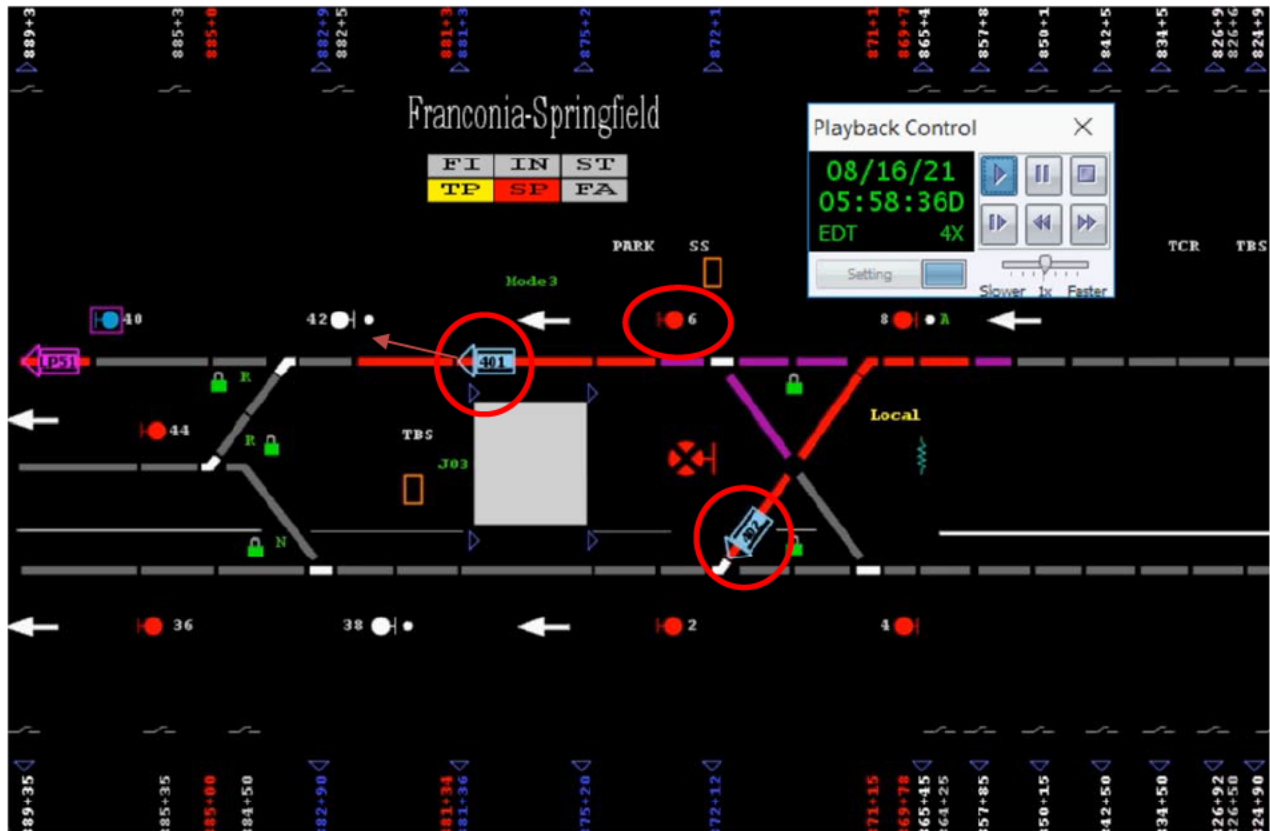
Figure 6 - Train ID 401 Keyed up facing J03-42 Signal and Train ID 402 crossing over from Track 2 to Track 1.

Train ID 401 Train Operator replied to the Terminal Supervisor: "I copy, crossing over from two to one," which is an incomplete 100% repeat-back.

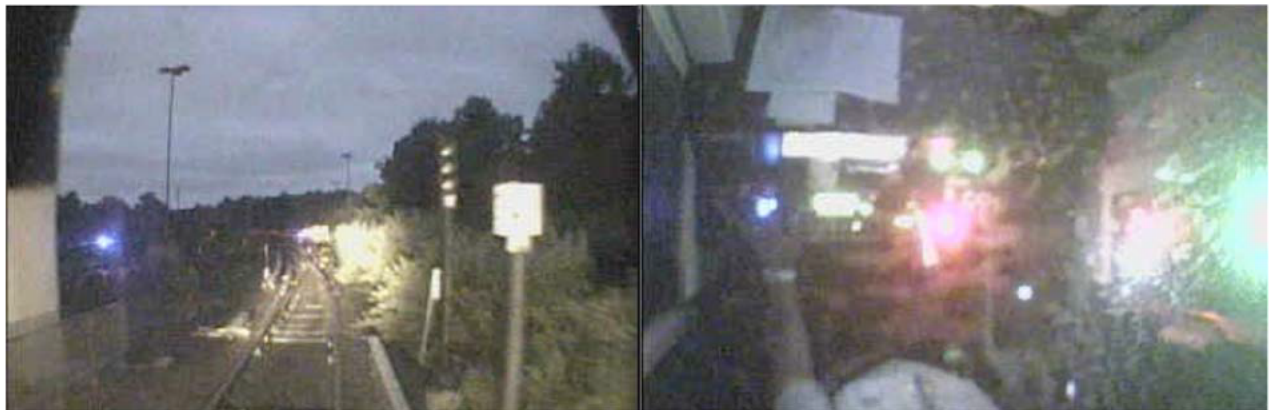
Train ID 401 Train Operator then performed a left door closing operation and operated Train ID 401 beyond the J03-42 signal, which displayed a flashing Lunar aspect.

Figure 7 - Train ID 401 Train Operator began to operate towards Franconia-Springfield Tail Track with a flashing lunar.

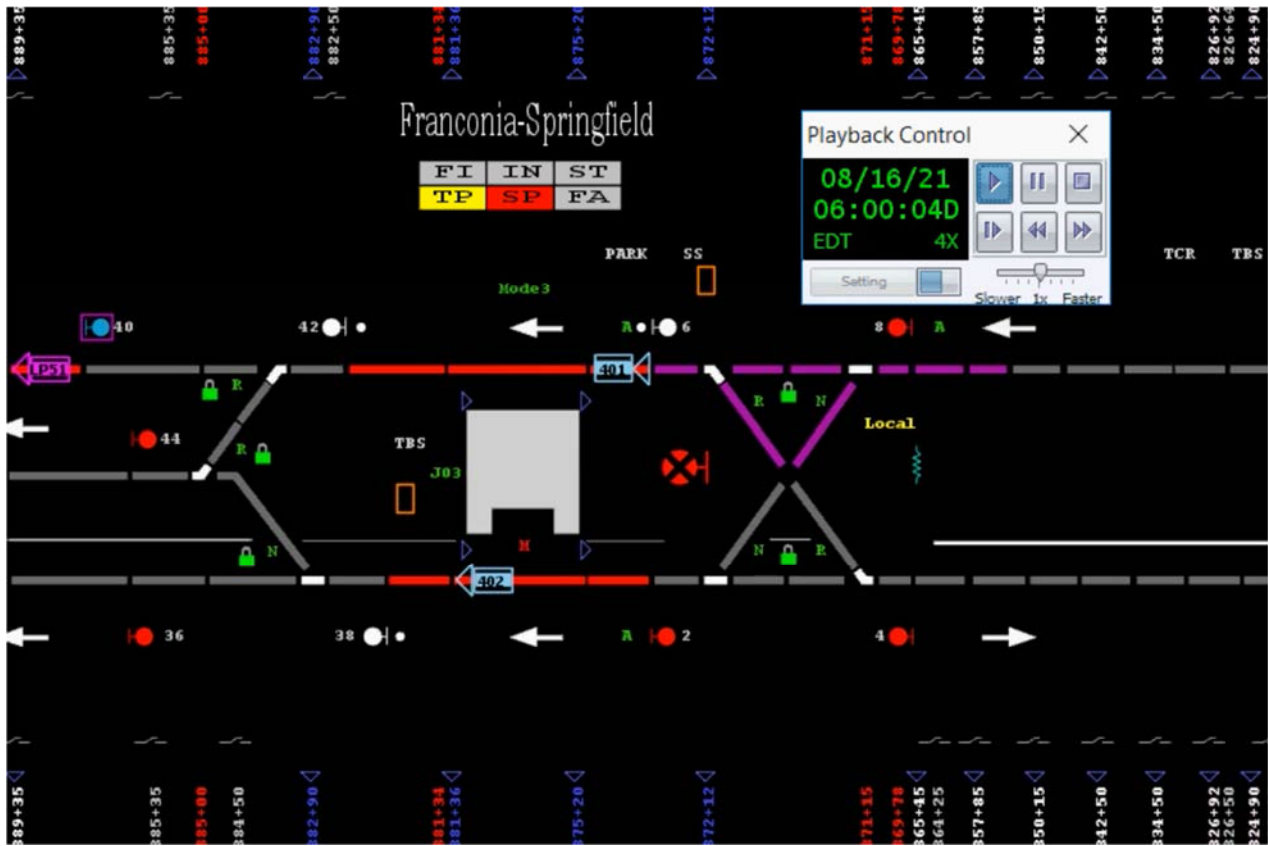
Figure 8 - AIMS playback showed Train ID 401 destination not consistent with direction of travel

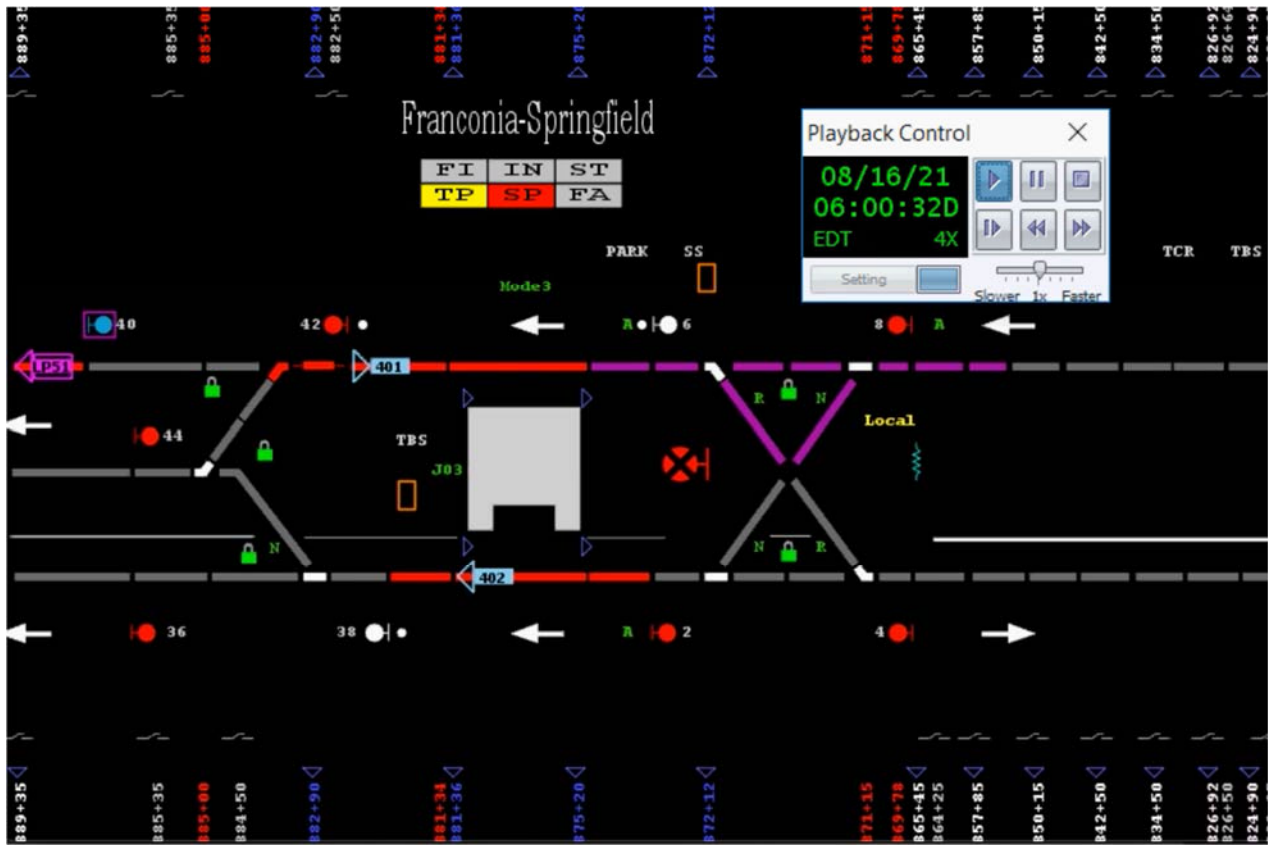
According to AIMS playback, Train ID 401 began moving towards the tail track area at approximately 06:00 hours.

Figure 9 - Train ID 401 moving towards tail track area.

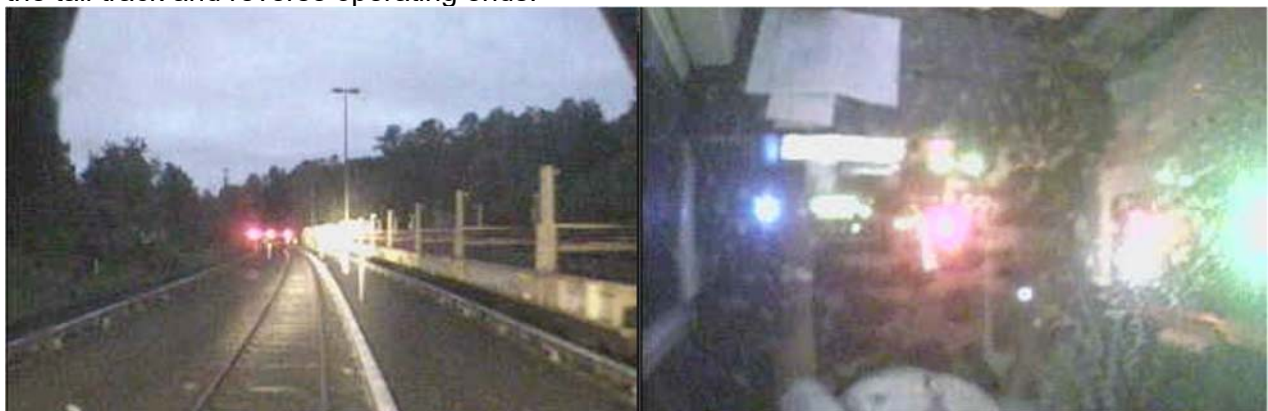
Franconia-Springfield Terminal Supervisor instructed Train ID 401 Train Operator to continue into the tail track and reverse operating ends.

Figure 10 - Train ID 401 Train Operator continued into the tail track as directed after stopping within the interlocking.

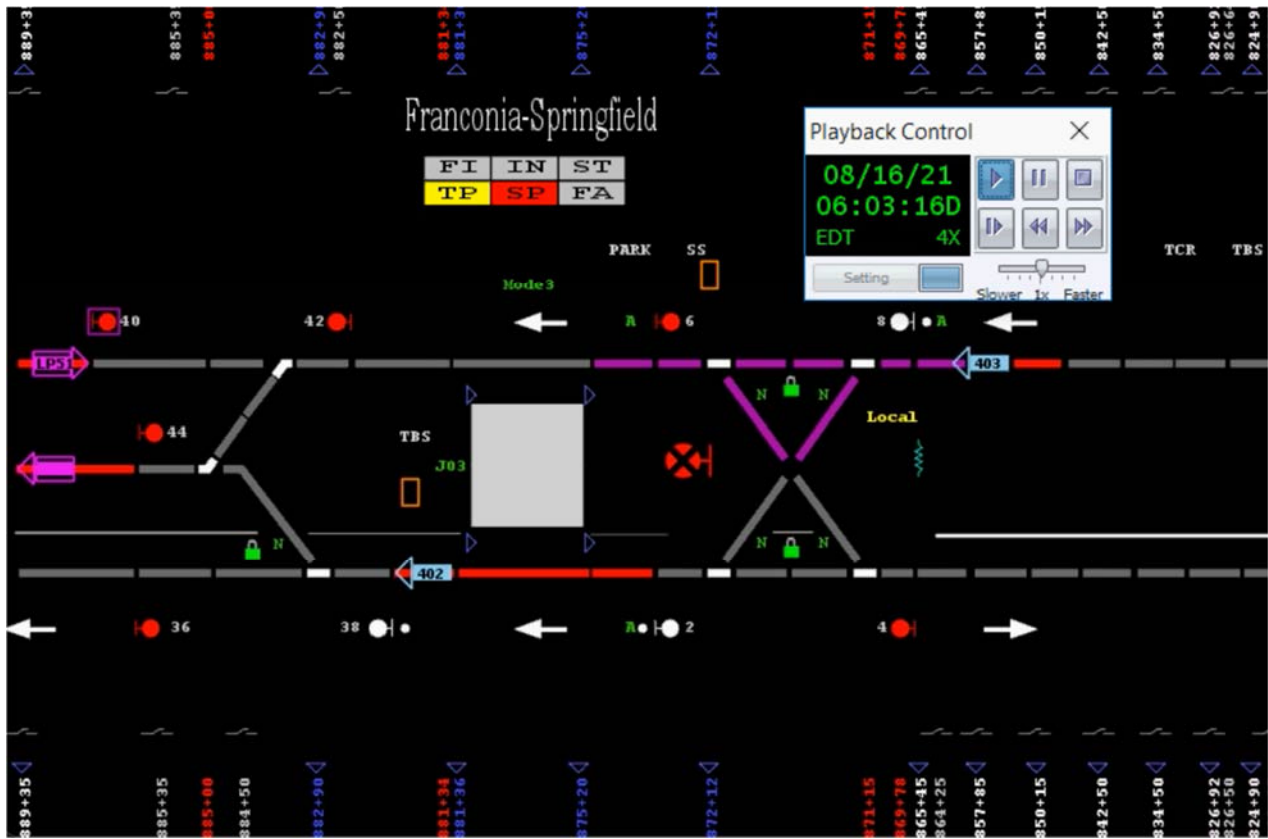
Figure 11 – Train ID 401 cleared signal 44 in the tail track area at approximately 06:03 hours. Train 403 passing lunar signal J03-08 and entering the platform on track 2.

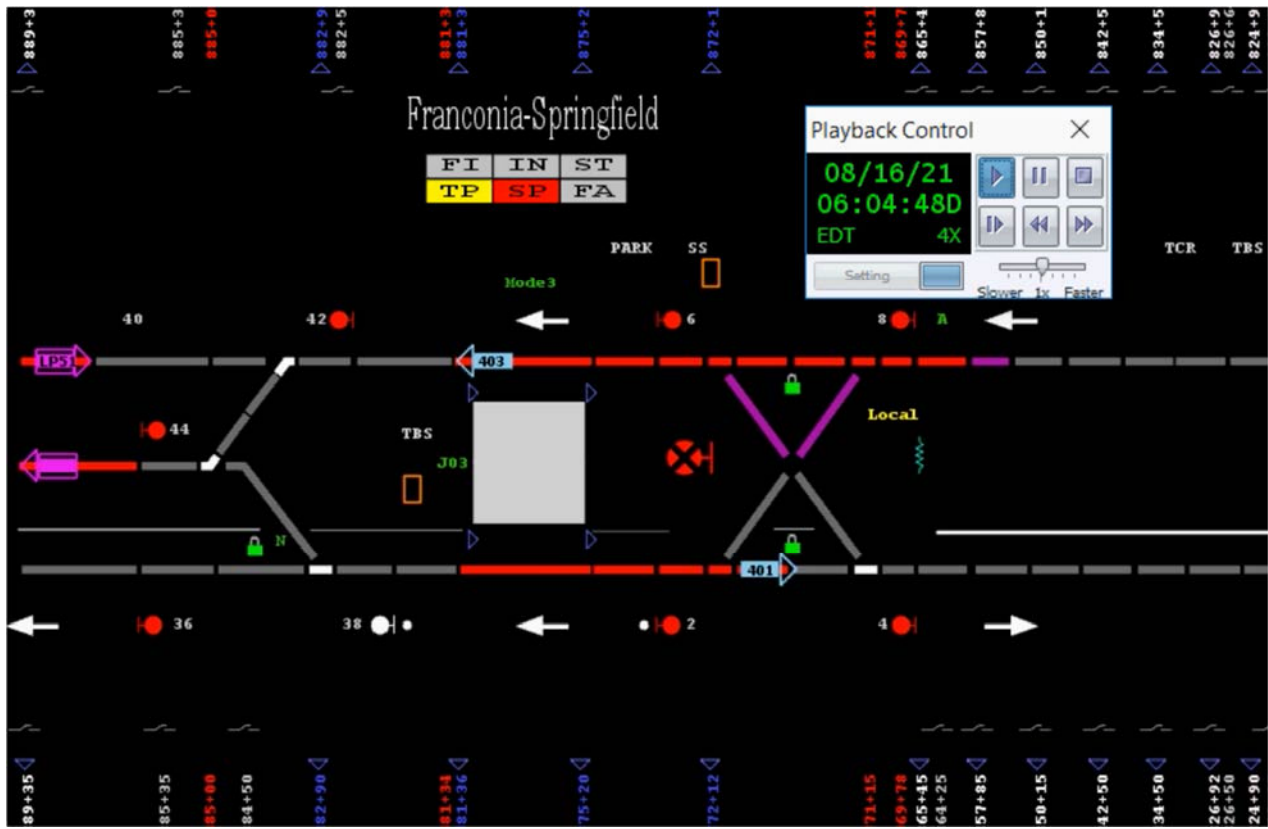
In order to open space on the platform for the train in the tail track, the Terminal Supervisor instructed Train ID 402 berthed at the 8-car marker on track 1 to change their destination code to Train ID 401 and proceed in service towards Largo Town Center.

Figure 12 - Train ID 402 changed to Train ID 401 and departed the station. Train ID 403 arrived on track 2, and the incident train was still in the tail track area.

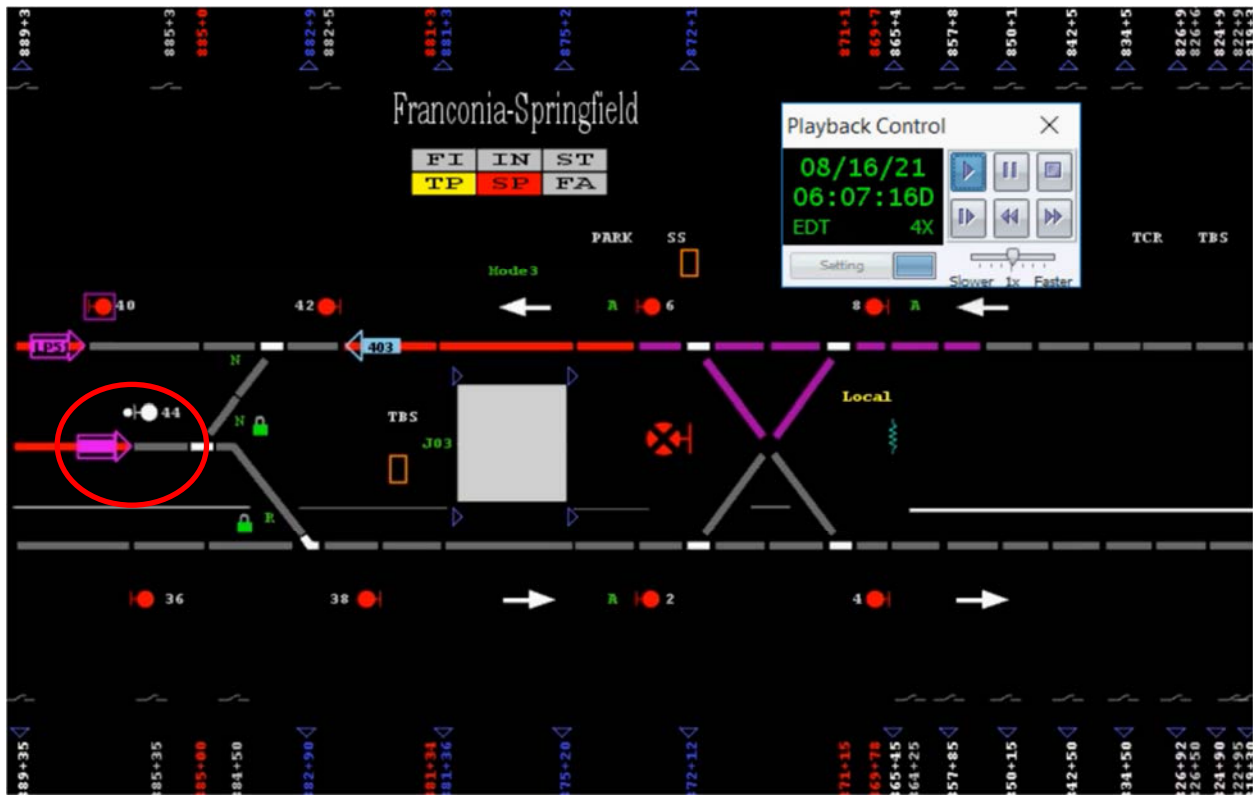
The Terminal Supervisor instructed the Train ID 401 Train Operator in the tail track to change their Train ID to 402 and proceed to the 8-car marker verifying their lunar at 44 signal crossing over from track 3 to track 1. Train ID 401, now Train ID 402, confirmed the Terminal Supervisor's instruction.

Figure 13 - Train ID 401, reassigned as 402, received a lunar at J03-44 Signal at approximately 06:07 hours.

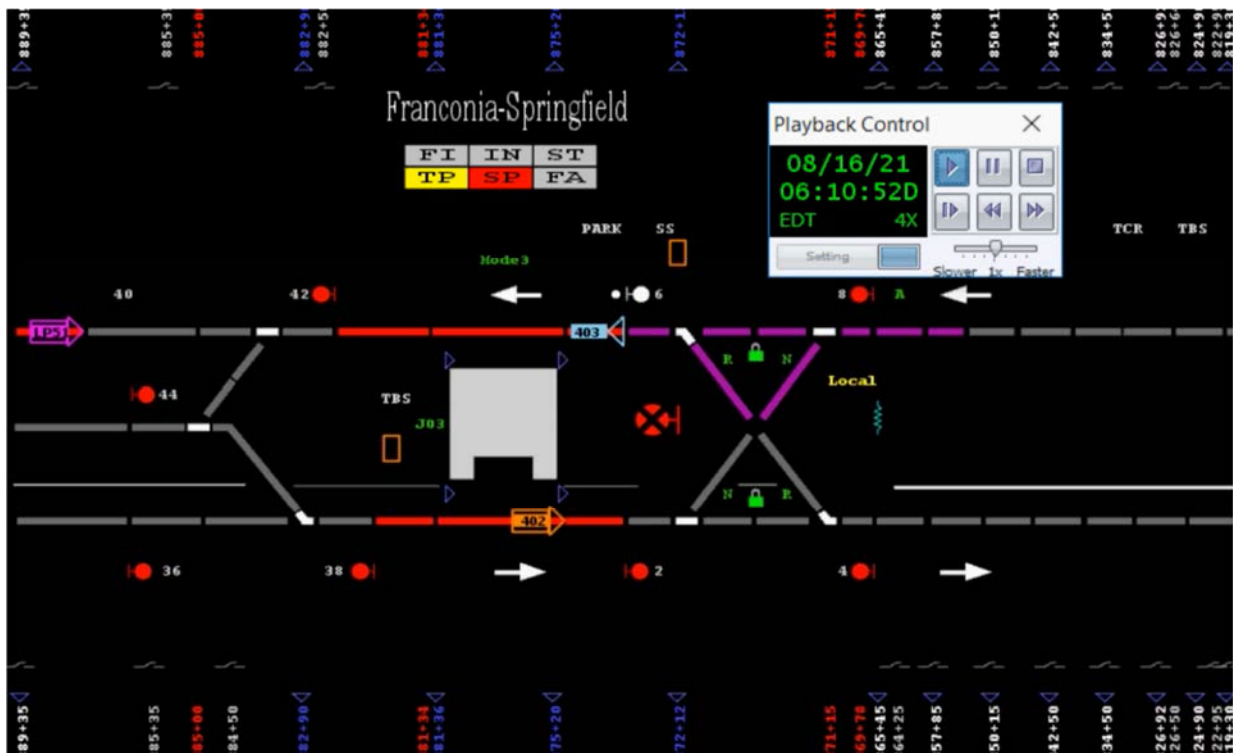
The incident train, re-blocked as Train ID 402, berthed at the 8-car marker on track 1 and performed a left-side door operation.

Figure 14 - Train ID 402 Berthed at the 8-car marker from the tail track at approximately 06:10 hours and performed a left door operation.

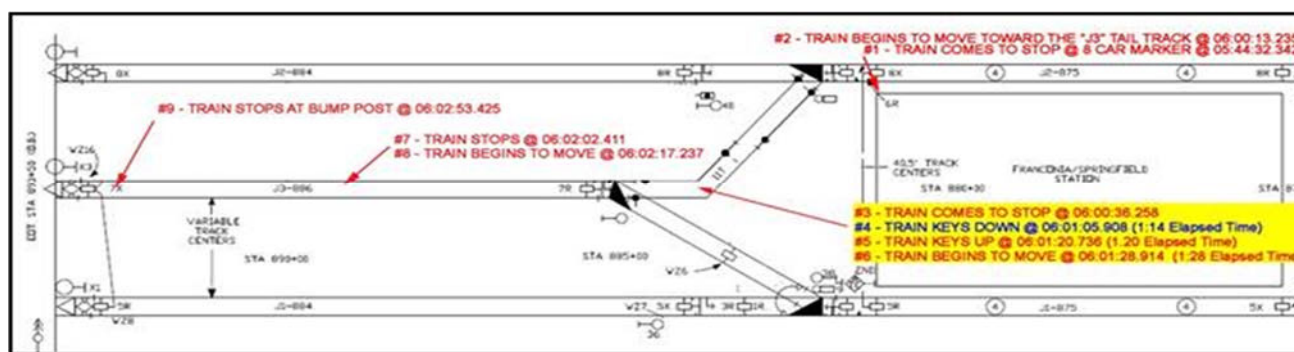
The graphic below depicts Train ID 401 moving from Franconia Platform J03 Track 2 to Tail (Middle) Track J3-886

- The times shown in the Graphic were adopted from the Video Playback Time and did not match the ER Data Time exactly.
- The Time shown during video playback is only the Elapsed Time of the video file being reviewed.

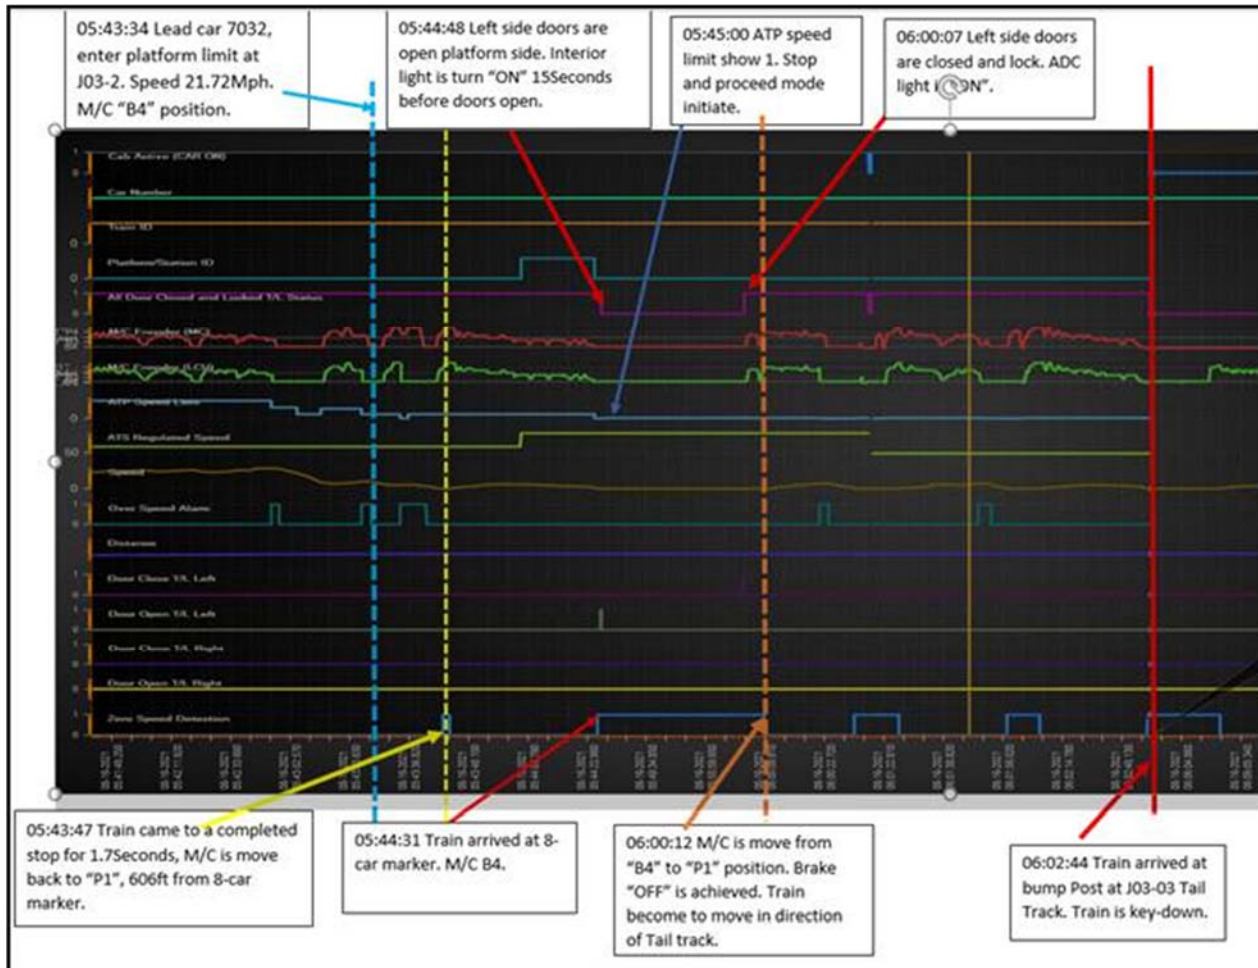
ER Graphic (Car 7032):

06:01:19 hours	Master Controller is moved from "B4" to "P1-P4". The train continued into J03-03 Tail Track.
06:02:44 hours	The train arrived at bump post at J03-886 (Middle) Tail Track. The train is key-down.

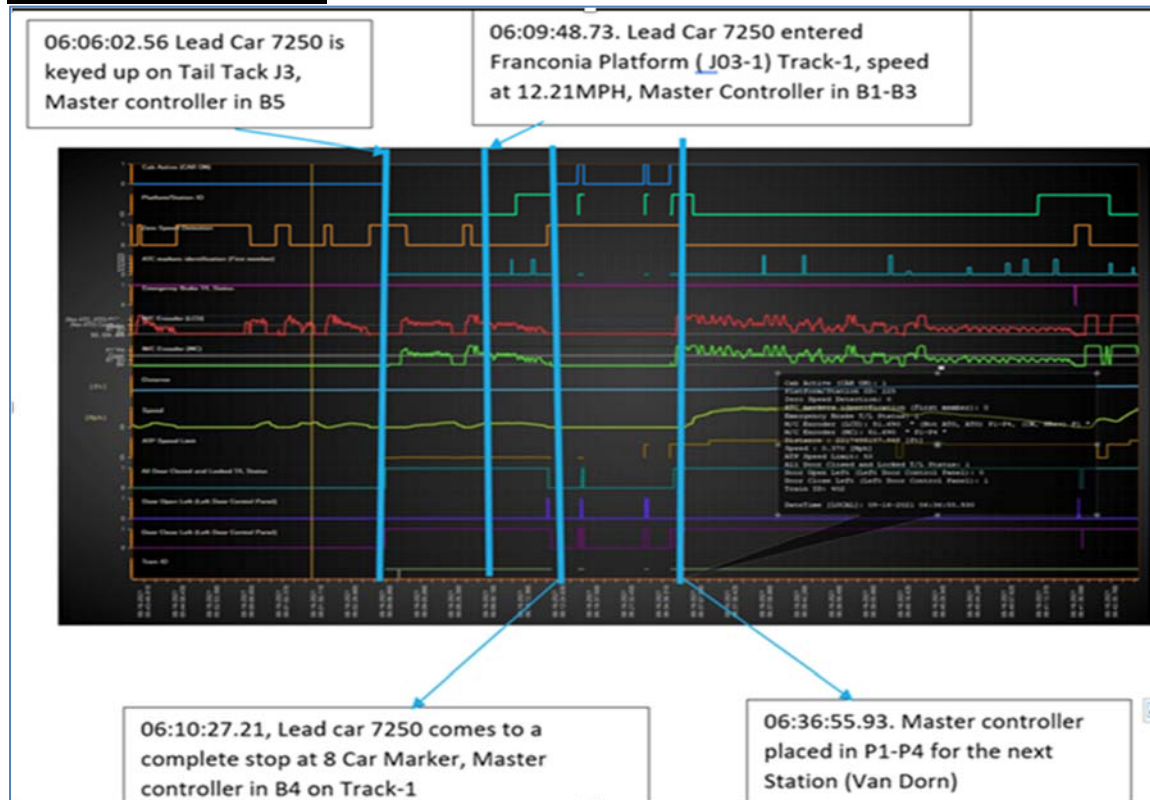
ER Graphic (Car 7250):

Time	Event
06:06:02 hours	Lead Car 7250 is keyed up on J3-886 Tail Track
06:08:57 hours	Master Controller is placed in P1-P4 and began moving towards the Franconia Platform J03 Track 1
06:09:48 hours	Lead Car 7250 entered Franconia Station Platform (J03-1) at speed 12.21 MPH, and the Master Controller was placed in B1-B3
06:10:27 hours	Lead Car 7250 comes to a complete stop at 8 Car Marker on Track-1 with Master controller in B4
06:10:29 hours	The door open pushbutton was depressed, and left side doors opened.
