WMSC Commissioner Brief: W-0130 - Improper Roadway Worker Protection - Red Line - July 21, 2023

FINAL REPORT OF INVESTIGATION A&I E21302

Date of Event:	07/21/2021
Type of Event:	Improper Roadway Worker Protection
Incident Time:	12:53 Hours
Location:	Takoma Station to Silver Spring Station,
	Track 2 (CM B2 425+00)
Time and How received by SAFE:	12:55 Hours; SAFE/IMO
WMSC Notification Time:	13:32 Hours
Responding Safety Officers:	WMATA: N/A
	WMSC: N/A
	Other: N/A
Rail Vehicle:	Train ID 205,
	L7386-7387.7329-7328.7414-7415.7443-7442T
Injuries:	None
Damage:	None
Emergency Responders:	None
SMS I/A Incident Number:	20210722#94597

Silver Spring Station – Improper Roadway Worker Protection

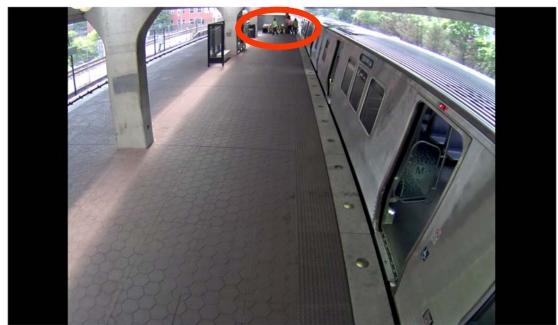
Figure 1 - Mobile Work Crew arriving at Takoma Station, approximately 12:14 hours.

The CCTV revealed that the work crew took a break at Takoma Station for approximately 21 minutes after arrival. As the mobile work crew took a break on the platform at Takoma Station, Train ID 110 entered the station on track 2, serviced the station, and departed at approximately 12:25 hours. At approximately 12:34 hours, the mobile work crew prepared to continue their track inspection as Train ID 204 entered the station on track 2, serviced the station, and then departed.

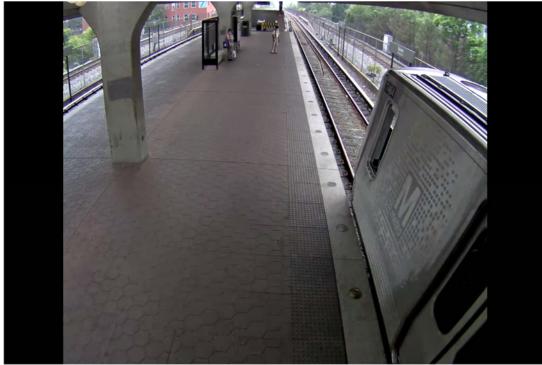
Figure 2 - Train ID 204 entering Takoma Station, approximately 12:34 hours.

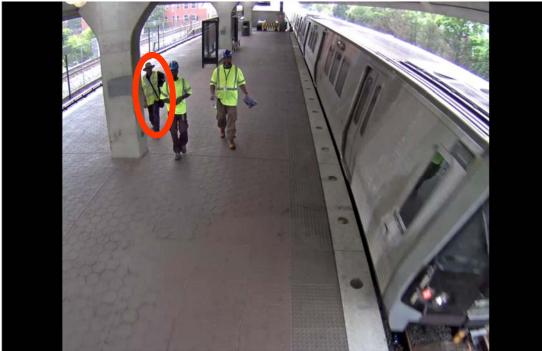
Figure 3 - Train ID 204 departing Takoma Station, approximately 12:35 hours.

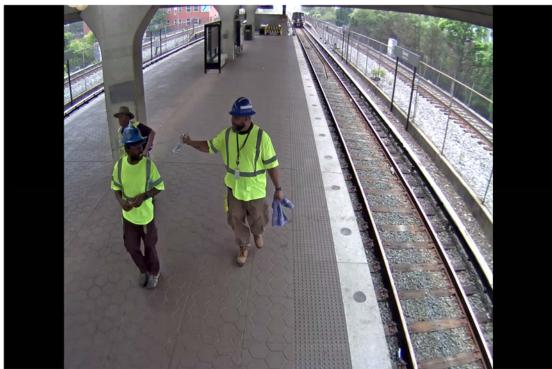
At approximately 12:36 hours, the mobile work crew departed Takoma Station, track 2, and entered the roadway without contacting ROCC and the AMF #2 located at Silver Spring Station. This action was not in compliance with MSRPH Section 5 – 5.13.6 Advanced Mobile Flagging – Mobile Work Crew, *The RWIC will contact ROCC and perform a radio check establishing positive communication.* After receiving confirmation that the AMF is in position, the RWIC will request permission from ROCC to enter the Roadway. Once ROCC gives permission, and before the Mobile Work Crew enters the Roadway, the RWIC will notify the AMF to begin AMF operations. **Note**: In Figure 3 above, the Track Inspector is observed wearing an unauthorized bag. This action was a violation of MSRPH Section 4 – Safety Rules, 4.33, Employees shall wear and/or use the prescribed safety equipment required for the type of work being performed.

Figure 4 - Mobile Work Crew departing Takoma Station, approximately 12:36 hours.

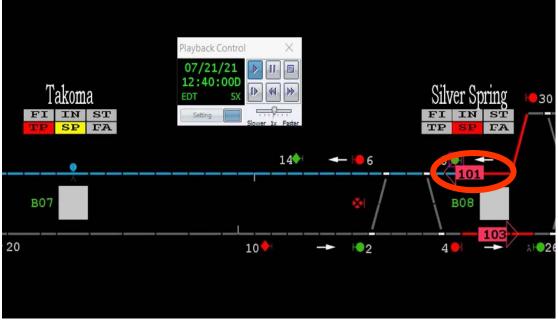
At approximately 12:40 hours, Train ID 101 departed Silver Spring Station, track 2, and arrived at Takoma Station at approximately 12:43 hours.

Figure 5 – Train ID 101 departing Silver Spring Station, approximately 12:40 hours.

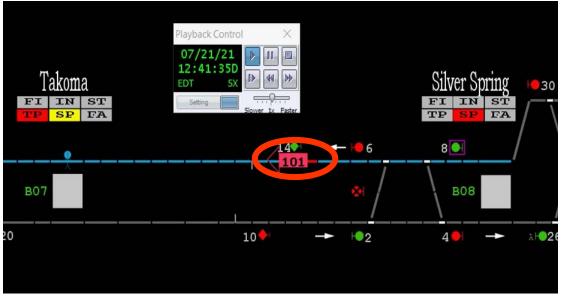
The time between Train ID 101 departing Silver Spring Station and traveling to Takoma Station suggests that the Mobile Work Crew was on the roadway during this time. (NVR images were not available; the train consist was not fitted with forward-facing imaging.)

Figure 6 – Train ID 101 traveling between Silver Spring and Takoma Stations, approximately 12:41 hours.

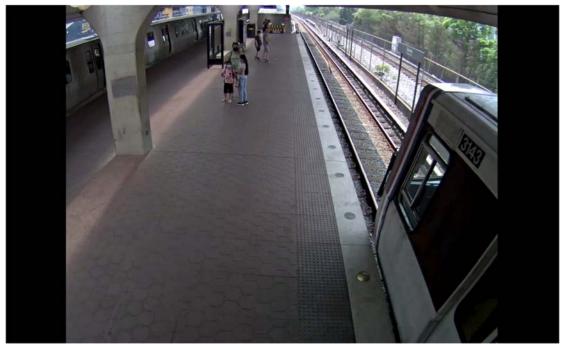
The Train Operator of Train ID 101 did not report seeing the Mobile Work Crew on the roadway and an AMF #2 not in place at the 8-car marker at Silver Spring Station, track 2. This action is not in compliance with Metrorail Safety Rules and Procedures Handbook (MSRPH), GR 1.32 -Employees involved in, witnessing, or informed of an accident or incident, to include near misses, on the Metrorail System shall inform their supervisor, Transit Police, ROCC and/or other appropriate authority as soon as possible, and shall file a written report requirements.

Figure 7 - Train ID 101 arriving at Takoma Station, approximately 12:43 hours.

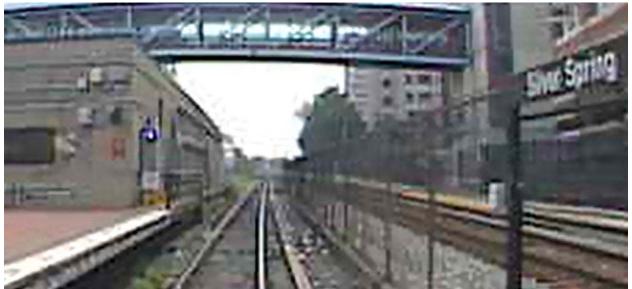
At approximately 12:49 hours, Train ID 205 entered Silver Spring Station, serviced the platform, and departed the station without seeing or communicating with an AMF #2.

Figure 8 - Train ID 205 arriving at Silver Spring, approximately 12:49 hours.

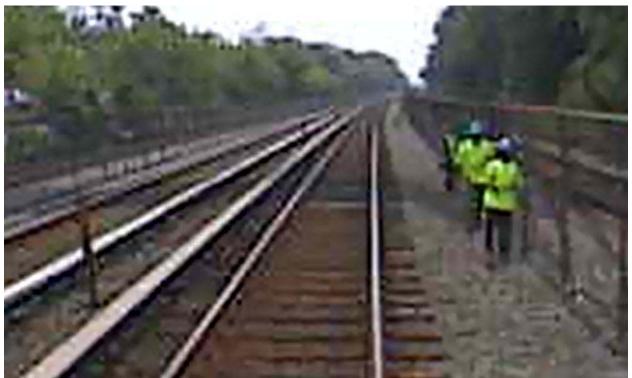
The Train Operator of Train ID 205 departed Silver Spring Station at approximately 12:50 hours, and after traveling approximately 3,543 feet the Train Operator contacted ROCC and reported seeing the Mobile Work Crew on the roadway without seeing or communicating with an AMF #2 at Silver Spring Station.

Figure 9 - Train ID 205 approaching the Mobile Work Crew at CM B2 404+00, approximately 12:51 hours.

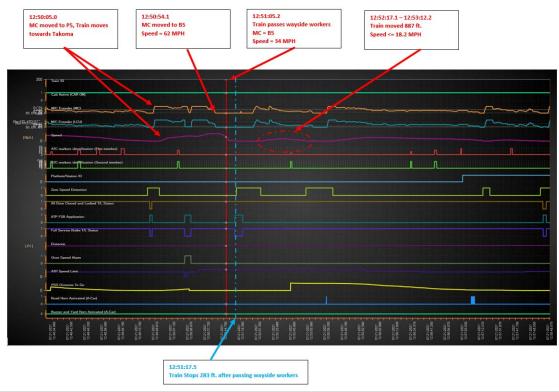
Figure 10 - Event Recorder Graphical Analysis

Based on the VMDS and ER data, all the subsystems' safety components such as Automatic Train Control (ATC), brakes, and propulsion acted as designed, and there were no faults with the train that contributed to this event.
