WMSC Commissioner Brief: W-0132 – Improper Roadway Worker Protection – L’Enfant Plaza Station – July 26, 2021

Washington Metro Area Transit Authority
Department of Safety and Environmental
Management (SAFE)
FINAL REPORT OF INVESTIGATION A&I E21324

Date of Event:	07/26/2021
Type of Event:	Improper Roadway Worker Protection
Incident Time:	01:08 hours
Location:	L'Enfant Plaza Station, at CM F1-037+00 to F1-060+00
Time and How received by SAFE:	01:30 hours. SAFE/IMO In-Person Notification
WMSC Notification Time:	03:01 hours
Responding Safety Officers:	WMATA: No WMSC: No Other: No
Rail Vehicle:	No
Injuries:	No
Damage:	No
Emergency Responders:	None
SMS I/A Number	20210727#94675

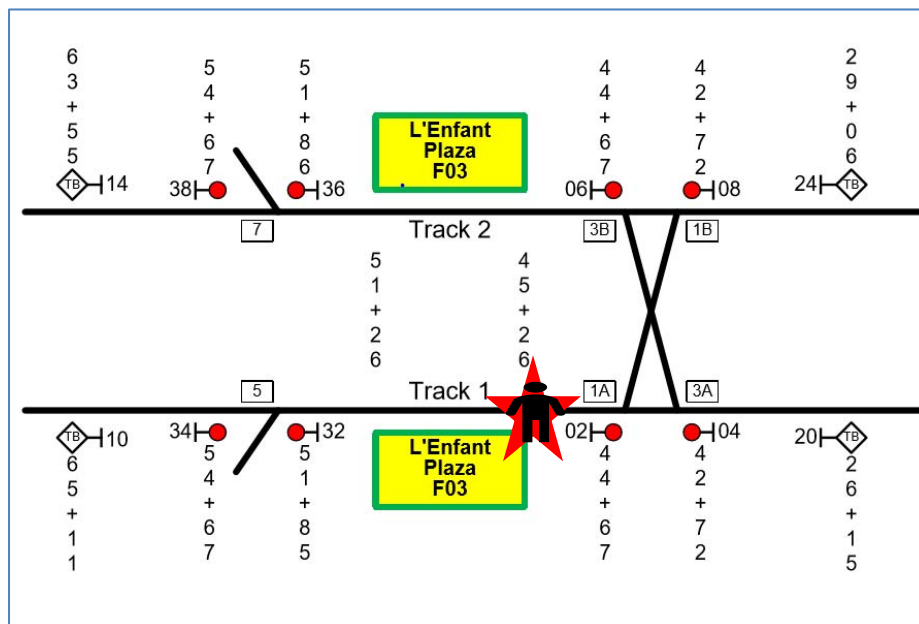
Field Sketch/Schematics

L'Enfant Plaza Station, at CM E1-037+00 to E1-060+00

Actual – Chain Marker E1-042+00 to E1-055+00 and E2-042+00 to E2-055+00

Protected – Chain Marker E1-037+00 to E1-060+00 and E2-037+00 to E2-060+00

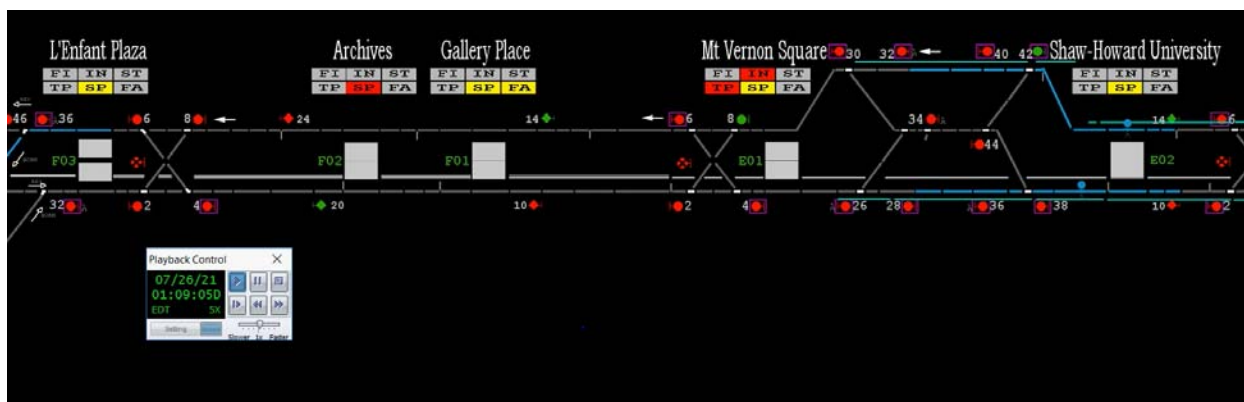
Diagram 2 - Based on the AIMS, at 01:09:05 hours, prohibit exits, block calls, cancellation of automatic signals, blue block, and human form status were not in place before the RWIC entered the roadway to hot stick and confirmed that third rail power was de-energized between L'Enfant Plaza Station, Track 1 and Track 2. However, blue block and human form status were in place, and third-rail power was de-energized at Shaw-Howard University Station at the CMs for the protected and actual work listed in the GOTRS.

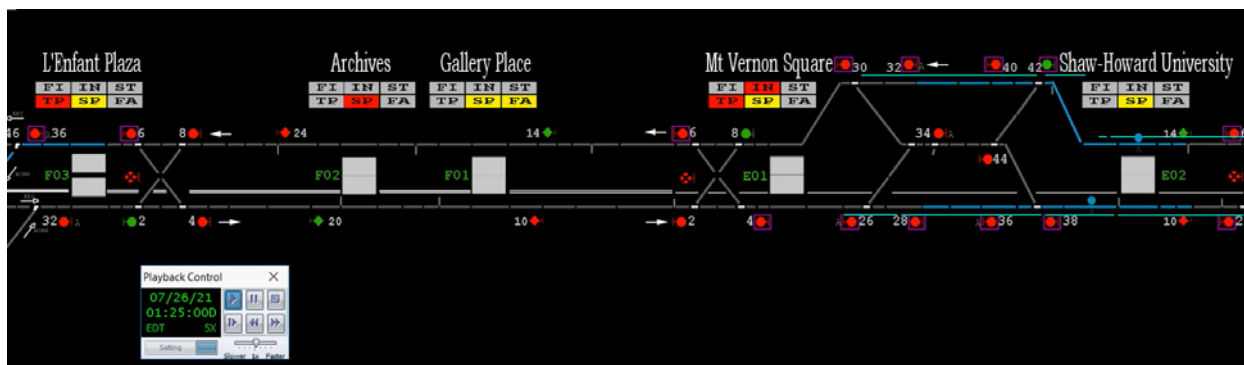
Diagram 3 - Based on the AIMS, at 01:25:00 hours, third rail power was not de-energized at L'Enfant Plaza Station, Track 1 and Track 2 after the RWIC contacted the Radio RTC and reported that they entered the roadway to hot stick and confirmed that third rail power was de-energized.

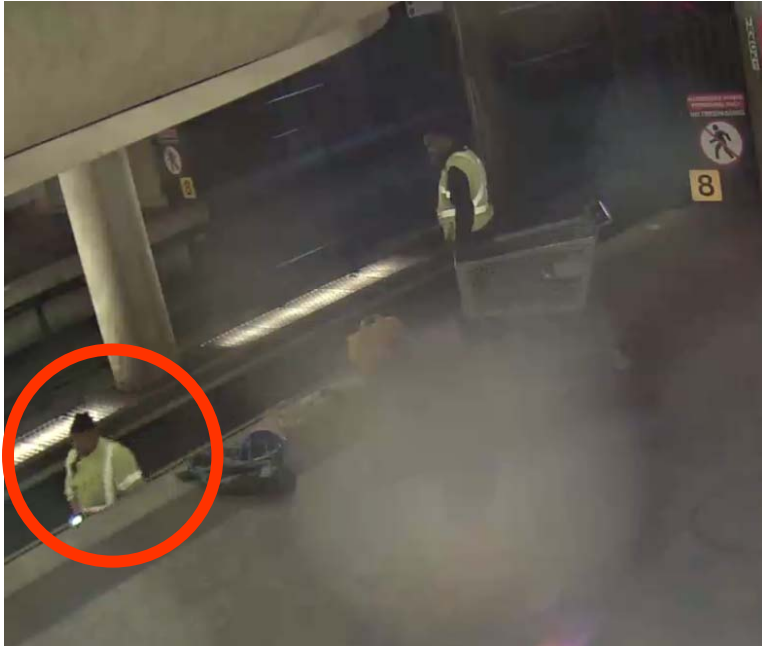
Figure 1 - The RWIC entered L'Enfant Plaza Station, Track 1 roadway, to perform hot stick efforts and without wearing a hard hat at approximately 01:10 hours.

- The RWIC was not wearing a hardhat while on WMATA's roadway. This action was not in compliance with MSRP 5.11, "Personal Protective Equipment Standard for On-Track Safety."

Metrorail conducted a roadway worker protection safety standdown emphasizing the importance of proper Communications and personal protective equipment.

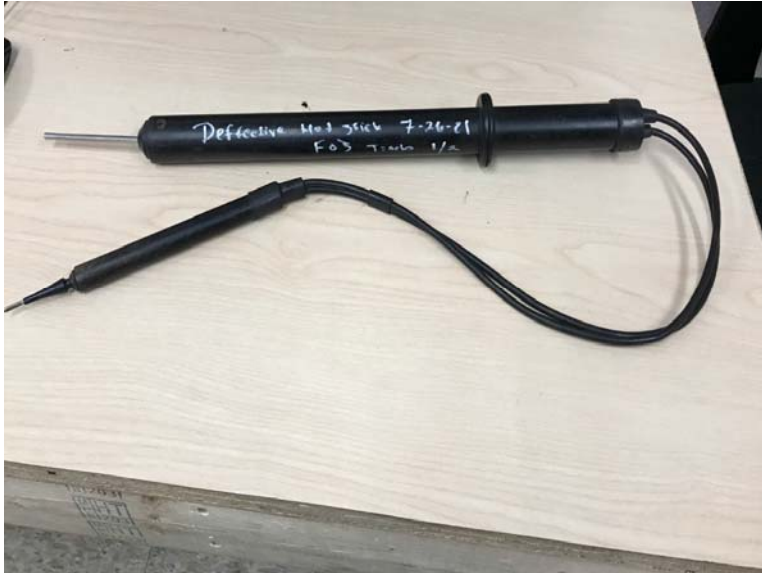
Figure 3 – The hot stick returned by the RWIC was reported as defective and tagged out of service by TRST.

- RWIC used a defective/damaged hot stick to confirm third rail was de-energized, providing a false indication of power down.
- It was determined that the hot stick the RWIC was using was defective, and therefore they mistakenly reported that the third rail at their location was de-energized.

Track and Structures distributed a lessons learned document emphasizing the importance of verifying chain markers in GOTRS before accessing the roadway, 100 percent word-for-word repeat back, use of phonetic alphabet, and testing a hot stick on a live circuit before each use.
