**WMSC Commissioner Brief: W-0134 – Improper Roadway Worker Protection – Fort Totten Station – July 30, 2021**

Washington Metro Area Transit Authority  
Department of Safety and Environmental  
Management (SAFE)  
**FINAL REPORT OF INVESTIGATION A&I**

## Fort Totten Station – Improper RWP

July 30, 2021

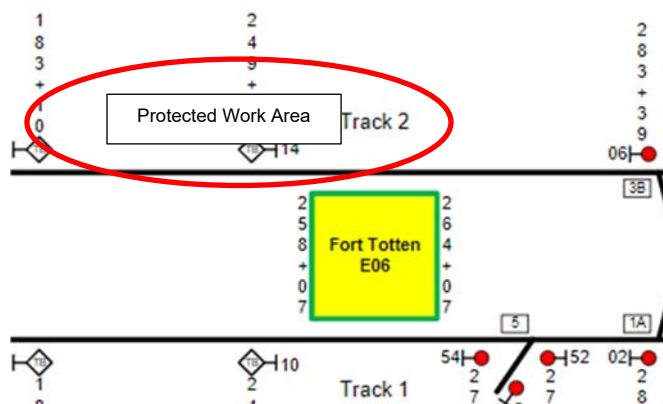
### **Field Sketch/Schematics**

*\*Note: PM 65 and the piggyback crew were located within the piggyback work zone at E2 249+00 – 241+00.*

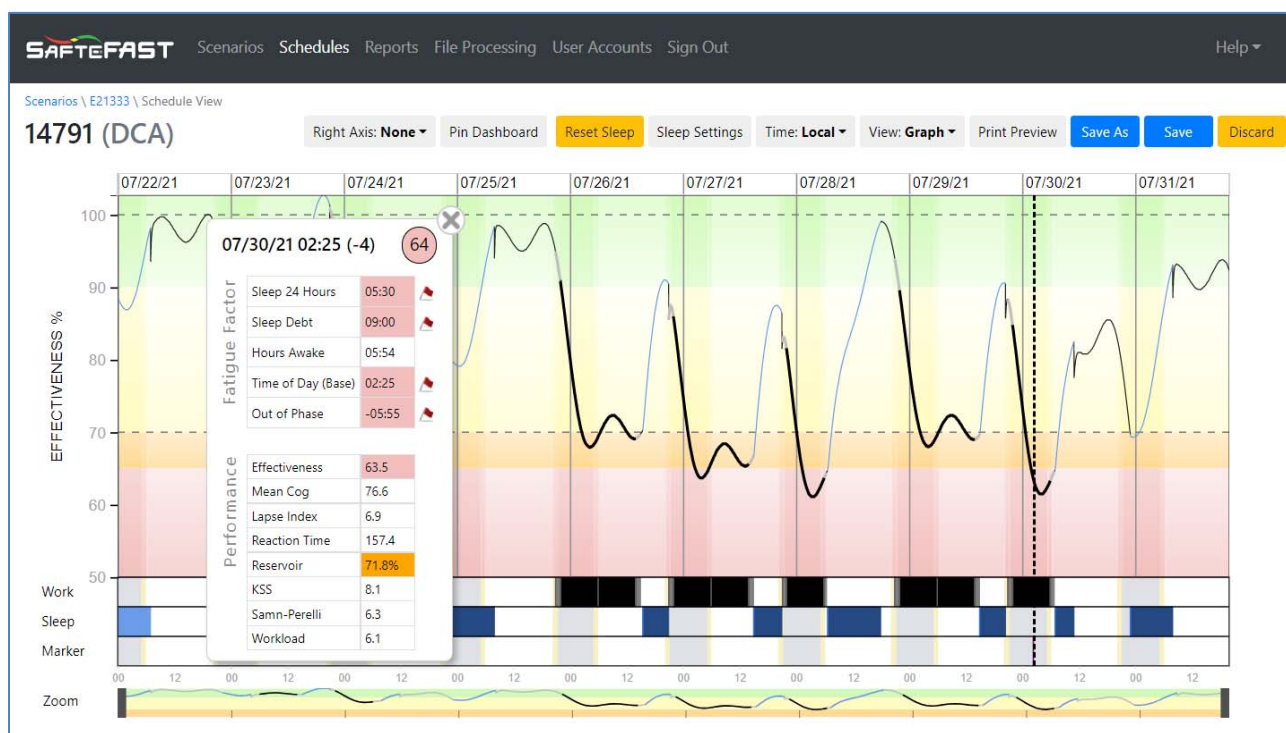
A biomathematical fatigue modelling application (SAFTE-FAST WebSFC) was used to further evaluate fatigue risk factors that may have been present in the RWIC's schedule. The analysis was based on the RWIC's work schedule, bed and wake times from the day before the incident and reported habitual sleep durations. Estimated performance effectiveness at the time of the incident was 63.5% and was significantly affected by the long, overnight shifts. Specifically, the analysis identified short sleep duration in the last 24 hours, the circadian effects of night work, and sleep debt (inferring accumulated sleep loss of more than 8 hours) as factors contributing to an increased risk of fatigue at the time of the incident.

Modeling analysis output shows estimated performance effectiveness during the incident work shift (top), and for the week leading up to the work shift (bottom) based on the employee work and reported sleep schedule. Estimates were based on the Technician's work schedule, bed and wake times from the day before the incident and reported habitual sleep durations (6 hours a day). Bold portions of the modeled curve show work (in black) and sleep times (in blue). Effectiveness is shown on the vertical axis, with colored fields in the chart background signifying ranges of effectiveness scores including high effectiveness (>90%) in green, and low effectiveness (<65%) in red. Time is shown on the horizontal axis. Markers for work and sleep times are shown in the lanes above the time of day on the horizontal axis.

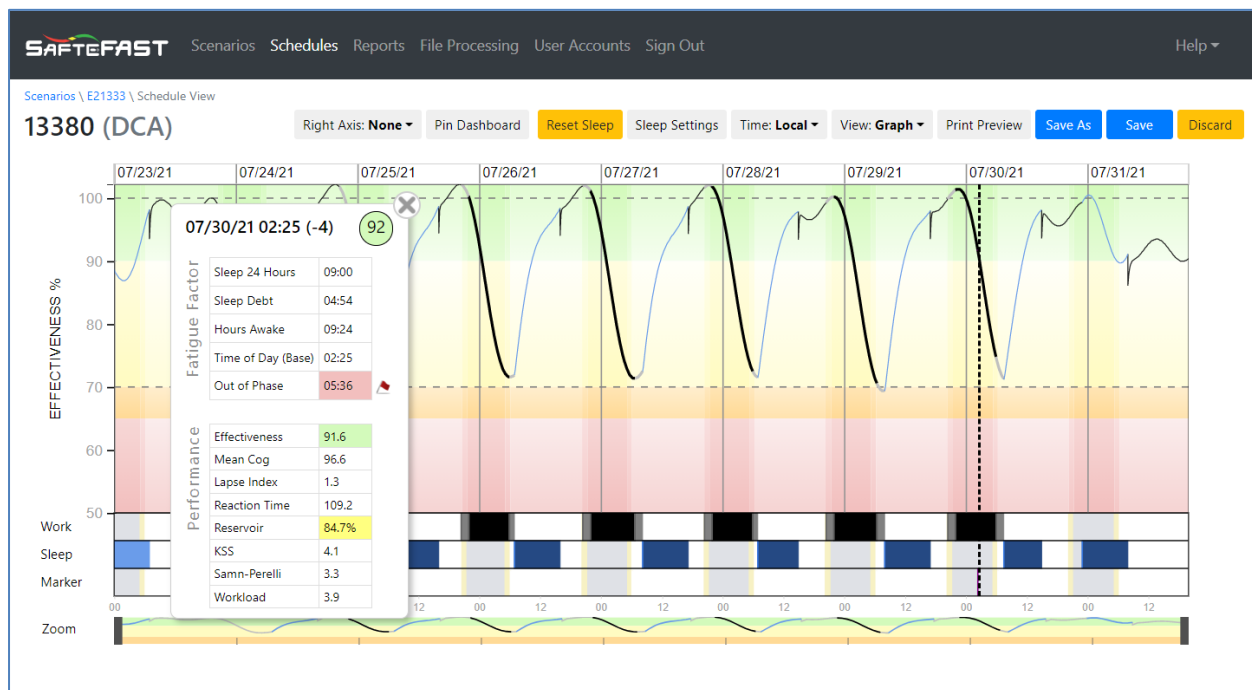
A SAFTE-FAST WebSFC was used to further evaluate fatigue risk factors that may have been present in the Piggyback Crew Leader's schedule. The analysis was based on the Piggyback Crew Leader's work schedule, bed and wake times from the day before the incident and reported habitual sleep durations. The estimated performance effectiveness at the time of the incident was 91.6%. The analysis identified the circadian effects of night work as a factor contributing to an increased risk of fatigue at the time of the incident.

Modeling analysis output shows estimated performance effectiveness during the incident work shift (top), and for the week leading up to the work shift (bottom) based on the employee work schedule and reported sleep schedule. Estimates are based on the Supervisor's work schedule, bed and wake times from the day before the incident and reported habitual sleep durations (9 hours a day). Bold portions of the modeled curve show work (in black) and sleep times (in blue). Effectiveness is shown on the vertical axis, with colored fields in the chart background signifying ranges of effectiveness scores including high effectiveness (>90%) in green, and low effectiveness (<65%) in red. Time is shown on the horizontal axis. Markers for work and sleep times are shown in the lanes above the time of day on the horizontal axis.

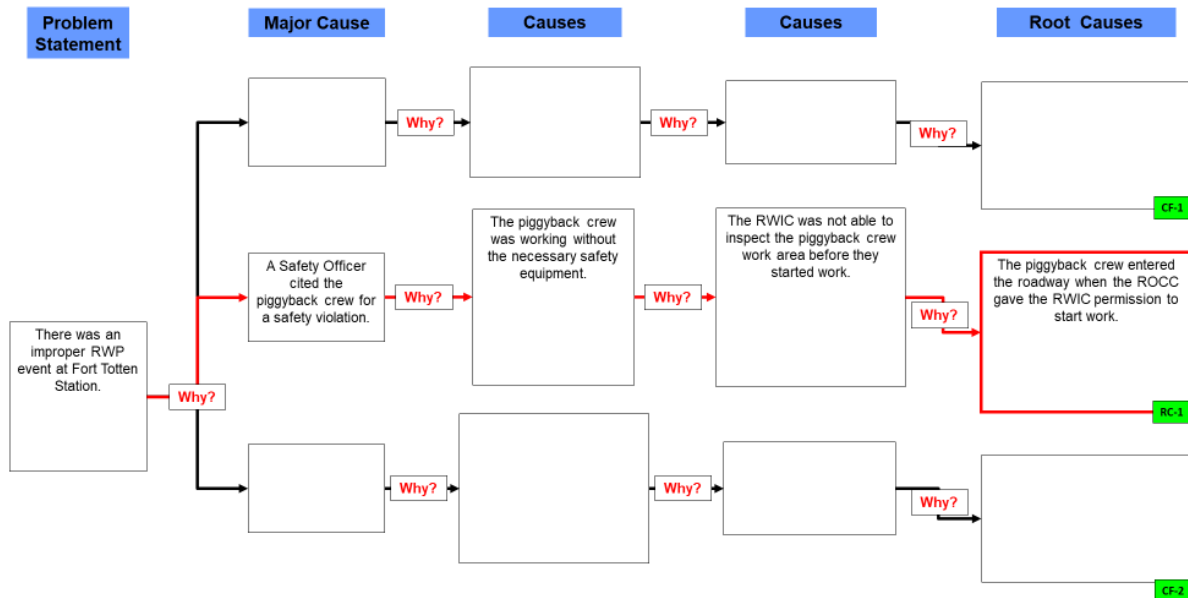
## Appendix C - Root Cause Analysis

The probable cause of this improper roadway worker protection incident is that the Piggyback Crew Leader failed to follow established procedure for setting up a piggyback work zone. MSRP 5.15 states the piggybacking responsibilities and the Piggyback Crew Leader failed to follow 5.15.2 and 5.15.3. A contributing factor is that the Crew Leader reported concerns about having enough time to complete their work.

<b>Corrective Action Code</b>	<b>Description</b>	<b>Due Date</b>
94858_SAFECAPS_TRST_001	Piggyback Crew Leader will have to reattend initial RWP Level 4 training.	Completed 10/8/21
94858_SAFECAPS_TRST_002	Develop guidance for personnel to aid decision-making on when to cancel work and to contact supervision for guidance/support. (e.g., if work has not started by 0230 hours)	01/30/2022
94858_SAFECAPS_TRST_003	Develop a Standard Operating Procedure consistent with Policy/Instruction 7.7.3 that details specific incidents and circumstances that require TRST personnel to be removed from service for drug/alcohol screening, including a method to ensure the screening is completed.	01/30/2022
94858_SAFECAPS_TRST_004	RWP-qualified personnel will attend and complete RWP Safety Stand Down, facilitated by Office of Personnel and Management Services (OPMS)	11/30/2021
94858_SAFECAPS_TRST_005	Develop a Standard Operating Procedure consistent with Policy/Instruction 7.7.3 that details specific incidents and circumstances that require TRST personnel to be removed from service for drug/alcohol screening, including a method to ensure the screening is completed.	1/30/2022
