WMSC Commissioner Brief: W-0135 – Red Signal Overrun – Cheverly Station – July 30, 2021

Washington Metro Area Transit Authority
Department of Safety and Environmental
Management (SAFE)
FINAL REPORT OF INVESTIGATION A&I E21332

Date of Event:	07/30/2021
Type of Event:	Red Signal Overrun
Incident Time:	00:25 hours
Location:	Outside of Cheverly Station at D11-08 Signal.
Time and How received by SAFE:	00:25 hours. SAFE/IMO In-Person Notification
WMSC Notification Time:	02:23 hours
Responding Safety Officers:	WMATA: Yes WMSC: Yes Other: No
Rail Vehicle:	Prime Mover (PM) 47 - Flatcar (F) 608
Injuries:	No
Damage:	No
Emergency Responders:	TRST, ATC, SAFE, WMSC
SMS I/A Incident Number:	20210730#94743MX

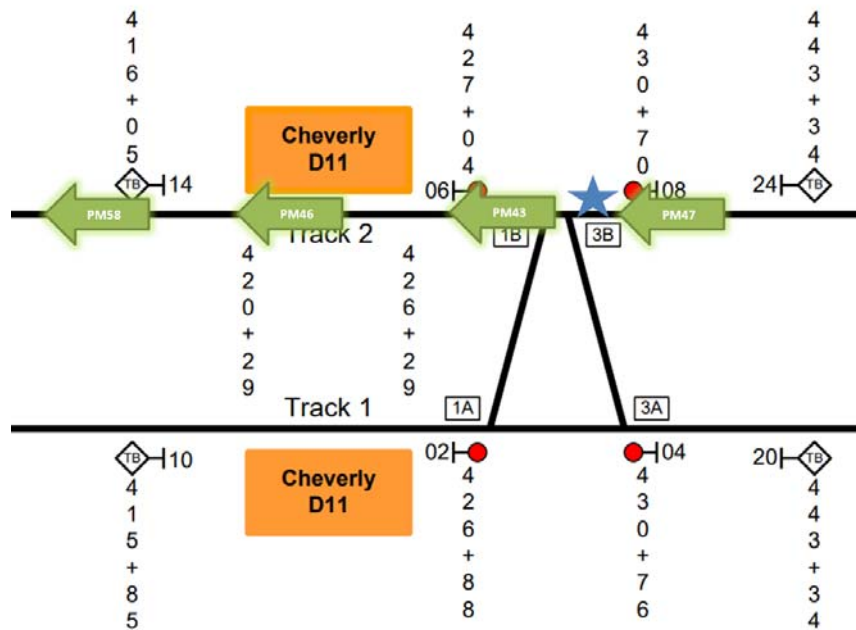
The incident area is located at CM 430+70 at D11-08 Signal, in approach to Cheverly Station, Track 2.

Diagram 1 – PM 47 was the last unit in a convoy block with PM58, PM46 and PM 43.

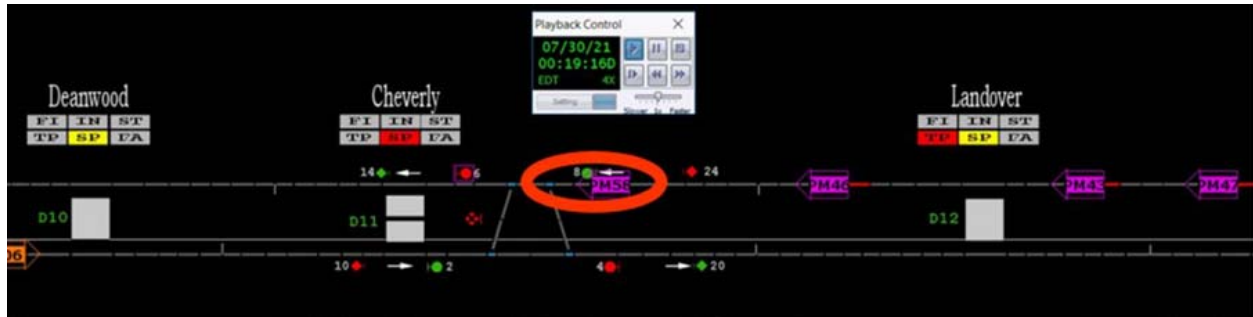
Diagram 2 - At 00:19:16 hours, PM58 was leading a convoy block on Track 2 plus three, with PM 47 being the last unit coming from New Carrollton Yard. D11-08 signal was fledted green (lunar).

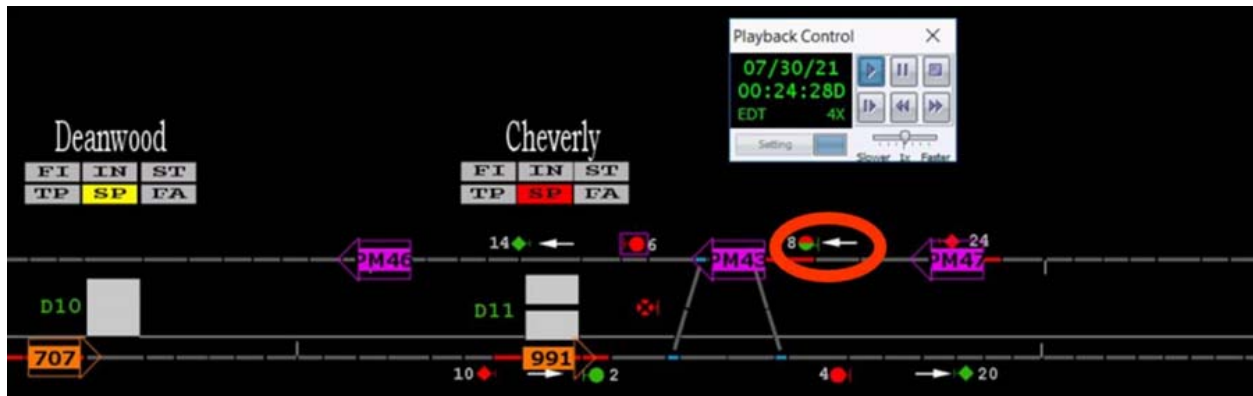
Diagram 3 – At 00:24:28 hours, D11-08 signal changed to fledted stop, which means red over green (red signal) after PM 43 passed D11-08 displaying a green (lunar) aspect.

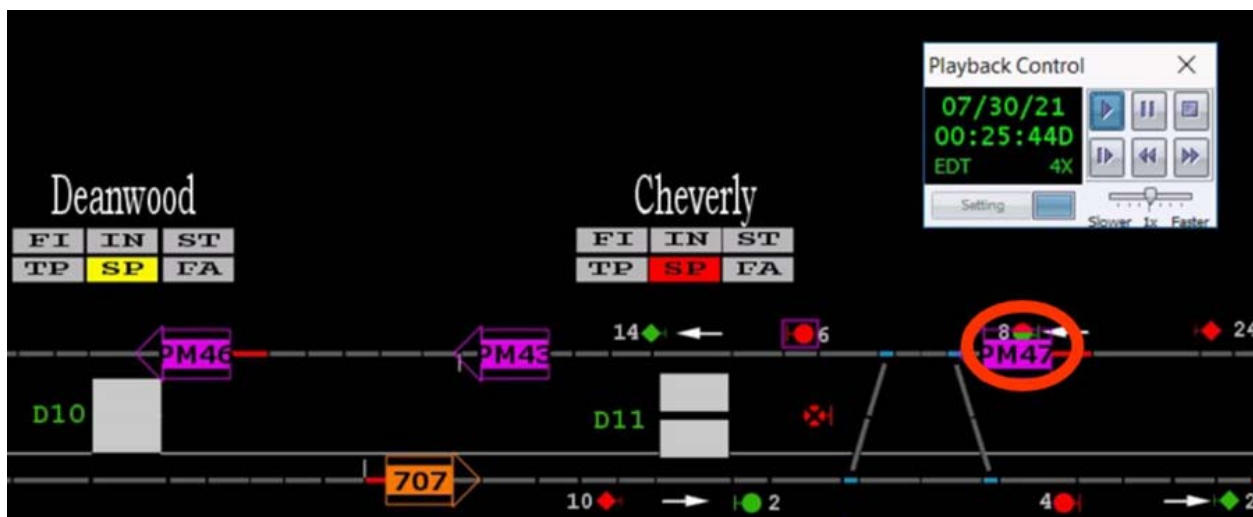
Diagram 4 – At 00:25:44 hours, PM 47 overran D11-08 displaying a red aspect.

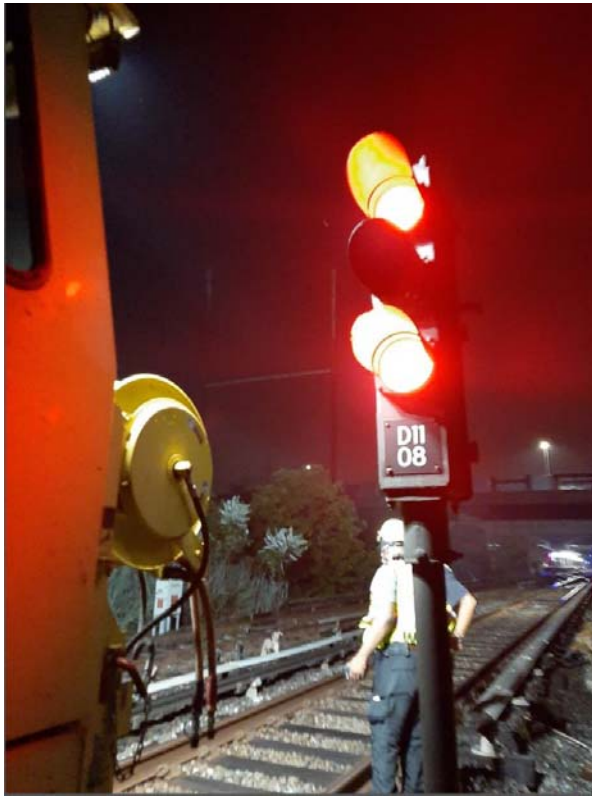
Figure 1 – D11-08 displaying a red aspect.

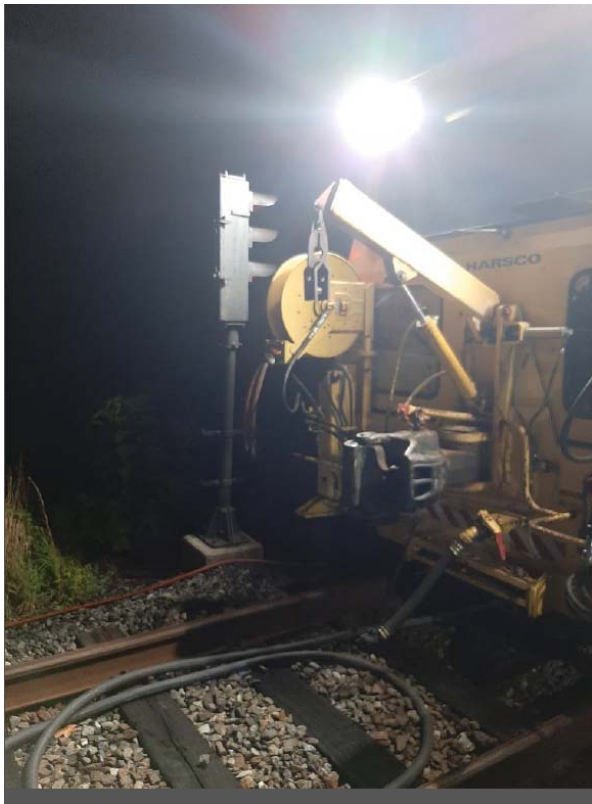
Figure 2 - PM 47 front of the vehicle passed D11-08 displaying a red aspect.

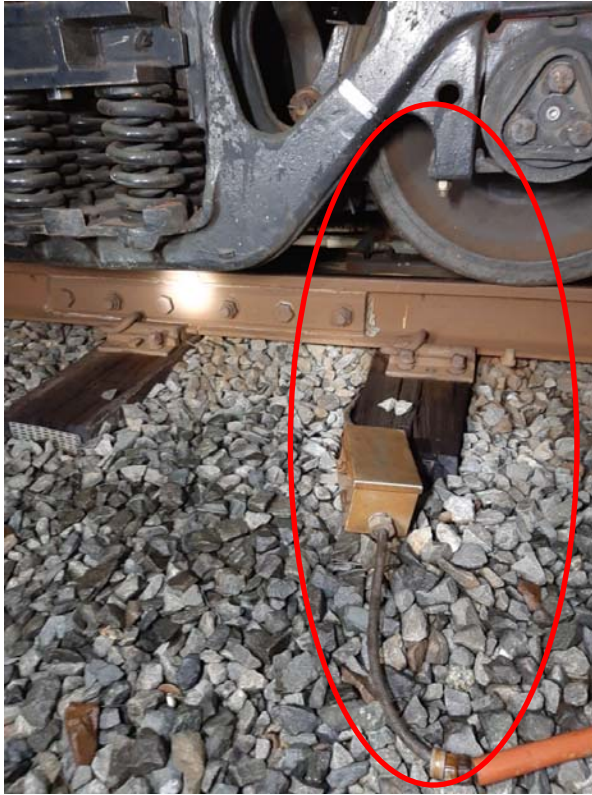
Figure 3 - PM 47 front wheel passed D11-08, IJ.

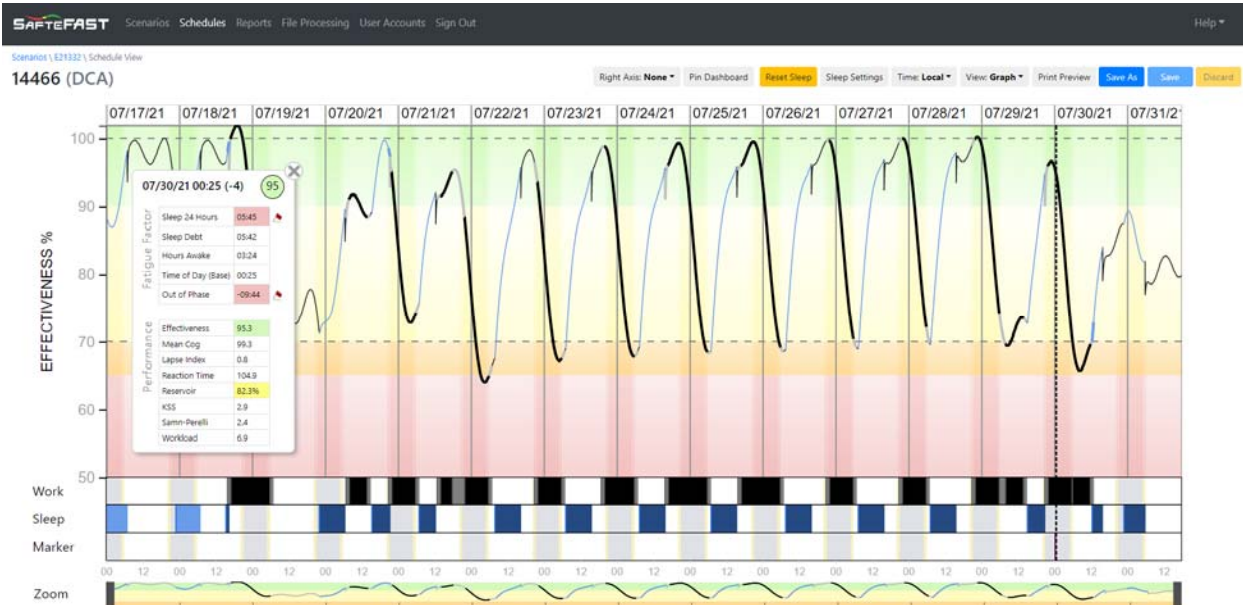
A biomathematical fatigue modelling application Sleep Activity Fatigue Task Effectiveness-Fatigue Avoidance Scheduling Tool (SAFTE- FAST) was used to further evaluate fatigue risk factors that may have been present in the Equipment Operator's schedule. The analysis was based on the Operator's work schedule, bed and wake times from the day before the incident and reported habitual sleep durations. Estimated performance effectiveness at the time of the incident was 95.3%. The analysis identified short sleep duration in the last 24 hours, and the circadian effects of night work as contributing to an increased risk of fatigue at the time of the incident.

Modeling analysis output shows estimated performance effectiveness during the incident work shift and for the week leading up to the work shift, based on the employee work and reported sleep schedule. Estimates were based on the Operator's work schedule, bed and wake times from the day before the incident, and reported habitual sleep durations (8.5 hours a day). Bold portions of the modeled curve show work (in black) and sleep times (in blue). Effectiveness is shown on the vertical axis, with colored fields in the chart background signifying ranges of effectiveness scores including high effectiveness (>90%) in green, and low effectiveness (<65%) in red. Time is shown on the horizontal axis. Markers for work and sleep times are shown in the lanes above the time of day on the horizontal axis. **Note:** while the modeling output shows estimated performance effectiveness for both the week leading up to the incident and at the time of the incident time, effectiveness and fatigue factors at the time of the incident is pinned in the chart output to highlight the combination of metrics related to fatigue at the time of the incident.
