WMSC Commissioner Brief: W-0136 – Improper Roadway Worker Protection – Van Dorn St. Station – July 8, 2021

FINAL REPORT OF INVESTIGATION A&I E21284

Date of Event:	07/08/2021
Type of Event:	Improper Roadway Worker Protection (RWP)
Incident Time:	10:50 hours
Location:	Van Dorn Station, Track 1, Chain Marker (CM) 730+00
Time and How received by SAFE:	11:00 hours – SAFE On-Call Phone
WMSC Notification Time:	12:59 hours
Responding Safety Officers:	WMATA: No WMSC: No Other: No
Rail Vehicle:	N/A
Injuries:	None
Damage:	None
SMS I/A Incident Number:	N/A

Van Dorn Station – Improper Roadway Worker Protection (RWP)

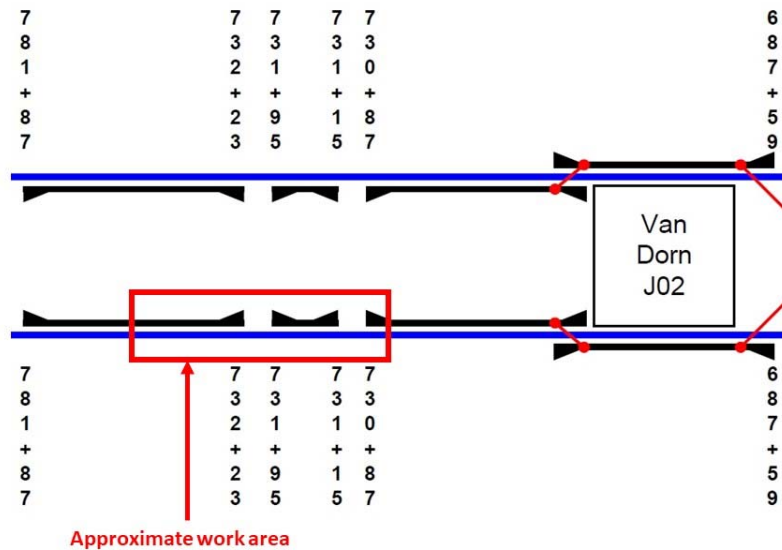
Field Sketch/Schematics

Van Dorn Station, Track 1, CM 730+00

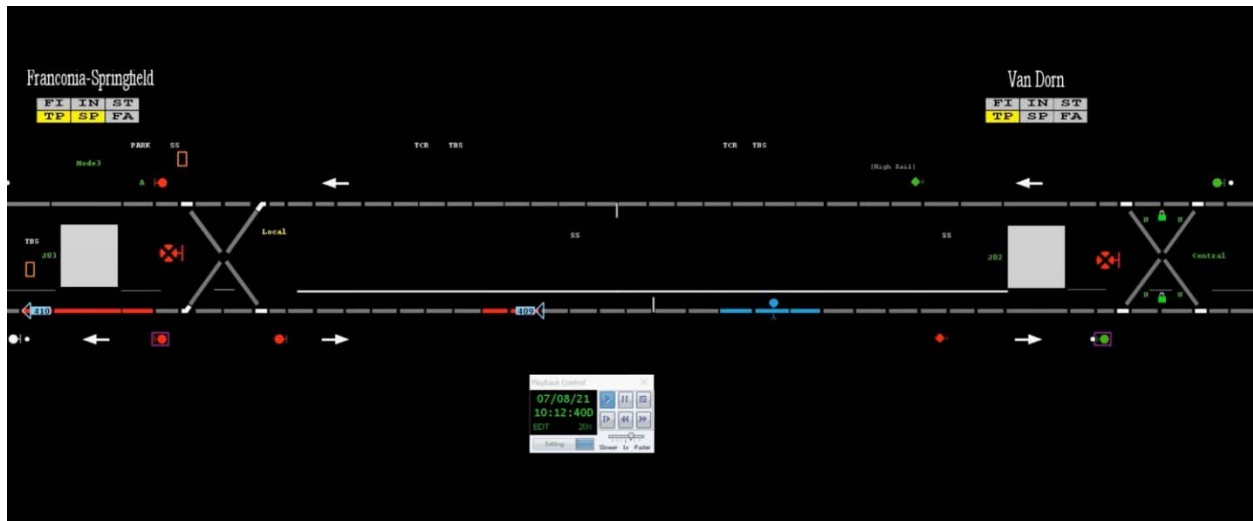
Photo #1 – Train ID 409 approaching the mobile work crew on Track 1 at approximately 10:12:40 hours.

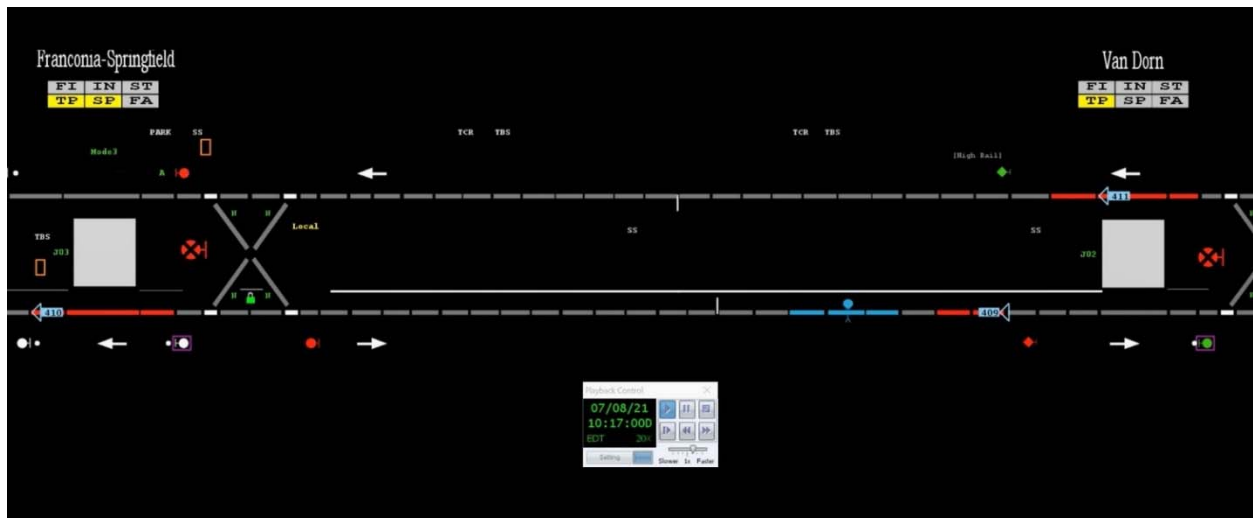
Photo #2 – Train ID 409 passed the mobile work crew on Track 1 at approximately 10:17 hours.

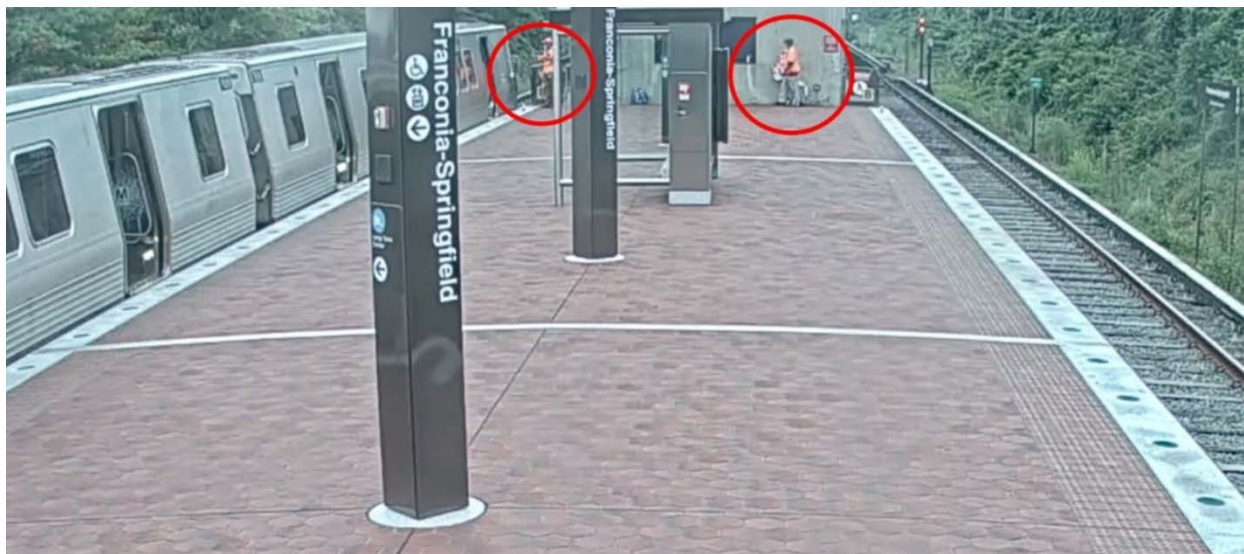
Photo #3 – Two AMFs stationed at the 8-Car Marker at Franconia-Springfield Station, Tracks 1 and 2 at approximately 08:43:17 hours.

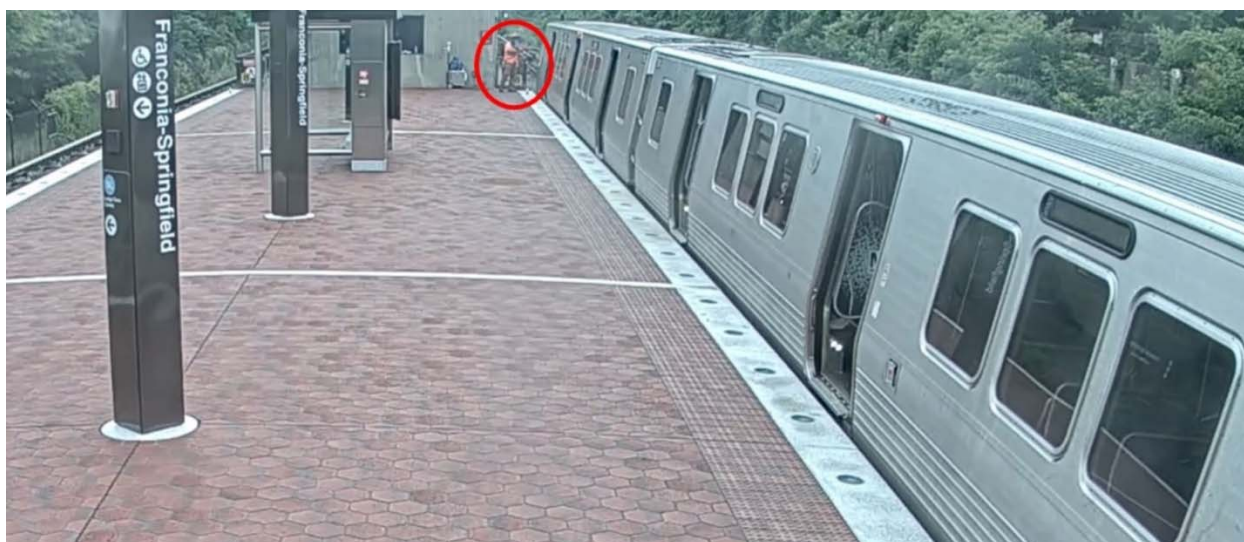
Photo #4 – AMF briefing the Train Operator of Train ID 409 on Track 1, Franconia-Springfield Station at approximately 10:40:39 hours.
