Inspection Form

Washington Metrorail Safety Commission

Inspection Date	YYYY/MM/DD 2021/05/04	Report Number	20210504-WMATA-LBW-1
Rail Agency Name	Washington Metropolitan Area Transit Authority	Rail Agency Department Contact Information	Name
Rail Agency Department	OEM		[Redacted]
Inspection Location	Glenmont Yard and Glenmont Portal

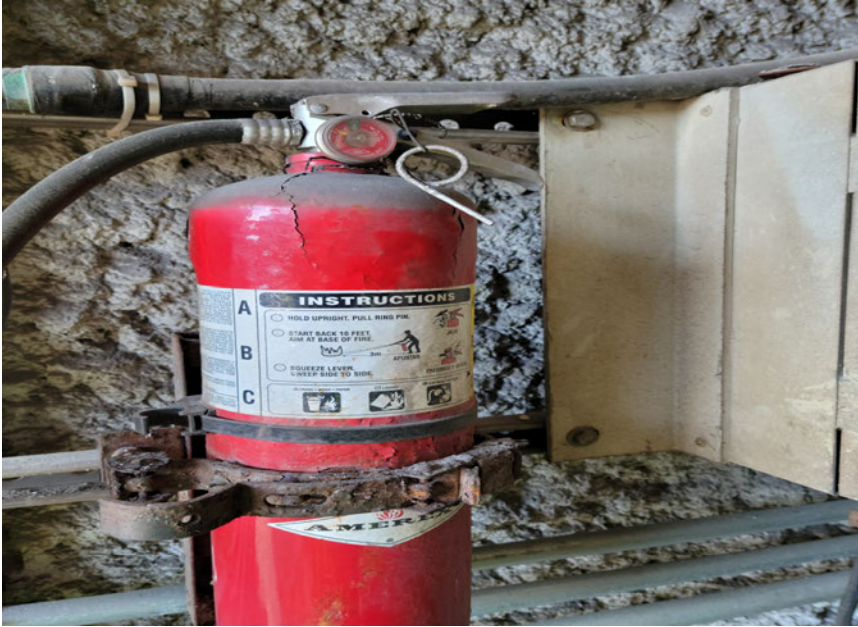
Photos:
showing recharge_needed

Recommended Finding?		Yes		
							Remedial Action Required?		Yes		
							Recommended Reinspection?		Yes		
Remedial Action	1. Inspect and/or replace fire extinguishers. 2. Replace non-illuminated blue ETS light 3. Replace missing emergency exit sign

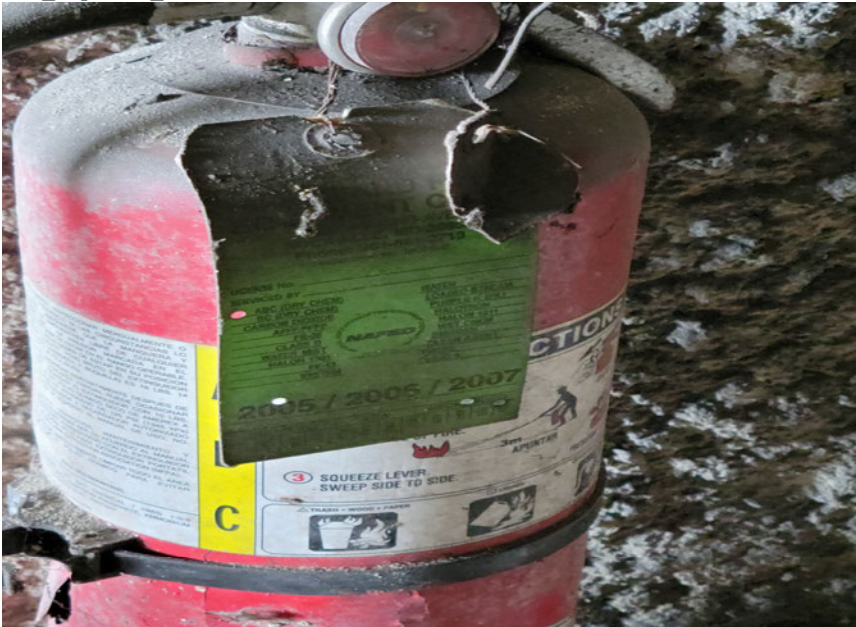
Due inspection 2005

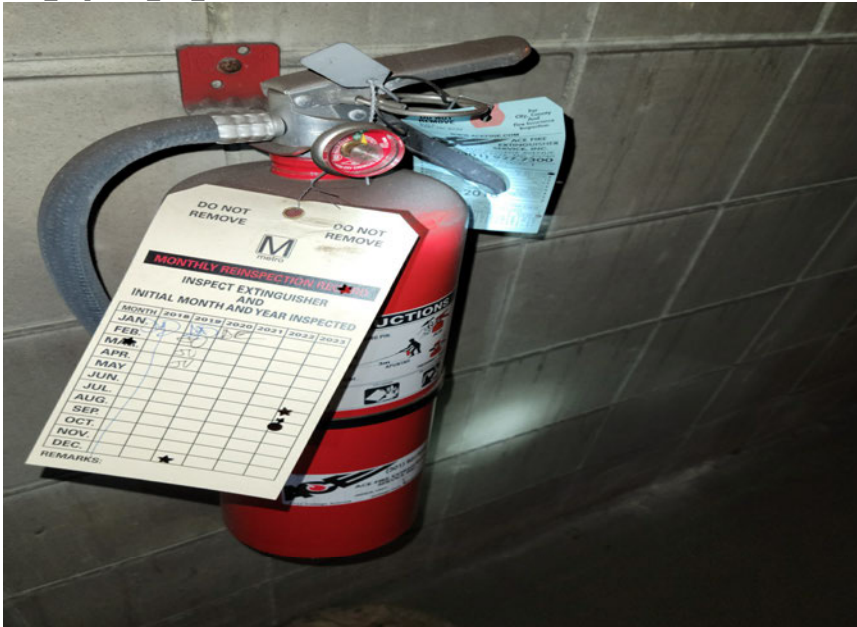
Last inspected Jan 2020

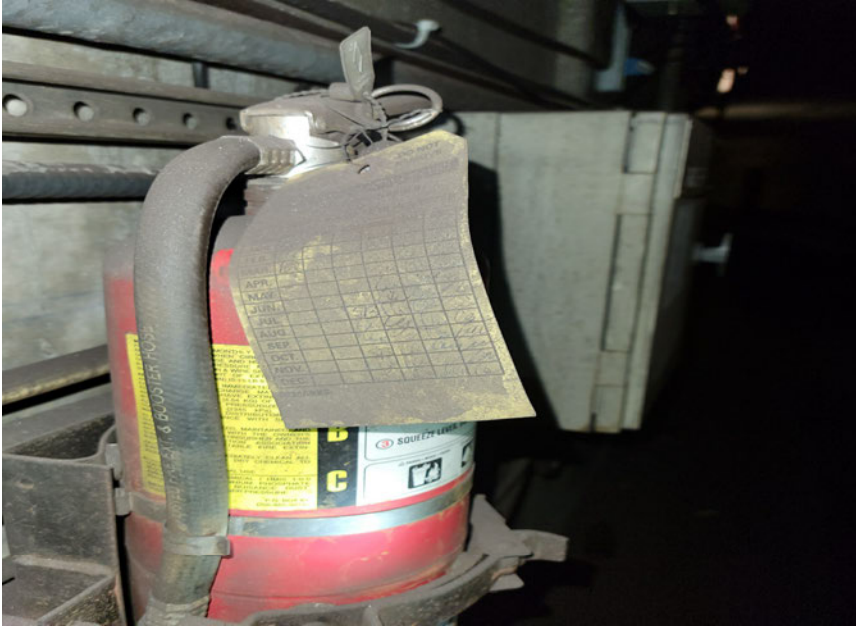
Inspection_tag_not_readable

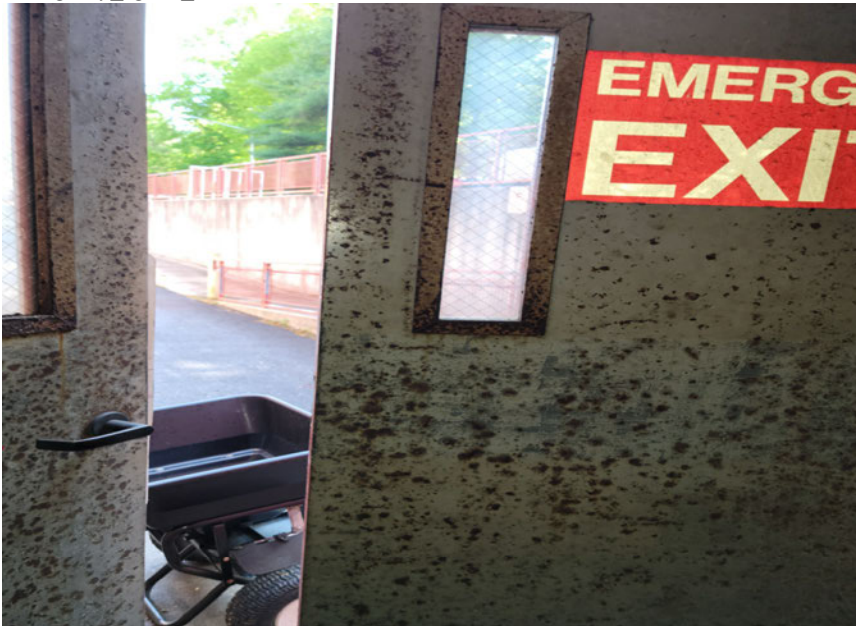
Emergency_egress_blocked
