**WMSC Commissioner Brief: W-0141 – Improper Roadway Worker Protection – Twinbrook Station – September 9, 2021**

**FINAL REPORT OF INVESTIGATION A&I E21429**

<b>Date of Event:</b>	09/09/2021
<b>Type of Event:</b>	Improper Roadway Worker Protection
<b>Incident Time:</b>	10:59 hours
<b>Location:</b>	Twinbrook Station, Track 1
<b>Time and How received by SAFE:</b>	11:17 hours IMO desk
<b>WMSC Notification Time:</b>	11:51 hours
<b>Responding Safety Officers:</b>	WMATA SAFE: No WMSC: No Other: N/A
<b>Rail Vehicle:</b>	Train 121 (L7298x7299-7291x7290-7424x7425-7317x7316)
<b>Injuries:</b>	None
<b>Damage:</b>	None
<b>Emergency Responders:</b>	None
<b>SMS I/A Number</b>	20210922#95727

Twinbrook Station – Improper Roadway Worker Protection

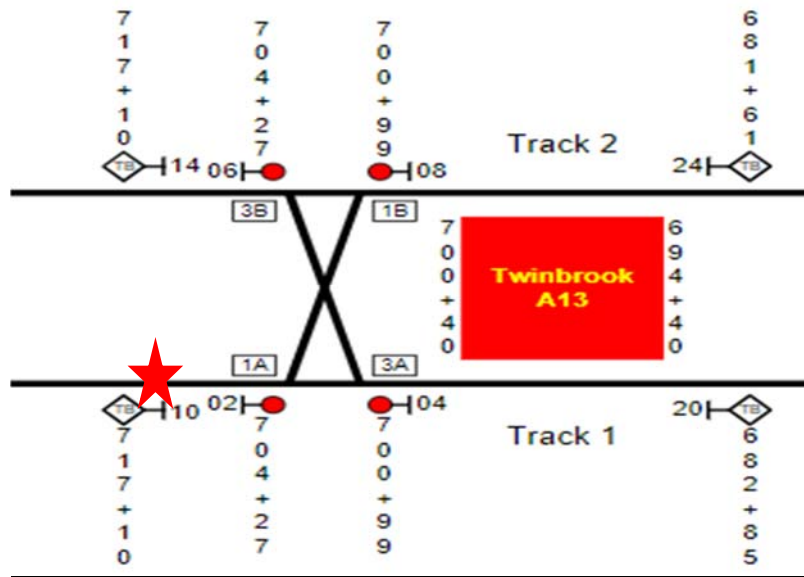
## Field Sketch/Schematics

\*This image shows the approximate location of the work crew when the train was approaching.

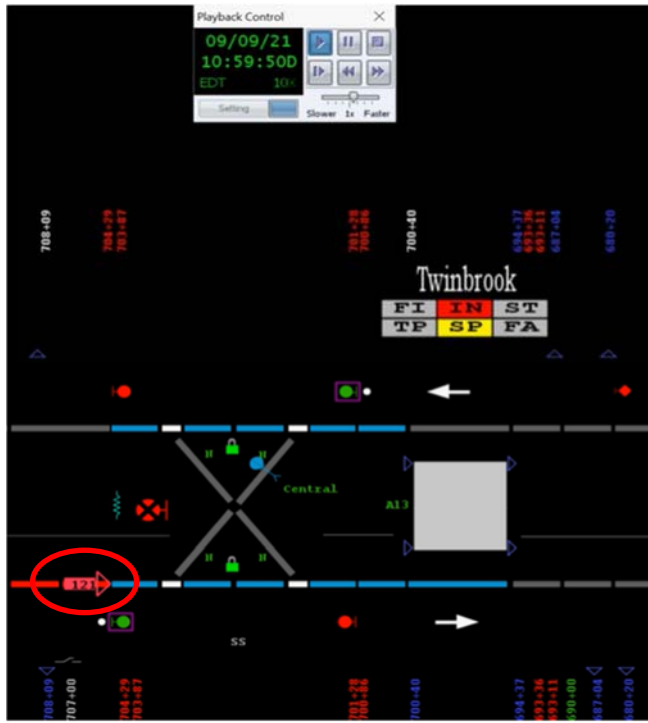
## Advanced Information Management System (AIMS)

\* This image shows when Train ID 121 stopped to talk to the track crew that was granted FT.

The RTC reported feeling moderately alert leading up to the incident. The RTC stated they pulled up the "big picture" [zoomed in view] of Shady Grove Station to make sure they had control of the board before granting the RWIC FT. When the RTC pulled up the big picture, the display covered the portion of the screen that would have shown Train ID 121's location. The RTC stated this caused them not to see Train ID 121 in approach to the RWIC's location when they granted the FT. The RTC stated there is a setting on the computer that would have prevented the zoomed in view from covering the FT area, but they did not have the setting enabled at the time of the incident.

- The RTC granted FT while a train was approaching the RWIC's location.
- The RWIC immediately told the RTC there was a train approaching their location.
- The RTC was unaware a train was approaching the RWIC when they granted FT.
- The "big picture" [zoomed in view] of Shady Grove Station covered the screen that would have shown the approaching train.
- There is a setting on the RTC's computer that would have minimized the "big picture" view but it was not selected when this incident occurred.

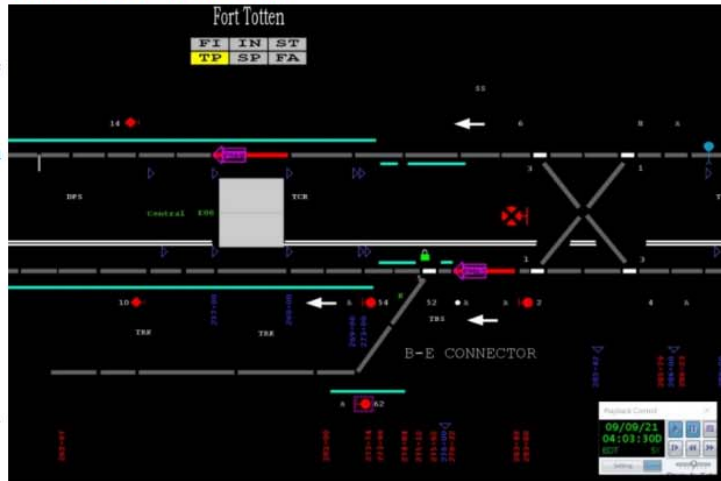
##### Incident A:

On Thursday, September 9, 2021, PM62 was en route to Branch Ave, under an Absolute Block from E1-345+00 (West Hyattsville) to Columbia Heights. AIM playback shows that lunar signals were set at E06 x 04 and 52 signals for PM62 moving inbound on track #1 at 0357. At 0359, PWR Unit 1239 requested Foul Time at Ft. Totten, track 1; chain markers E1-265+00 to E1-276+00 to enter the tiebreaker room for switching. The student RTC asked PWR Unit 1239 if he was relinquishing Foul Time. PWR Unit 1239 stated, no, he needed Foul Time to enter the tiebreaker room. The student RTC acknowledged the transmission and proceeded to transmit the status of the signals at Mt. Vernon Square as protection. The student RTC then proceeded to grant Foul Time to PWR Unit 1239. At 0404, PM62 reported seeing personnel roadway (within the Absolute Block) at Ft. Totten, track 1.

- The student RTC did not completely understand the RWIC's transmission but failed to ask for clarity.
- The student RTC did not comply with the 100% Repeat Back Rule.
- The student RTC did not locate the chain markers on AIM and verify.
- The student RTC failed to fully protect the Foul Time area, granting Foul Time while PM62 had a block and lunar signals at E06x04 and E06x52
- The OJTI did not properly oversee this event and intervene.

Extra care and attention must be given, especially when rail vehicles are moving against the normal flow of traffic. PM 62 had an absolute block travelling inbound on track #1 at Fort Totten, however the student RTC was setting up protection at Mt. Vernon Square for the requested Foul Time area. There was a clear lack of understanding of where rail movement was occurring and where Foul Time protection was being requested. OJTIs **MUST** be fully observant of student actions at all times.

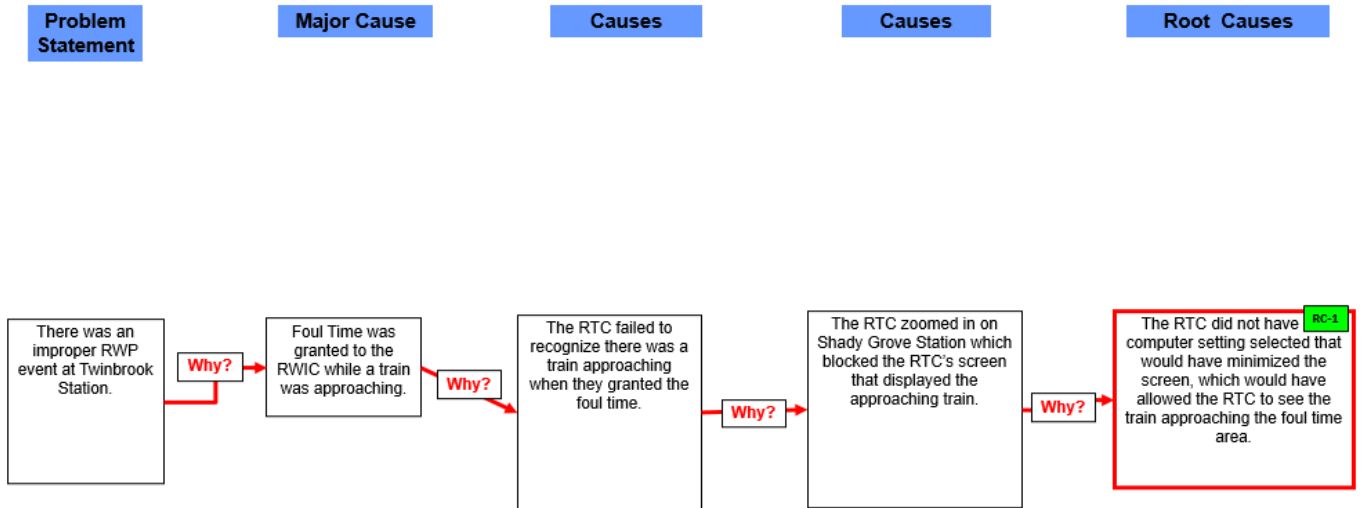
## Appendix D - Root Cause Analysis

The probable cause of this event was a human performance deficiency where the Radio RTC failed to confirm that there was no rail vehicle movement within the FT area prior to granting FT protection. The Radio RTC did not have the computer setting selected that would have minimized the "big picture" screen and allowed them to see the train approaching the FT area.

<b>Corrective Action Code</b>	<b>Description</b>	<b>Responsible Party</b>	<b>Due Date</b>
95727_SAFECAPS_ROCC_01	Lessons Learned Notice: Foul Time Violations	ROCC	Completed
95727_SAFECAPS_ROCC_02	Foul Time Memorandum and Procedural Change: On-Duty Assistant Operations Manager must be notified of all FT requests prior to a RTC granting FT.	ROCC	Completed
95727_SAFECAPS_ROCC_03	ROCC FT Safety Standdown	ROCC	Completed
95727_SAFECAPS_ROCC_04	RWP Standdown for RWP Qualified Personnel	ROCC	Completed
95727_SAFECAPS_ROCC_05	RTC completed refresher training on FT procedures.	ROCC	Completed
