WMSC Commissioner Brief: W-0143 – Evacuation for Life Safety Reasons – Capitol South Station – October 4, 2021

FINAL REPORT OF INVESTIGATION A&I E21481

Capitol South Station – Evacuation for Life Safety

| | Subject: | D05x04 Escalator Fire | Inspected By: | |

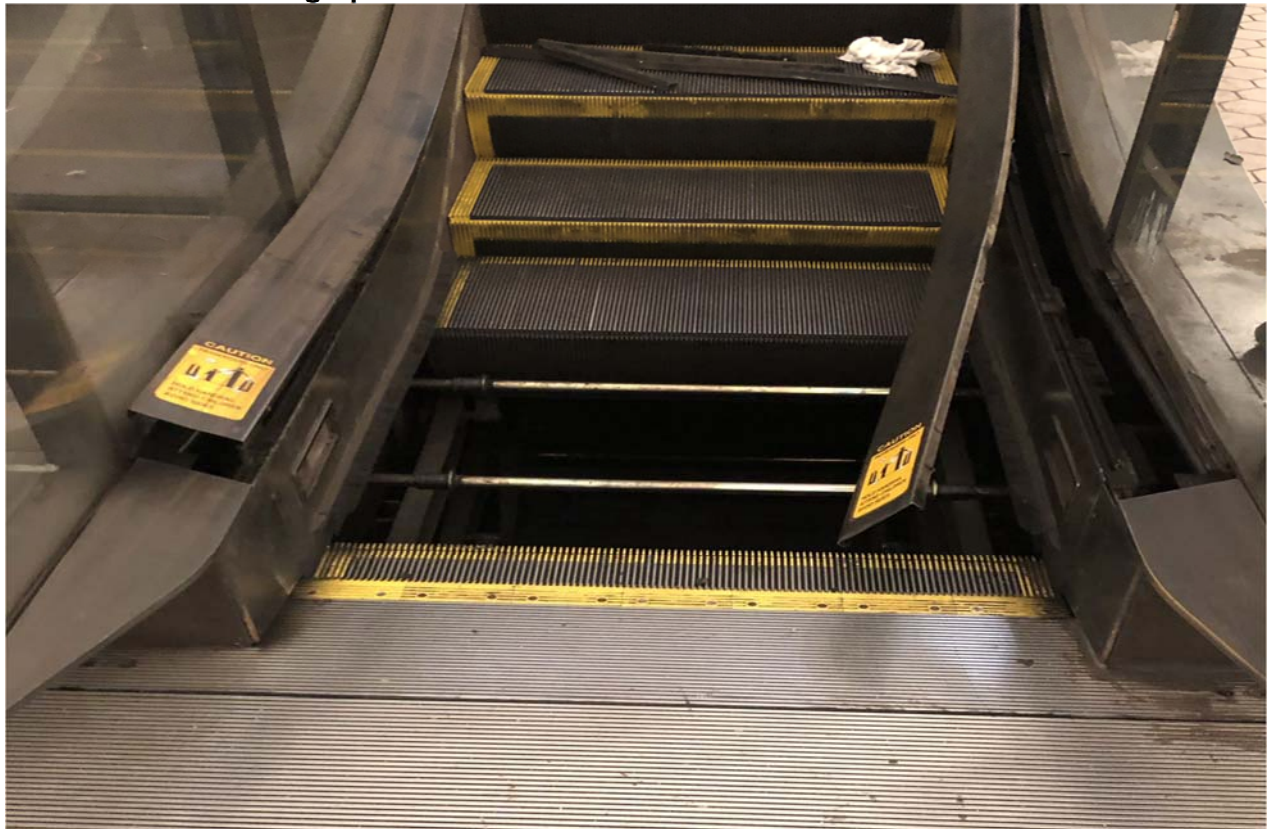
Figure 5 - Escalator #4 Platform Level affected area.

The “under step” lighting consists of two separate florescent tube housings fed by one circuit. The fire originated from a failed tombstone connection with the fluorescent bulb on the left side, top unit of the consist.

The fire was contained to the lower part of the escalator with some residual damage to step demarcations located close to the heat source.

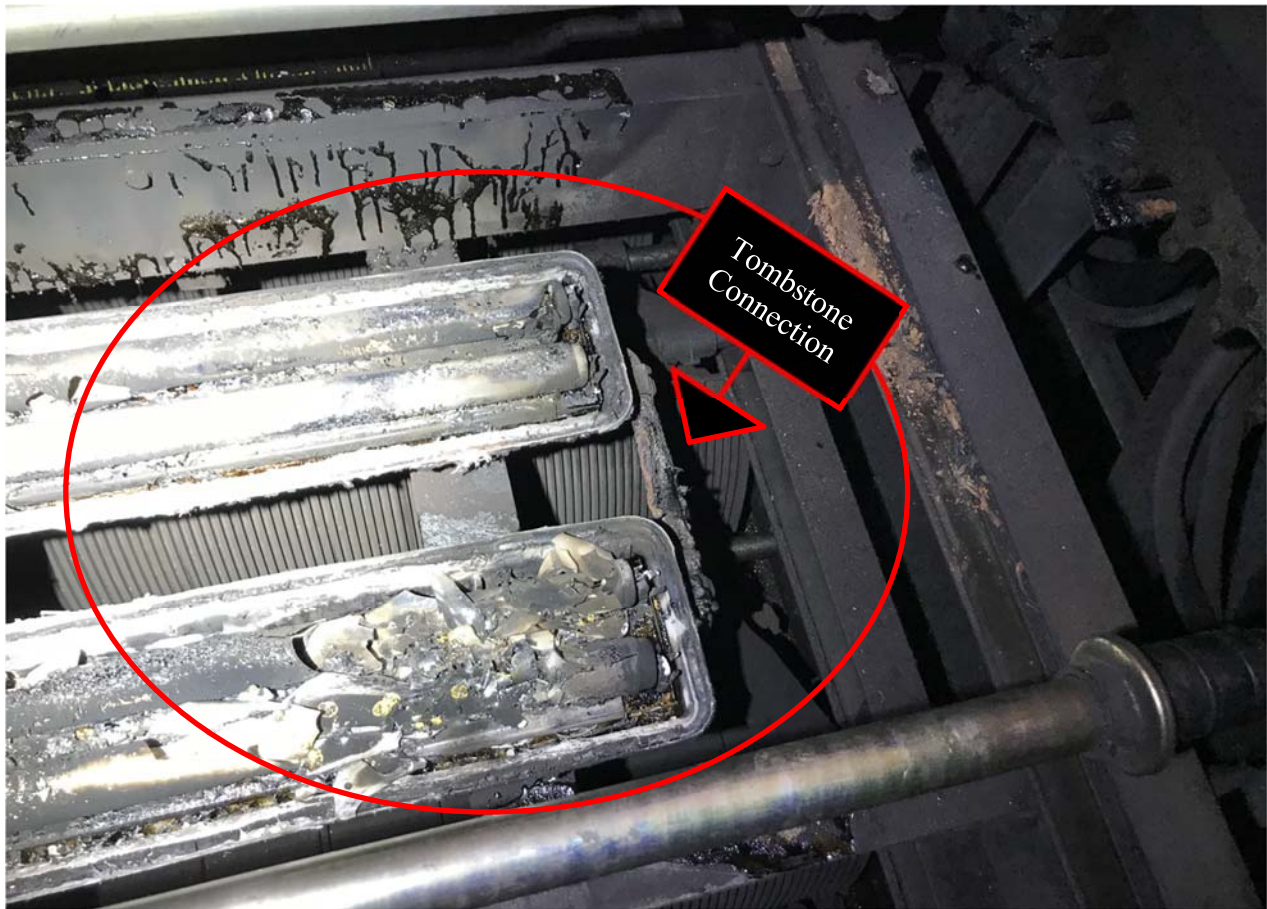
Figure 7 - Escalator #4 under step lighting and tombstone connection.

- The fire resulted from a faulty tombstone on the left side florescent bulb assembly. located on the under-step lighting at the lower portion of the unit.

The probable cause of the October 14, 2021, evacuation for life safety reason event at Capitol South Station was a failure of the left side florescent bulb tombstone connection, located in the lower portion of the escalator unit step band under-step lighting. The fire was contained to the lower part of the escalator with some residual damage to step demarcations located close to the heat source.

| Corrective Action Code | Description | Responsible Party | Targeted Completion Date |
|---|--|---|---|
| 95983_SAFECAPS_ELES_001 | (RC-1,) ELES shall remove and replace all existing florescent light housing from all units and install LED to eliminate excess heat and reduce the chance of connectivity issues with the under-step lighting. | ELES/SRC | March 1, 2022 |

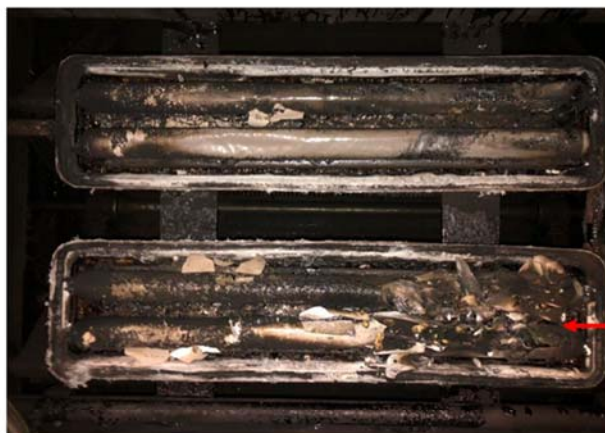
Investigation: On October 5, 2021 ELES Engineering arrived on site to investigate the cause(s) of fire within the escalator. After determining the fire originated in the lower portion within the step band, escalator “under step” lighting, it was further determined which component and the what side the malfunction occurred. “Under step” Lighting consists of two separate florescent tube housings fed by one circuit. The fire originated from a faulty tombstone connection with the fluorescent bulb on the left side, top unit of the consist. The fire was contained to the lower part of the escalator with some residual damage to step demarcations located close to the heat source.

Florescent light housings lower portion of Escalator. Notice top housing were electrical fire ignited.

- Remove all existing florescent light housings from all units and install LED style. This will help eliminate excess heat and reduce chance of connectivity issues with under step lighting.
Replacement WMATA part # **R38301286**

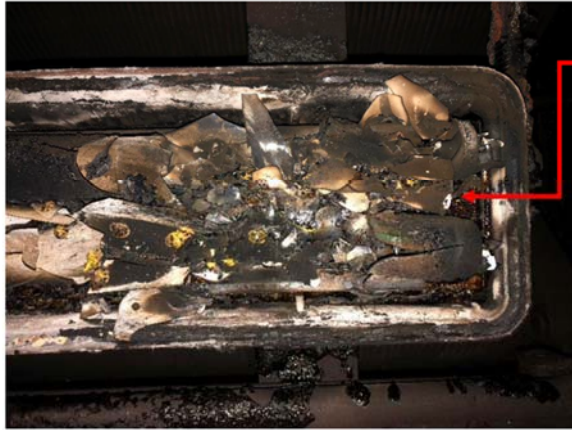
Top housing left side
where fire originated.

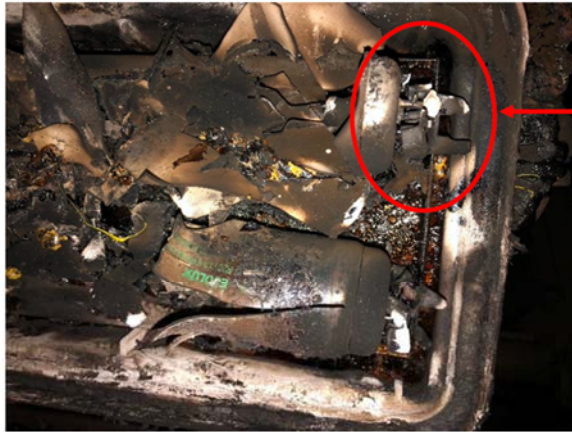
Tombstone connection
to florescent bulb.
