WMSC Commissioner Brief: W-0145 – Improper Movement – Medical Center Station – September 28, 2021

FINAL REPORT OF INVESTIGATION A&I E21474

Date of Event:	09/28/2021
Type of Event:	Improper Rail Vehicle Movement
Incident Time:	2024 hours
Location:	Medical Center Station, Track 2
Time and How received by SAFE:	0921 hours WMSC via Text
WMSC Notification Time:	1131 hours, 9/29/2021
Responding Safety Officers:	WMATA SAFE: No WMSC: No Other: N/A
Rail Vehicle:	Train ID 108, (L) <u>7722</u> -23X7741-40x7744-45x7313-12 (T)
Injuries:	None
Damage:	None
Emergency Responders:	None
SMS I/A Incident Number:	20211126#97047

Medical Center Station – Improper Rail Vehicle Movement

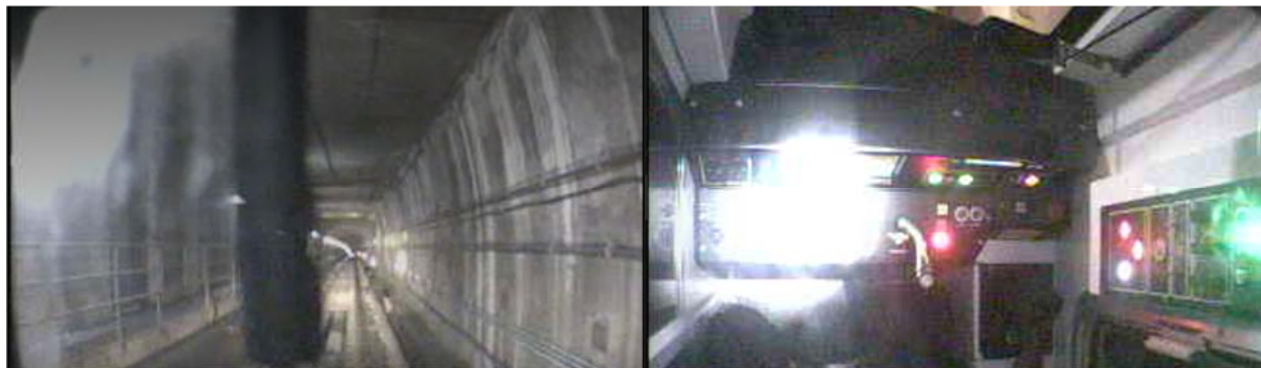
According to the System Recording Data, at approximately 20:24 hours, Train ID 108 Train Operator arrived at Medical Center Station and properly berthed at the 8-car marker on Track #2 outbound in Shady Grove Station's direction. Upon arrival, Train ID 108 performed a left-side door operation and allowed customers to board. NVR playback showed Train ID 108 Train Operator did not return to the console before performing a left side closing door operation.

Based on the MSRP SOP #40 40.5.3 Door Closing Procedures: 40.5.3.1, *"Prior to initiating the Close Door button, the train operator shall check the operating console for speed commands and check Roadway ahead of the train to ensure it is clear."* NVR playback and CMOR IIT analysis supported that Train ID 108 attempted to move the train after conducting a left-side door operation. Train ID 108 Train Operator was unable to move due to a controlled audit being undertaken by RTRA QA/QC to cause trains at Medical Center Station to lose speed readouts upon arrival at the eight-car marker.

Figure 1 - Train ID 108 Train Operator attempting to take a point of power with Master Controller (MC) moved to the P4 Position.

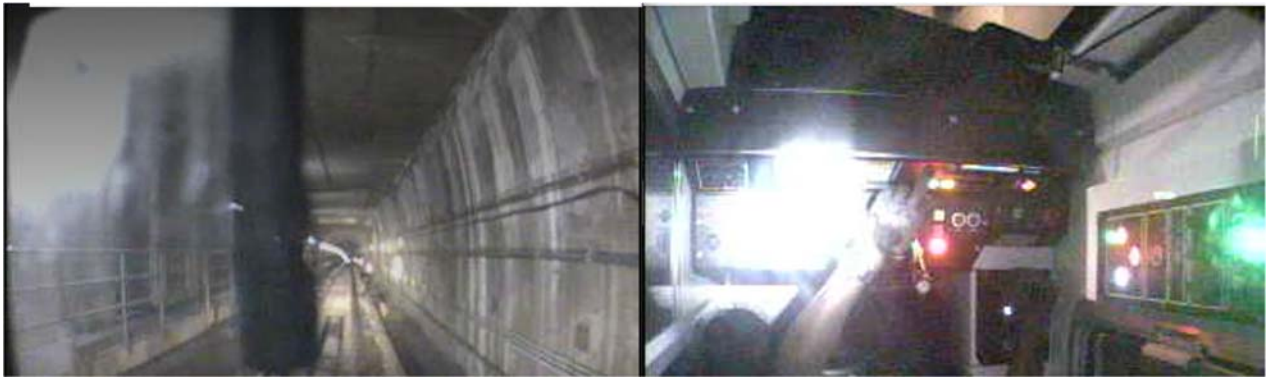
At approximately 20:24:34 hours, NVR playback and CMOR IIT data confirmed Train ID 108 Train Operator entered Stop and Proceed on the operator's console after performing a left-side door operation.

Figure 2 - Train ID 108 Train Operator entering Stop and Proceed without ROCC Authorization.

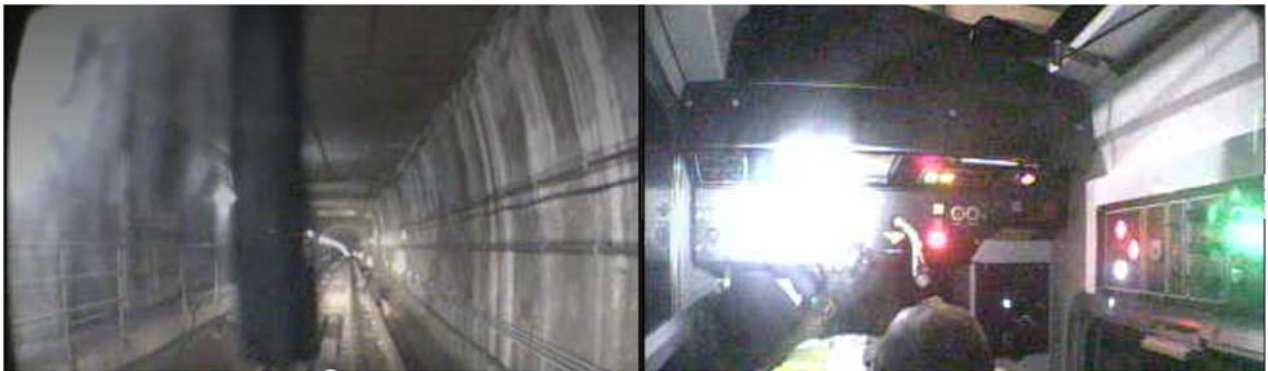
Audio Recording Services ARS playback determined Train ID 108 Train Operator did not request permission to enter Stop and Proceed mode before moving approximately five feet outside the platform limits. The Train Operator placed the MC in coast and depressed the car wash pushbutton. The Train then moved at two mph for two seconds before the Train Operator entered a braking mode. At approximately 20:25 hours, Train ID 108 Train Operator notified the Radio RTC that they did not have speed commands at Medical Center Station. The Radio RTC granted Train ID 108 Train Operator permission to enter stop and proceed mode and continue.

Figure 3 - Train ID 108 Train Operator asking for permission to enter Stop and Proceed mode.

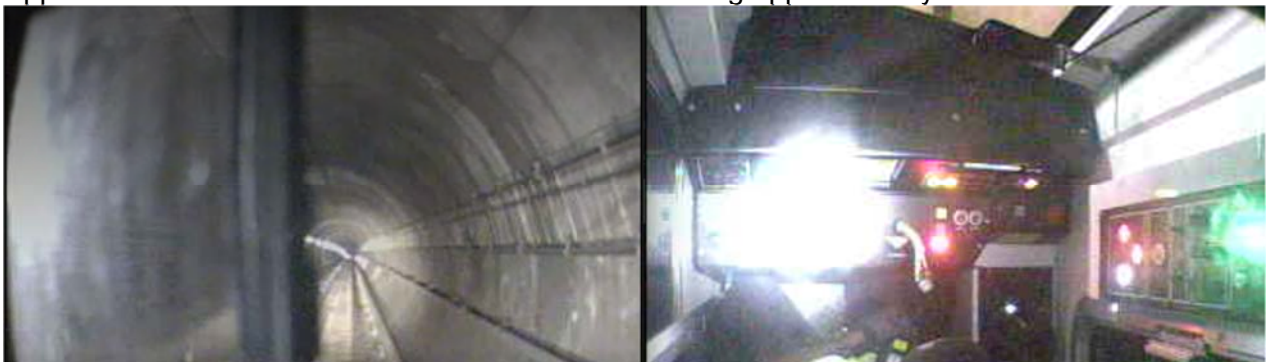
According to CMOR IIT analysis, Train ID 108 Train Operator continued operating towards the next station [Grosvenor-Strathmore] until the ATC applied Full-Service brake in B4 Brake Application at 20:25 hours and 24 seconds after traveling approximately 265 feet.

Figure 4 – ATP activated, and Train ID 108 came to a complete stop after traveling 263 feet.

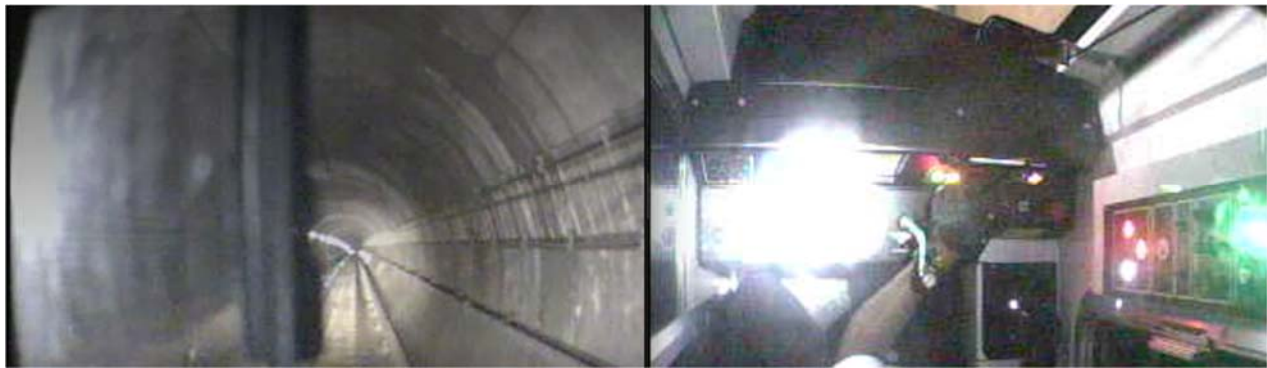
NVR console playback showed Train ID 108 Train Operator entered Stop and Proceed mode a second time at 20:25 hours and 47 seconds.

Figure 5 - Train ID 108 Train Operator entering Stop and Proceed a second time.

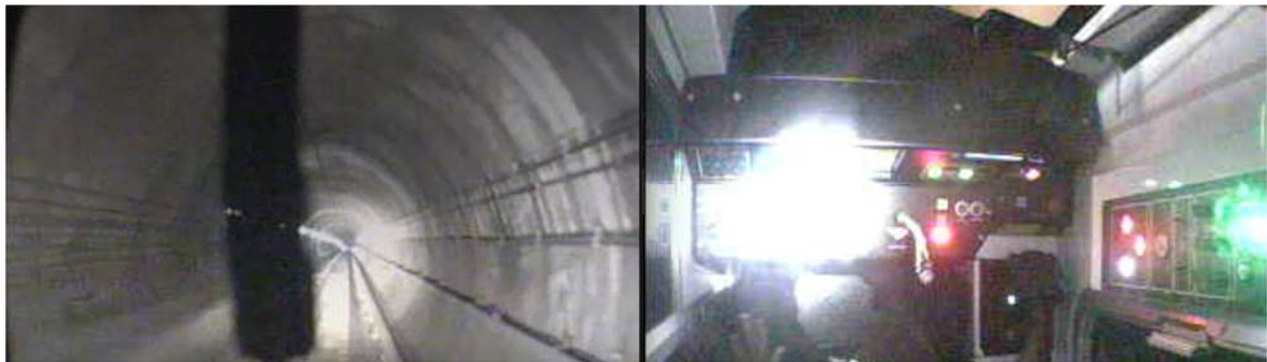
Train ID 108 Train Operator then operated in Shady Grove's direction without further incident.

Figure 6 - Train ID 108 Train Operator resumed normal operations towards Grosvenor

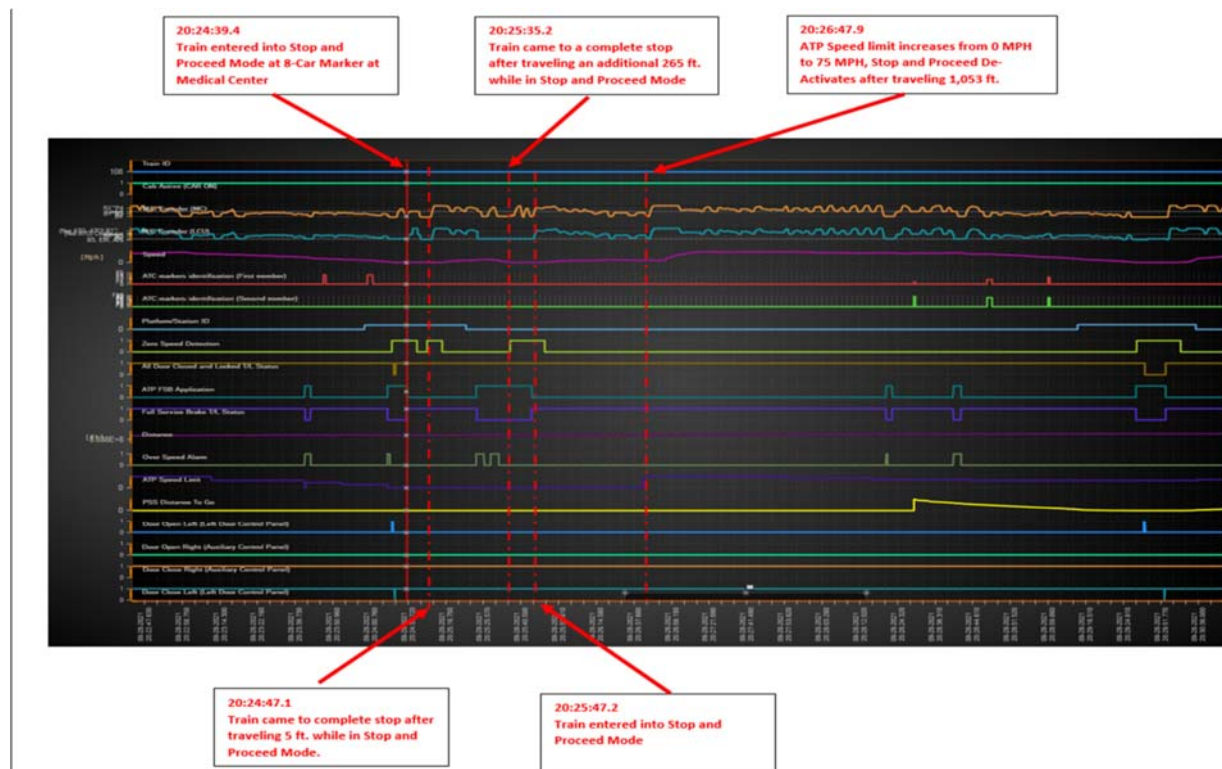
Description of Events (ER Log Data for Car 7722):

Based on the CMOR IIT data analysis of Train ID 108, after Train ID 108 Train Operator serviced Medical Center Station, Track #2, with an ATP Speed limit of 0 MPH, the train was entered into Stop and Proceed mode. The train traveled 5 feet, then another 265 feet before Stop and Proceed deactivated. The train was again entered into Stop and Proceed Mode and traveled another 1,053 ft. before the ATP Speed limit increased from 0 to 75 MPH, deactivating Stop and Proceed.
