**WMSC Commissioner Brief: W-0146 – Train Passed Personnel at Excessive Speed – Red Line – November 17, 2021**

Washington Metro Area Transit Authority  
Department of Safety and Environmental  
Management (SAFE)  
**FINAL REPORT OF INVESTIGATION A&I E21586**

**Between Takoma Station & Fort Totten Station, Track 2 – Train Passed Personnel at Excessive Speed**

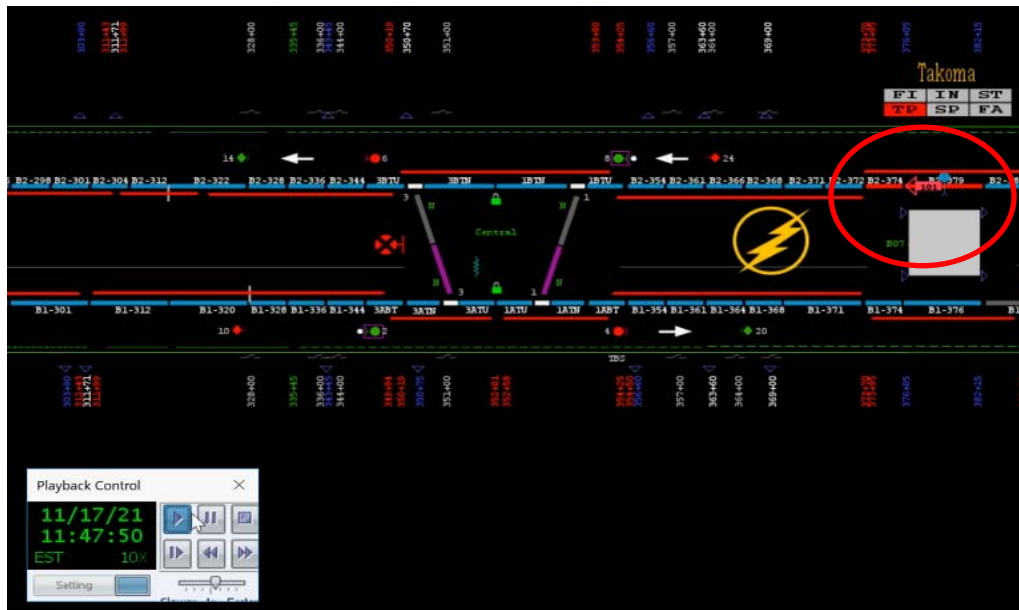
As observed on CCTV, at approximately 11:47 hours, Train ID 101 entered the platform at Takoma Station, track 2, with two personnel in the operating cab, the Train Operator and Rail Supervisor.

Figure 1 - Train ID 101 entering Takoma Station, track 2 at approximately 11:47 hours.

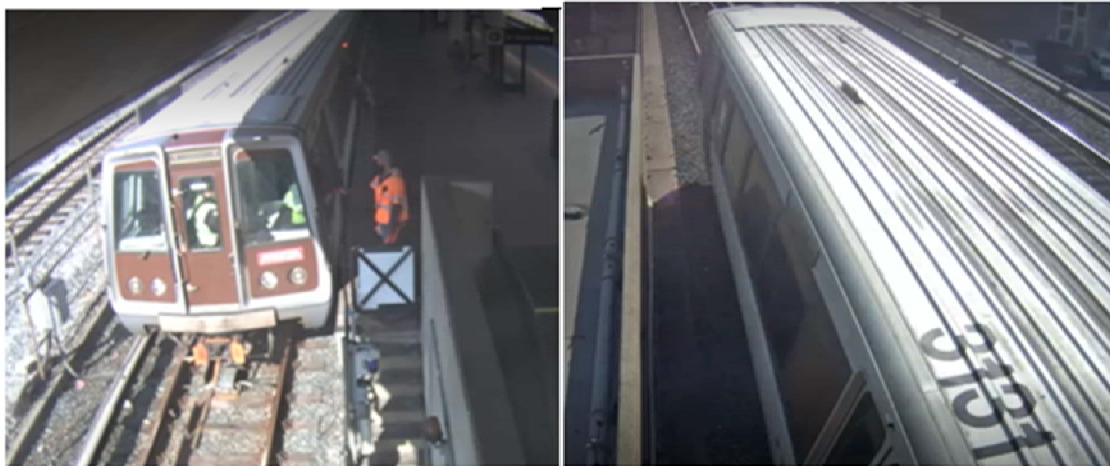
After receiving the AMF instructions, Train ID 101 departed Takoma Station at approximately 11:49 hours in Fort Totten Station's direction. The RTRA Supervisor remained in the operating cab as the train departed.

Figure 2 - Train Operator receiving instructions from the AMF at Takoma Station and Train ID 101 departing Takoma Station.

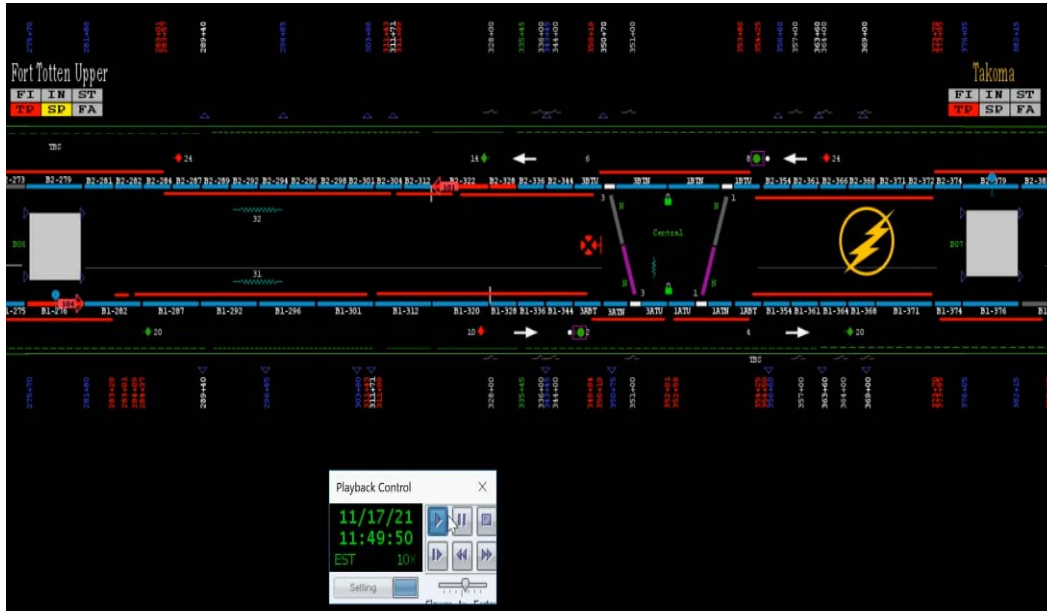
At approximately 11:49 hours, Train ID 101 entered the Restricted View: Curve and encountered the Mobile Work Crew at CM B2 317+00. The Train Operator and Rail Supervisor were engaged in discussions relating to train operation and non-work-related conversations. This action led the Train Operator to become distracted from performing their duties after receiving instructions from the AMF minutes prior.

Figure 3 - Train ID 101 at CM B2 317+00, the approximate location of the Mobile Work at approximately 11:49 hours.

The train was traveling at a speed of 59 MPH as the consist approached the Mobile Work Crew, well above the required one-half of regulated speed. The Mobile Work Crew noticed the train traveling at a high rate of speed and immediately jumped from the track bed to a place of safety and leaned against the fence to avoid being swept in the wind caused by the dynamic envelope of the train passing their location. The Train Operator placed the Master Controller in the emergency position, activated the horn, and the train came to a stop after the entire consist passed the Mobile Work Crew. The Train Operator recharged the train brake pipe pressure, and approximately 18 seconds after stopping, the Train Operator continued towards Fort Totten Station without reporting the incident.

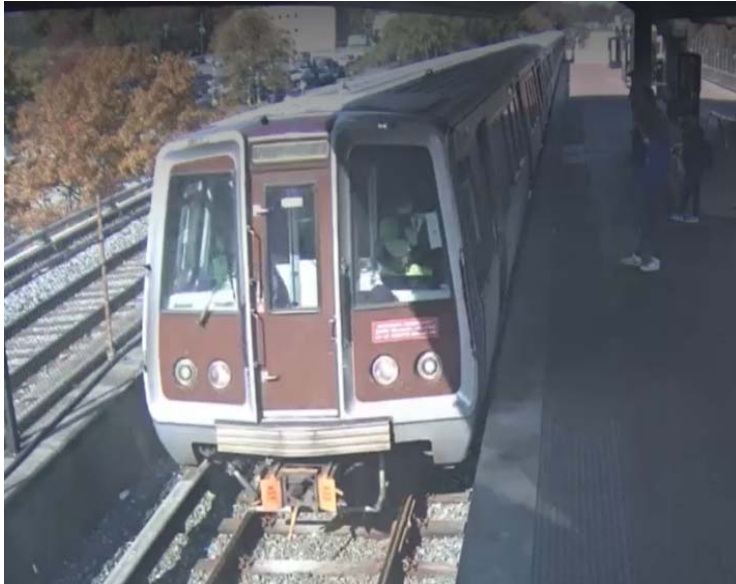
Following the train passing the mobile work crew at excessive speed, the Rail Supervisor was observed onboard the consist in the Operator's Cab when the train arrived at Fort Totten, Brookland, and Rhode Island Avenue Stations.

Figure 4 - Train ID 101 entering Fort Totten Station. (Rail Supervisor observed in the cab area)

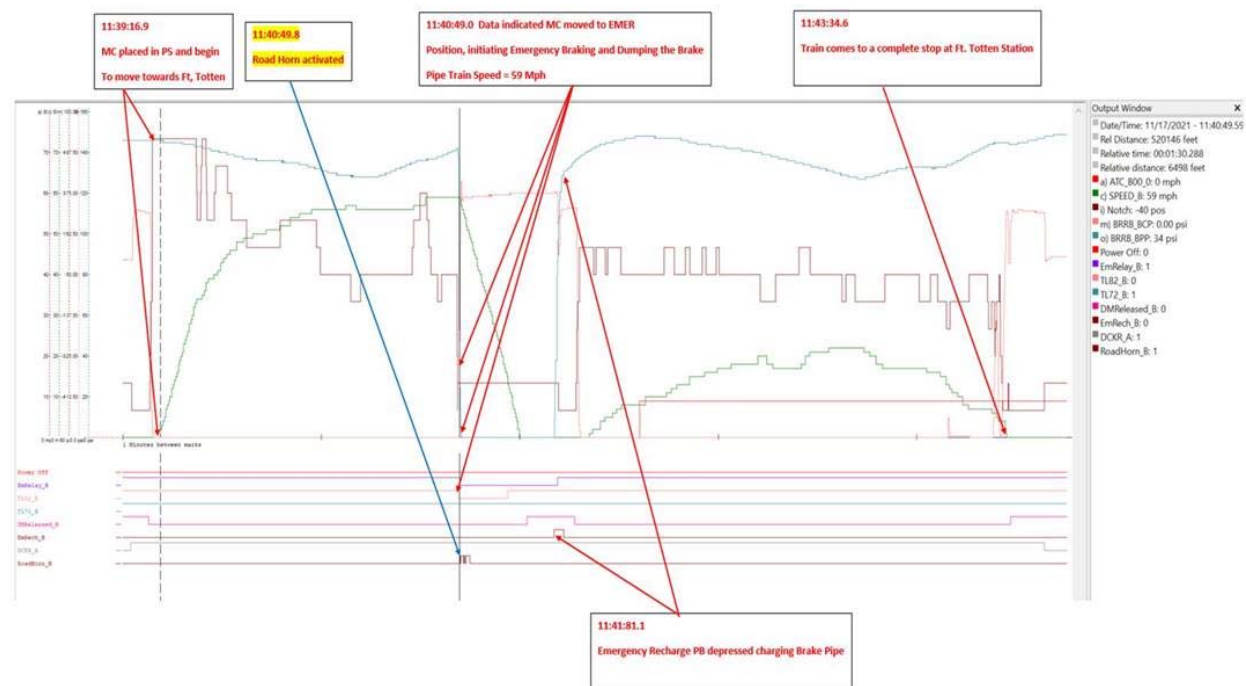
### VMS Data Visualization R3131

The brake logs were downloaded from the entire consist, and there were no faults logged with the friction brake system during the time in question. The train performed as designed.

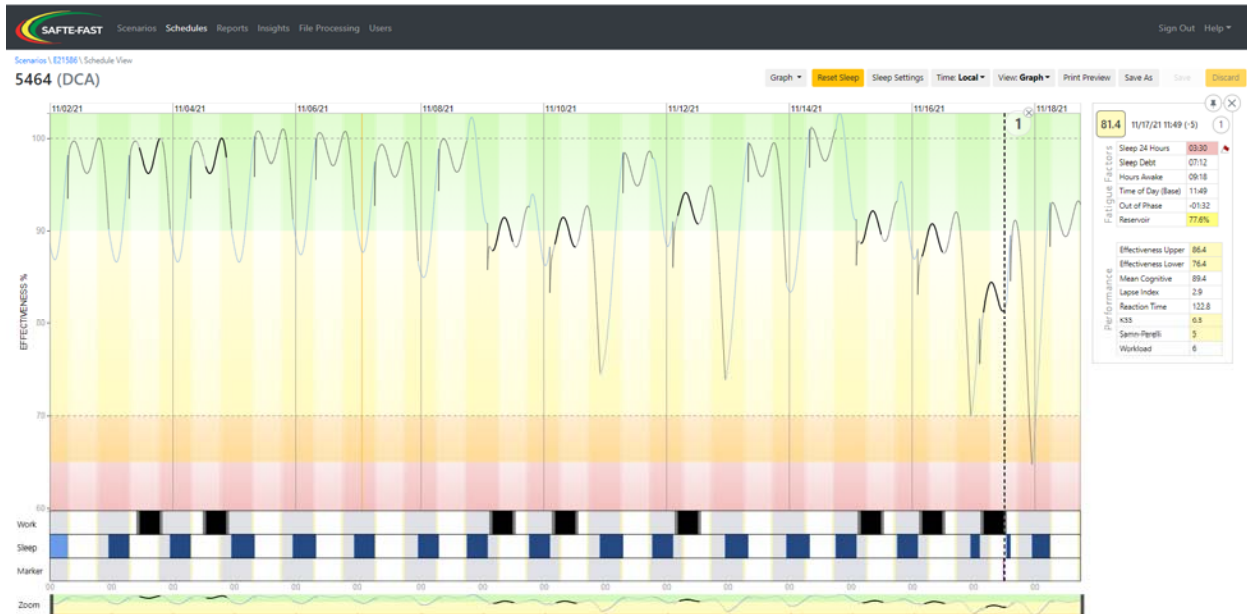
sleep in the 24 hours preceding the incident as a factor contributing to an increased risk of fatigue at the time of the incident. The estimated performance effectiveness at the time of the incident was 81.4%.

Modeling analysis output shows estimated performance effectiveness during the incident work shift and for the week leading up to the work shift, based on the employee work and reported sleep schedule. Estimates were based on the Rail Supervisor's work schedule, bed and wake times from the day before the incident, and reported habitual sleep durations (8 hours a day). Bold portions of the modeled curve show work (in black) and sleep times (in blue). Effectiveness is shown on the vertical axis, with colored fields in the chart background signifying ranges of effectiveness scores, including high effectiveness (>90%) in green and low effectiveness (<65%) in red. Time is shown on the horizontal axis. Markers for work and sleep times are shown in the lanes above the time of day on the horizontal axis.

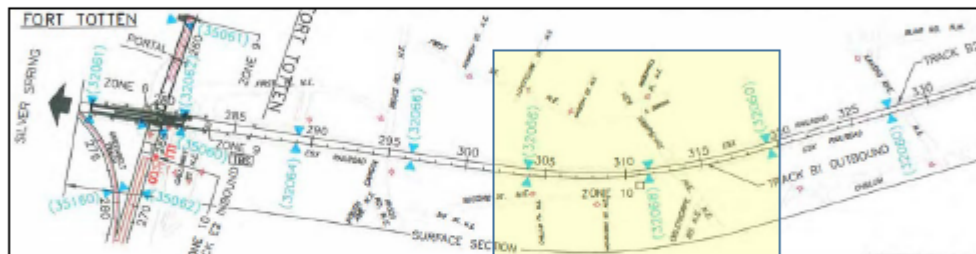
Figure 1, Section B2 302+00 to B2 320+00

The physical characteristics of chain markers B2 302+00 to 320+00 are ballasted tangent tracks with track centers of 14 feet. The third rail is back-to-back. The distance from the field side of the running rail to the fence is approximately eight to ten feet—the track 2 curves to the left when walking outbound to the North on track 2, and the curve radius is 4563.75 feet. A chain-link fence borders the WMATA right-of-way on both sides. CSX tracks run adjacent to WMATA's right-of-way on track 1 and 2 sides. The civil track speed is 75 mph, and the required sight distance is 1650 feet. The regulated speed in this section of the track is 65 mph. The distance of sight needed for a vehicle moving at 65 mph is 1430 feet.

The Watchman/Lookout standing in a place of safety at CM B2 302+00 can only see to CM B2 312+00 or 1000 feet. The fence, trees, the curve in track alignment, and the bridge block the Watchman/Lookout's view. The Watchman/Lookout's line of sight does not improve until they pass CM B2 319+00. However, there is ample space for the work crew to stand of the dynamic envelope of the train.

The recommendation from this SAFE investigation is to make B2 302+00 to 320+00 a permanent RED HOT SPOT in the Track Access Guide. Even though there is ample space to reach a place of safety, the visual sight distance for the Watchman/lookout does not allow them to ample time warning.

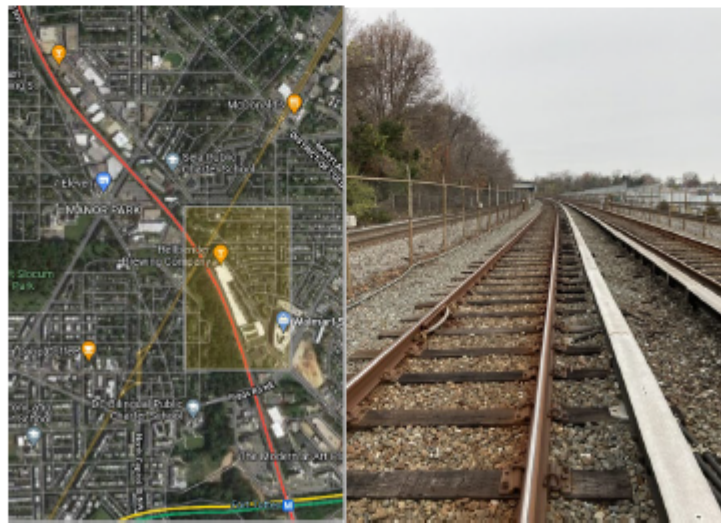
Figure 2, Track alignment from 302+00 to 320+00 looking North

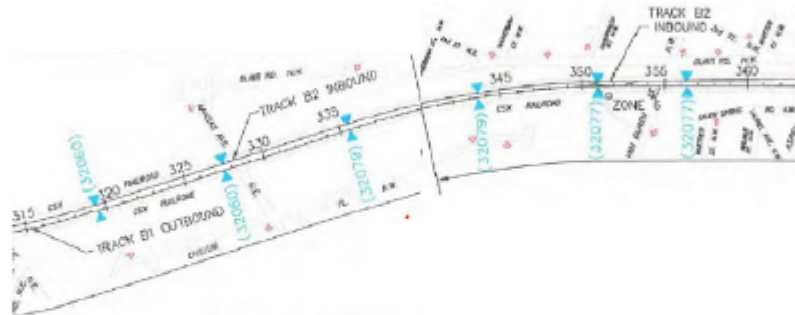
Figure 3, Section B2 334+00 to 340+00

The physical characteristics of the roadway starting at chain makers B2 334+00 to 340+00 are ballasted tangent tracks with tack centers of 14 feet. The third rail is back-to-back. The distance from the field side of the rail to the fence is ten feet—the track curves to the right when you walk outbound to the North on Track 2, and the curve radius is 3839.83 feet. A chain-link fence borders the WMATA right-of-way on both sides. CSX tracks run adjacent to WMATA right-of-way on track 1 and 2 sides. The civil track speed is 55 mph, and the required sight distance is 1210 feet. The regulated speed in this section of the track is 50 mph. The range of sight needed for a vehicle moving at 50 mph is 1100 feet. The Watchman/Lookout standing in a place of safety at CM B2 334+00 can see to CM B2 346+00. A distance of 1200 feet. The fence, trees, and curve in track alignment can restrict the Watchman/Lookout's ability to warn the mobile work crew with ample time. Proper placement of the Watchman/lookout will eliminate any view restrictions.

The recommendation from this SAFE investigation is to maintain B2 334+00 to 340+00 at its current condition (Restricted View Curve) in the Track Access Guide. With proper placement of the Watchman/lookout able to provide ample time warning. The physical characteristics of the roadway allow the work crew to easily clear to a place of safety. A possible hazard for this location is the CSX tracks. When there are no trains noise levels, allow the mobile crew to hear the Watchman/Lookout's warning. A CSX train was not present during the evaluation, and noise levels were not measured.

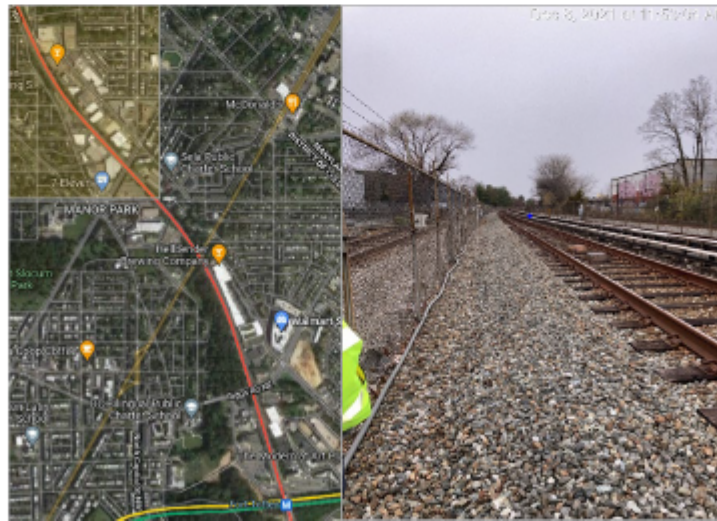
Figure 4, Picture looking North from CM B2 334+00
