WMSC Commissioner Brief: W-0147 – Evacuation for Life Safety Reasons – Yellow Line – October 22, 2021

Washington Metro Area Transit Authority
Department of Safety and Environmental
Management (SAFE)
FINAL REPORT OF INVESTIGATION A&I E21513

Date of Event:	10/22/2021
Type of Event:	Evacuation for Life Safety Reasons
Incident Time:	14:11 hours.
Location:	Between Gallery Place and Mt Vernon Station's, Track 2
Time and How received by SAFE:	14:16 hours. SAFE/IMO On-call Phone
WMSC Notification Time:	14:16 hours.
Responding Safety Officers:	WMATA SAFE: Yes WMSC: No Other: N/A
Rail Vehicle:	Train ID 302 L-3040-3041.3091-3090. 3283-3282-T
Injuries:	No
Damage:	Car 3040 Interior Windscreen Glass Broken, Extensive Over-Heated Damage to Cables and Wires on Car 3283, and Signs of Arc Flash on Car 3282.
SMS I/A Incident Number:	20211022#96319MX

Gallery Place Station
Evacuation for Life Safety Reasons
October 22, 2021

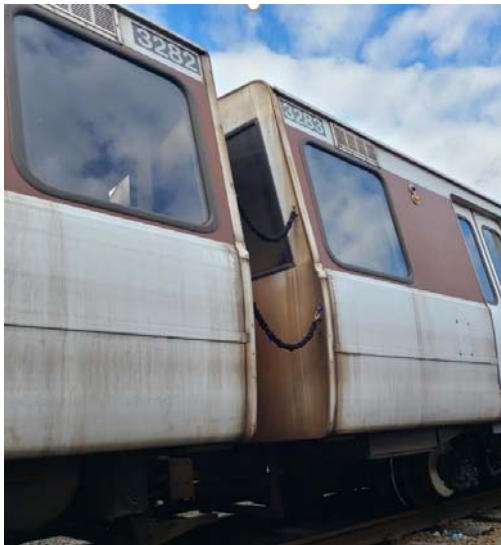
Figure 1 – Incident Cars 3282 and 3283.

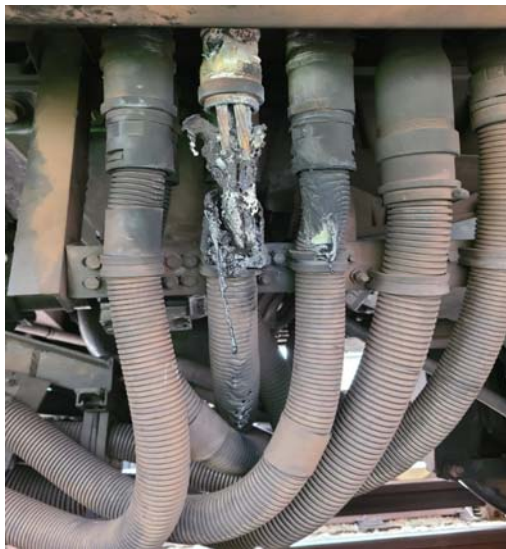
Figure 2 - Over-heated damage to cables and wires on Car 3283.

The train failure and the smoke reported with this incident was caused by the short circuiting of the battery power wires and the plastic conduit burning (within the ER box of car 3283) due to the heat associated with the short circuiting.

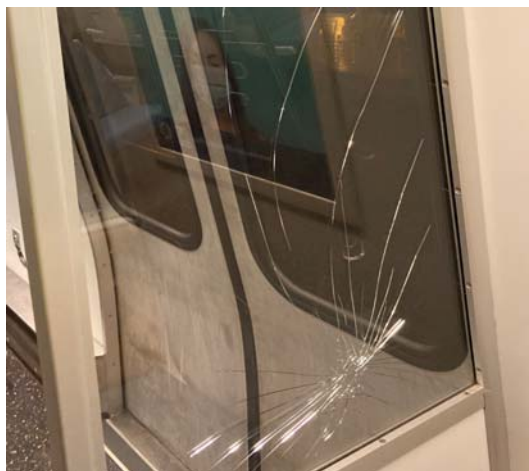
15:20:41 hours	<u>Train ID 302 Train Operator:</u> Contacted Radio RTC and reported that on car 3040, the interior windscreen glass was broken on door 7. [Ops 3]

Figure 3 – Car 3040 broken interior windscreen glass.

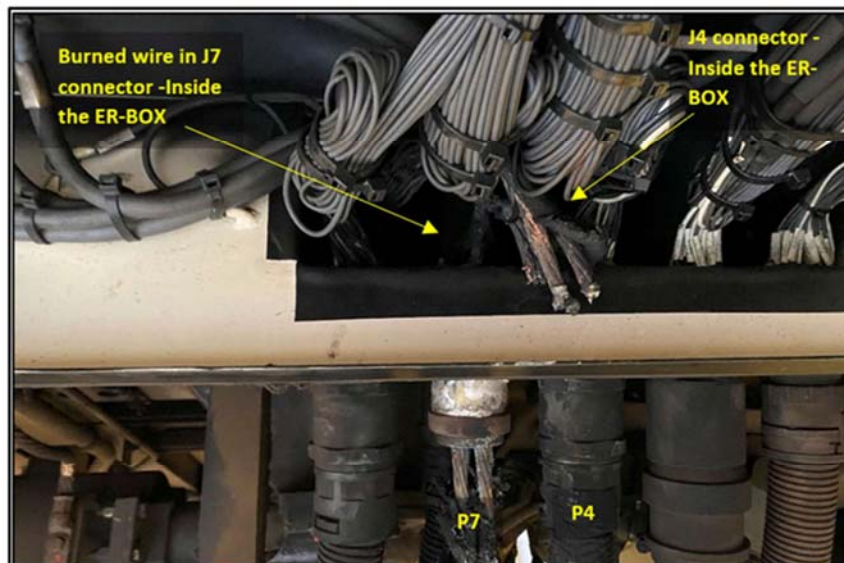
6. Inspected ER box, cannon plugs and inter-car jumpers (Refer to Figures 5, 6 and 7). The findings are identified below:
 - a. P7 connector burnt and partially melted, negative cable still connected.

- b. The other 3 cables (2 positives and 1 negative) were broken due to overcurrent.
 - c. J7 socket burnt and partially melted with pins from P7 connector completely welded.

- d. The cover plate of ER junction box connectors was found damaged and perforated.
 - e. P4-J4 (next to P7-J7) cannon plugs and conduit also damaged due to heat caused by overcurrent.

Figure 5. Damaged Connectors J7-P7 and J4-P4, Inside ER Box

2. Car 3283
 - Replace the J7 connector and cables to the terminal board
 - Replace the P7 inter-car jumper
 - Replace the J4 connector
 - Replace the P4 inter-car jumper

- Replace the cover plate and mounting hardware for the ER junction box connectors and all Veam connectors found in the affected area
3. Car 3282
 - Replace the J7 connector and cables to the terminal board

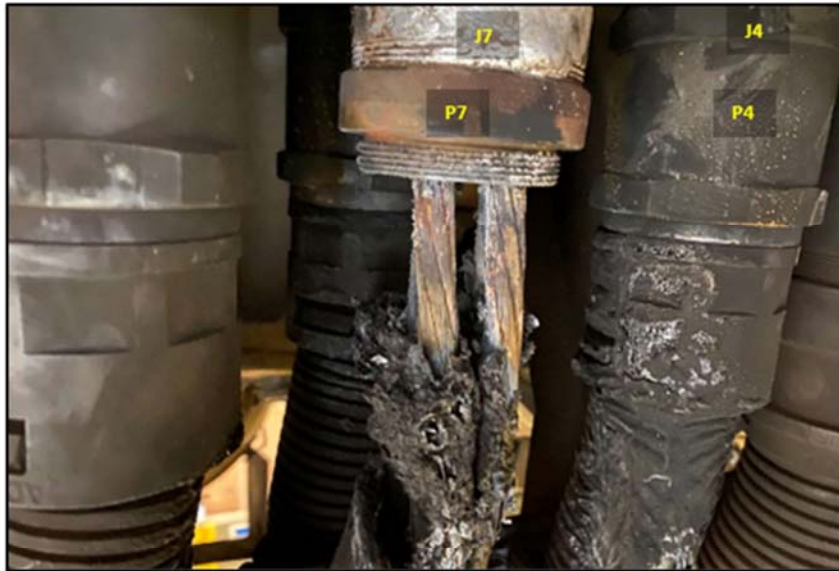
Figure 6. Damaged Connectors J7-P7 and J4-P4, Front View

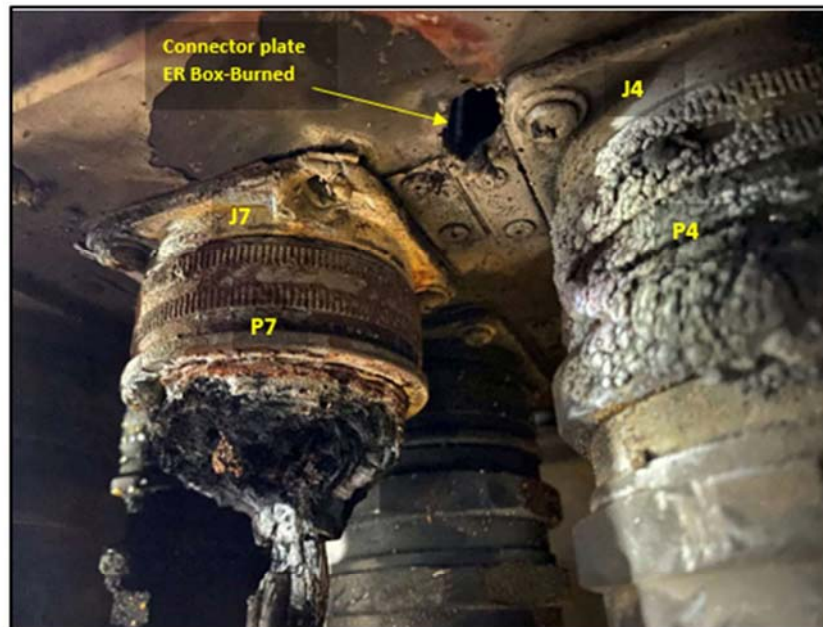
Figure 7. Burnt Connectors- View from behind

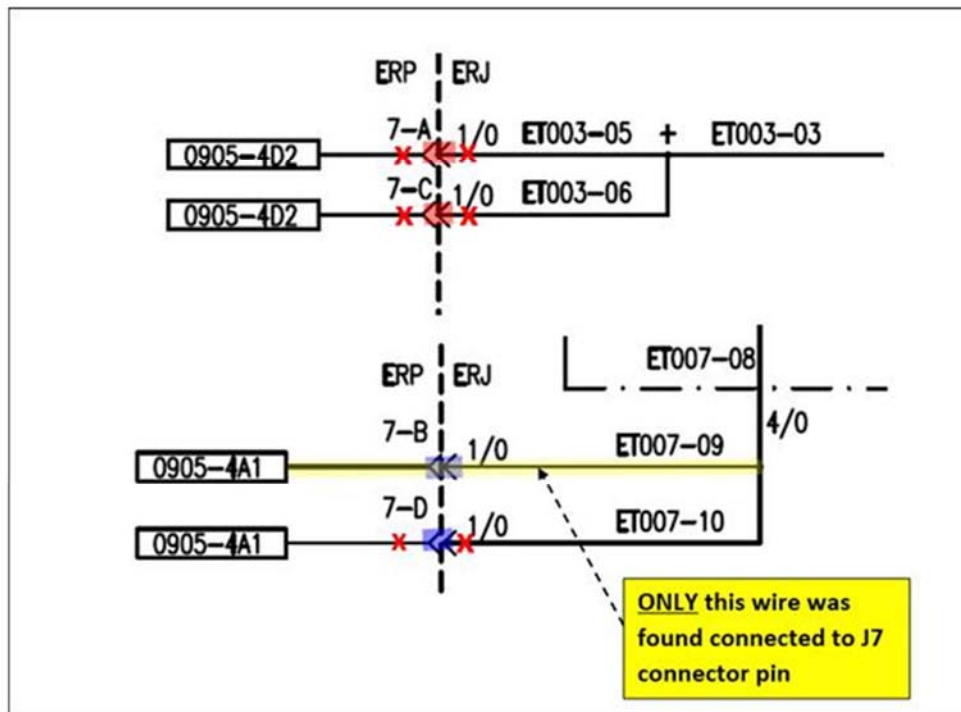
The wires ET003-5, ET003-6 (positive 37.5v) and ET007-10 (negative 37.5v) found burned and disconnected (detached) from the J7 connector pins. All these wires supply 37.5v from the battery/LVPS, located in CAR 3283, to CAR 3282 low voltage loads. Refer to Figure 8 below.

Figure 8. Drawing of burnt connector J7-P7

1. Engineering isolated cables ET007 (negative) and ET003 (positive) in A and B cars from the loads.
2. Separated the burnt wires from each other and from car body.
3. Measured the cables isolation against car body and between each other. The resistance of the positive cables had a reading of infinity (OL) and the resistance of the negative

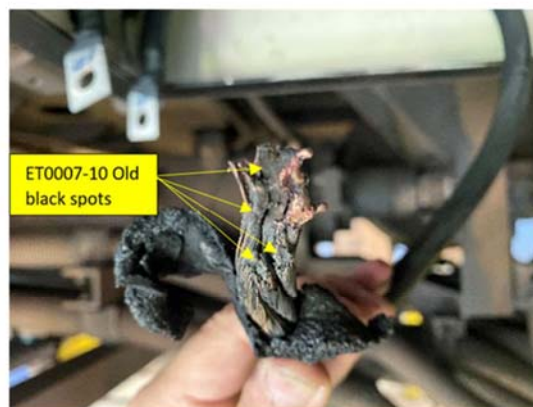
1. The burnt cable ET007-10 (one of the negative wires) was found to have black marks in the wire strands. These wire strands may have been partially melted prior to this incident. Refer to Figure 9 below.

- A. The burnt cable ET007-10 (one of the negative wires) was found to have black marks in the wire strands. These wire strands may have been partially melted prior to this incident. Refer to Figure 9 below.

Figure 9. Damaged Wires ET007-10 Cable

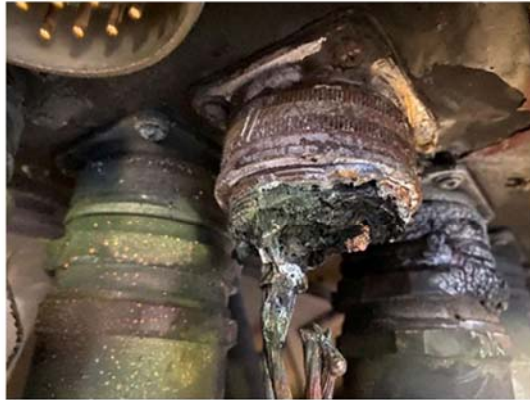
2. The J7-P7 connector shell has signs of extensive discoloration, in comparison to other connectors in ER box. Refer to Figure 10 below. The aspect of the burnt connector suggests the electrical integrity of the connector shell had been compromised.

3. The excessive heat from current imbalance, contributed to the deterioration of the J7-P7 connector, which is located outside the ER Box, underneath the car.

- B. The J7-P7 connector shell has signs of extensive discoloration, in comparison to other connectors in ER box. Refer to Figure 10 below. The aspect of the burnt connector suggests the electrical integrity of the connector shell had been compromised.

Figure 10. Rusted J7-P7 Connector

Vehicle Engineering is revising Periodic C inspections to include inspections of cables inside the ER box and to include checks of cable terminal lugs to carbody ground continuity.
