WMSC Commissioner Brief: W-0148 – Derailment – near Deanwood Station – October 1, 2021

Washington Metro Area Transit Authority
Department of Safety and Environmental
Management (SAFE)
FINAL REPORT OF INVESTIGATION A&I E21476

Date of Event:	10/01/2021
Type of Event:	Derailment
Incident Time:	01:34 hours.
Location:	Deanwood Station, Track 1, CM 360+50
Time and How received by SAFE:	01:43 hours. IMO
WMSC Notification Time:	03:10 hours.
Responding Safety Officers:	WMATA SAFE: Yes WMSC: No Other: N/A
Rail Vehicle:	Nordco Tie Remover and Insertter (TR) 05
Injuries:	None
Damage:	None
SMS I/A Number:	20211001#95911

Deanwood Station – Derailment

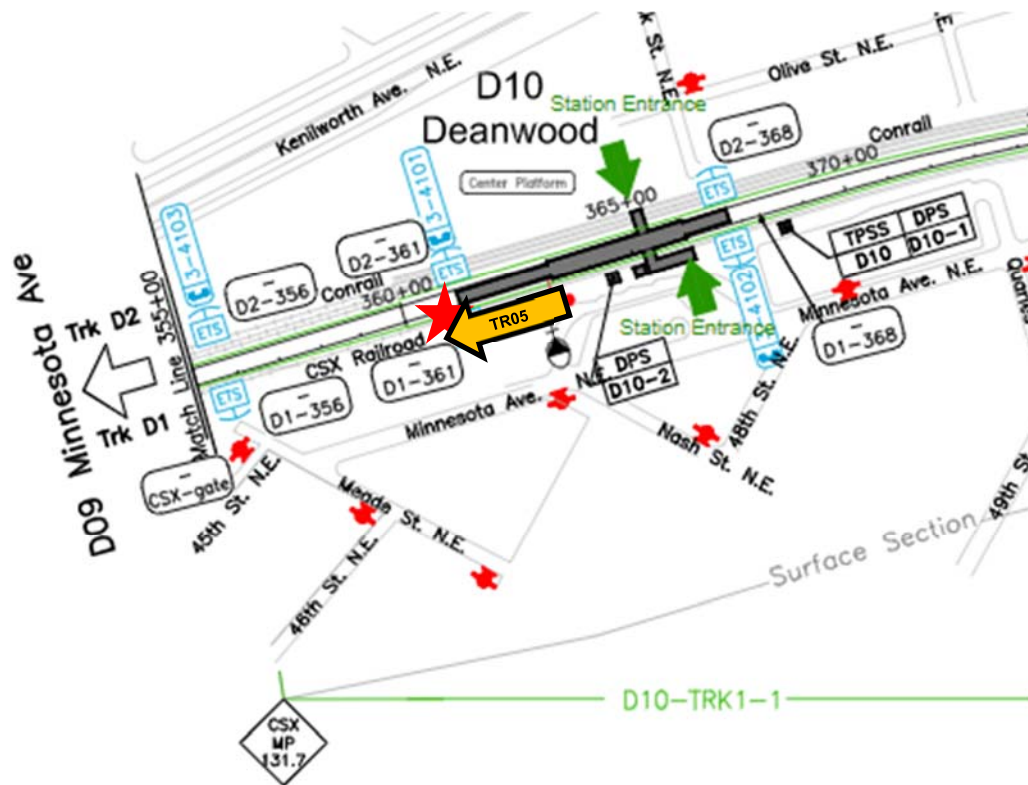
Field Sketch/Schematics

***This image shows the approximate location where TR05 derailed.*

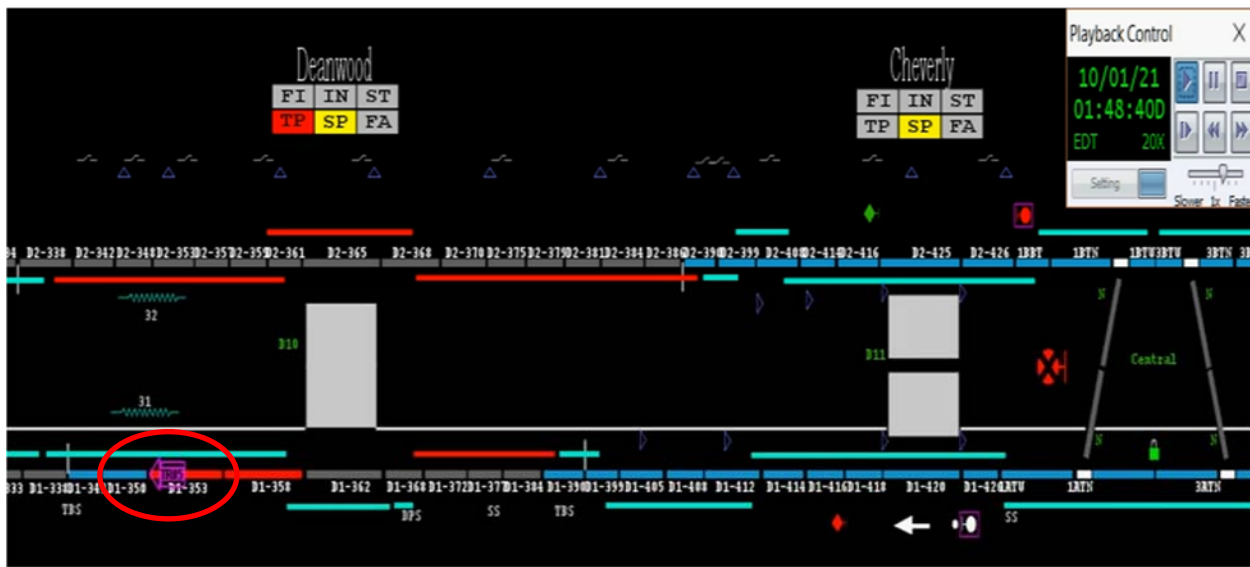
Based on the Advanced Information Management System (AIMS) playback data review, third rail power was de-energized in the derailment area at 01:48 hours.

**This image shows the time that third rail power was de-energized in the derailment area.*

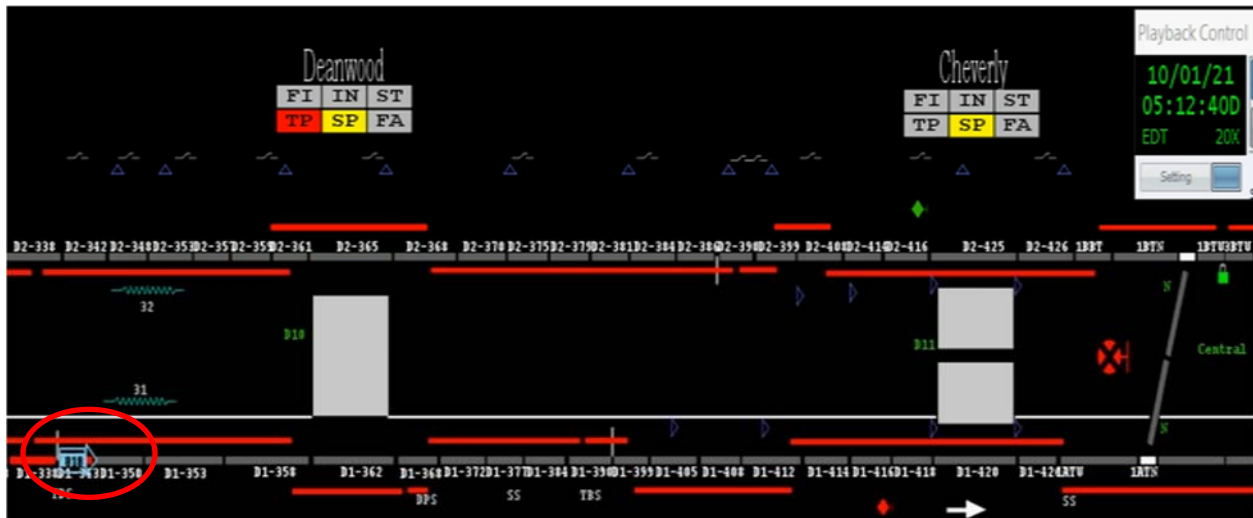
*This image shows third power re-energized and Test Train 818 going through the derailment area to make sure the tracks were safe for revenue service.

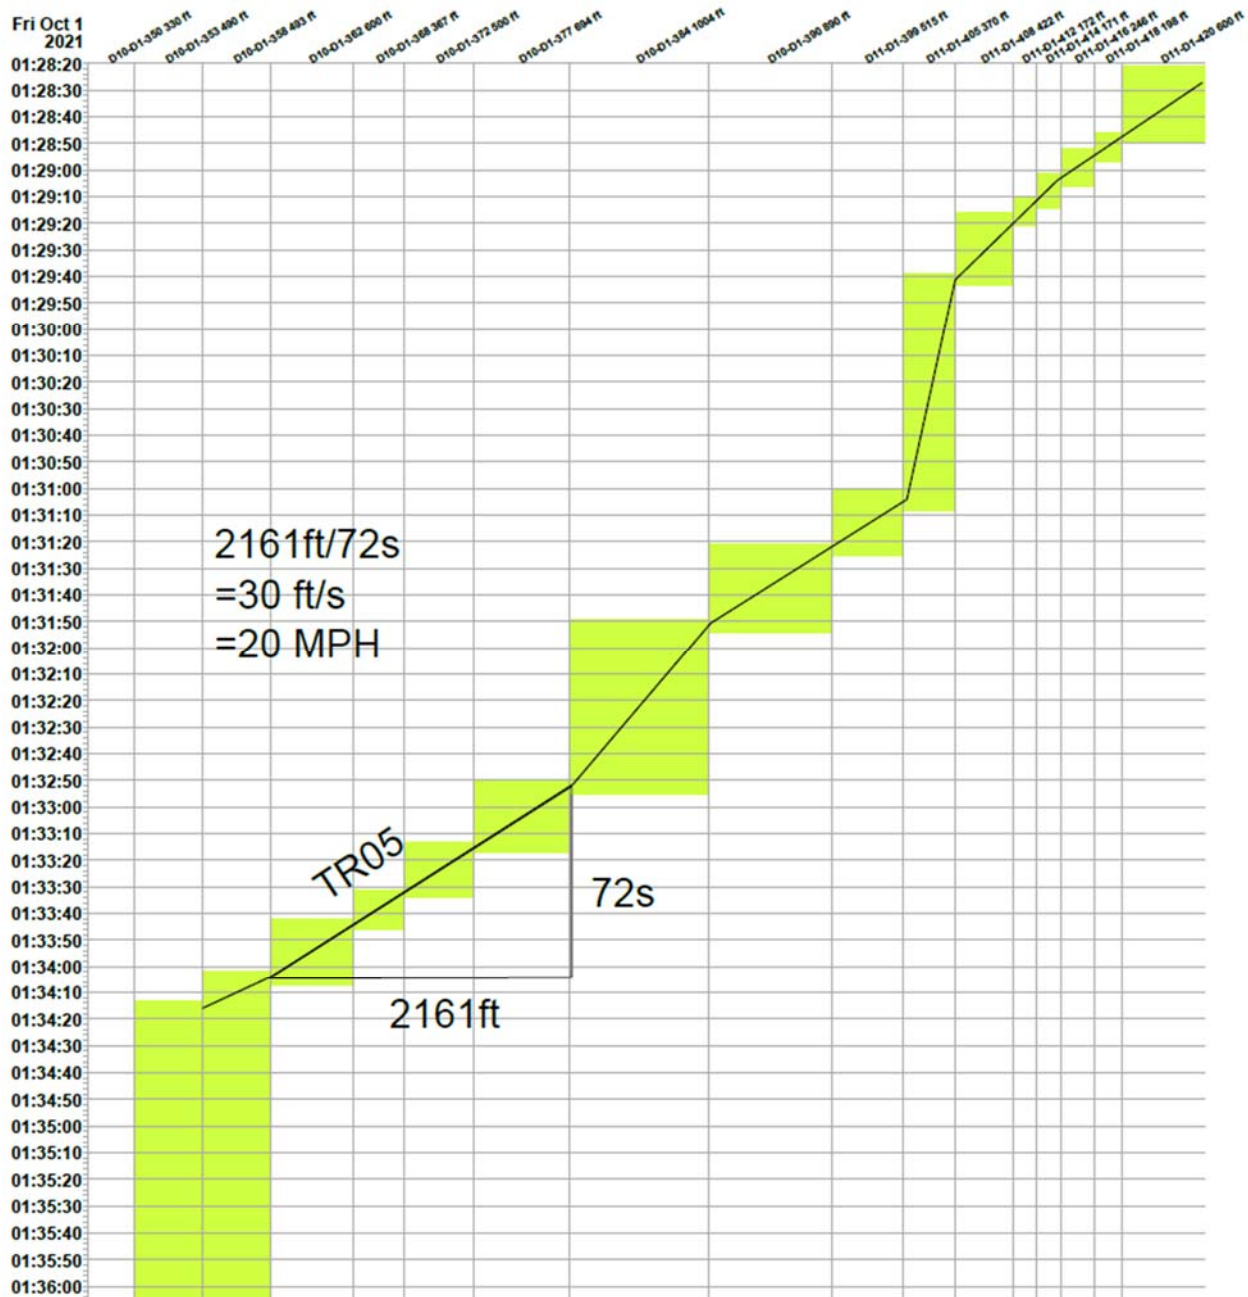
Based on AIMS playback, TR05 came to a stop, occupying track circuit D10-D1-353 at 01:37 hours. The black diagonal line drawn through the green occupancies on the occupancy chart showed TR05 moving 2,161 feet in 72 seconds before it stopped. This translates to an average speed of 30 ft/s or 20 mph at the time of derailment.

**** This illustration represents a track circuit occupancy chart showing the calculation of TR05's average speed. The black diagonal line drawn through the green occupancies on the occupancy chart shows TR05 moving 2,161 feet in 72 seconds before it stopped; 2,161 feet in 72 seconds is 30ft/s or 20 mph.**

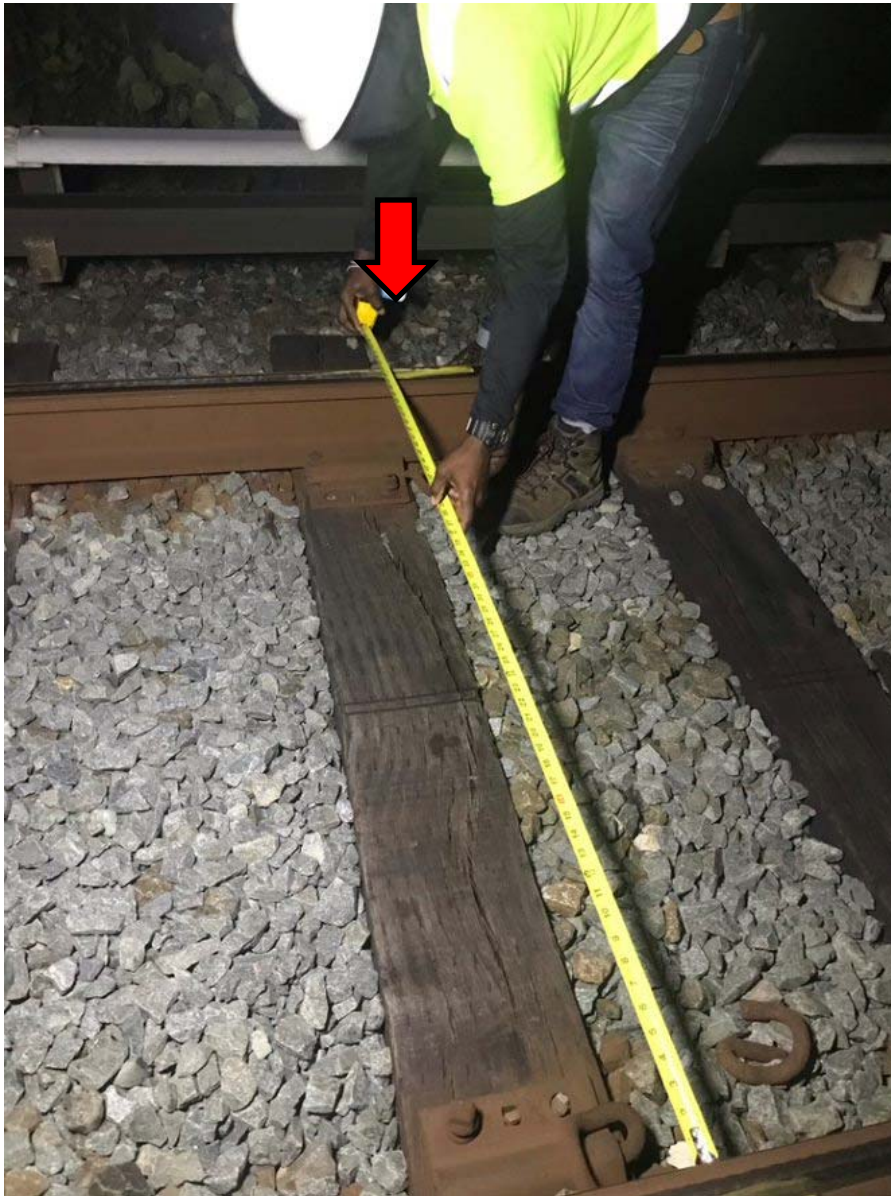
- Track conditions were assessed on scene by TRST and SAFE personnel. Gauge, crosstie, and fastener conditions in the immediate area preceding the point of derailment were found to be within tolerance.

Figure 2: This image shows personnel measuring track gauge in the area of the point of derailment (POD) for TR05.

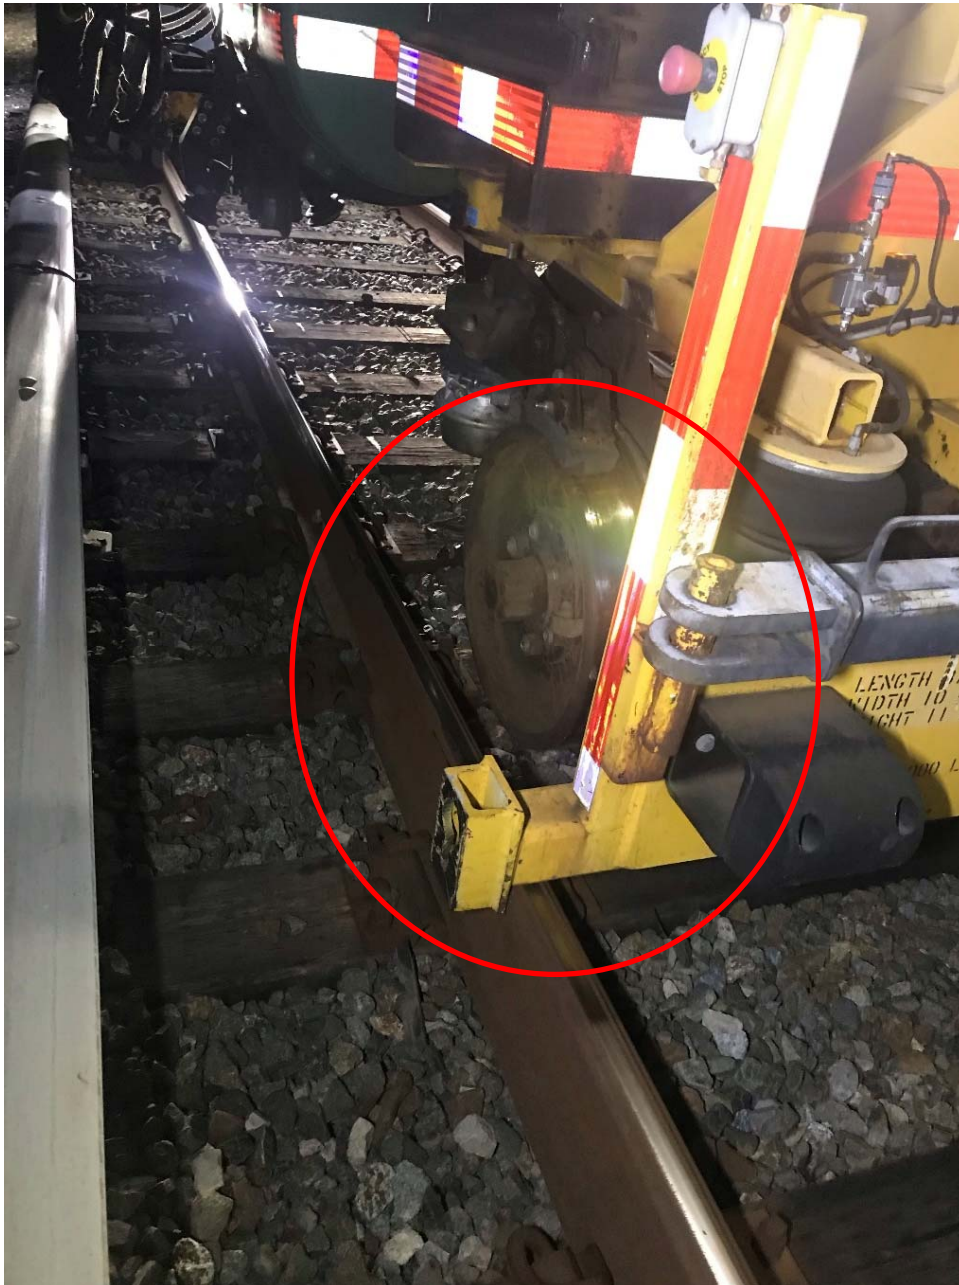
Figure 3: This image shows the place of rest of the front right wheel of TR05 after derailing.

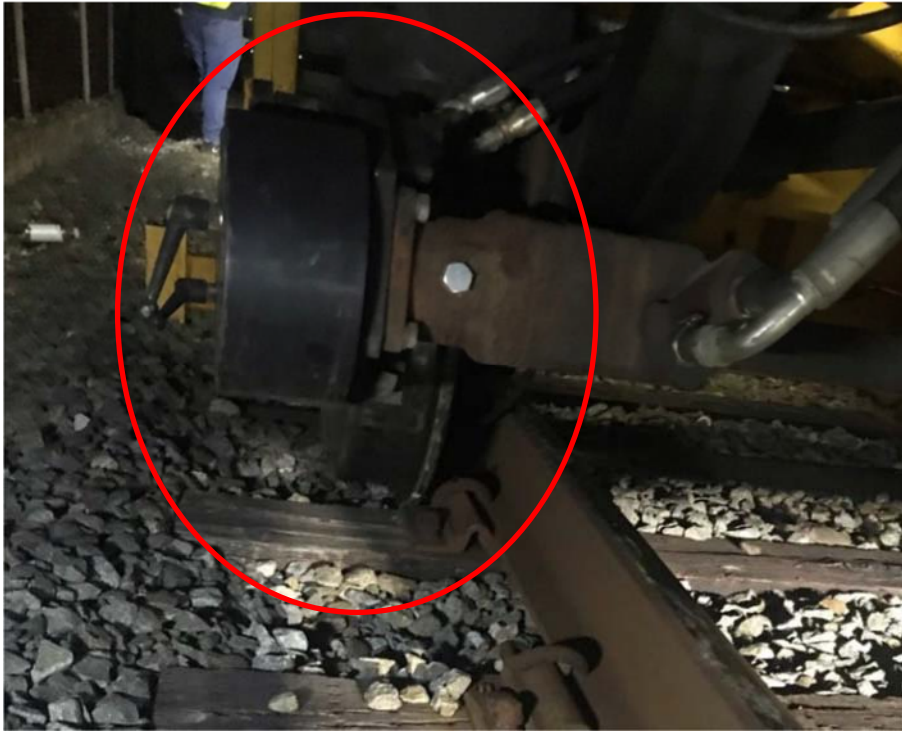
Figure 4: This image shows the front left wheel of TR05 on the ground after derailing.

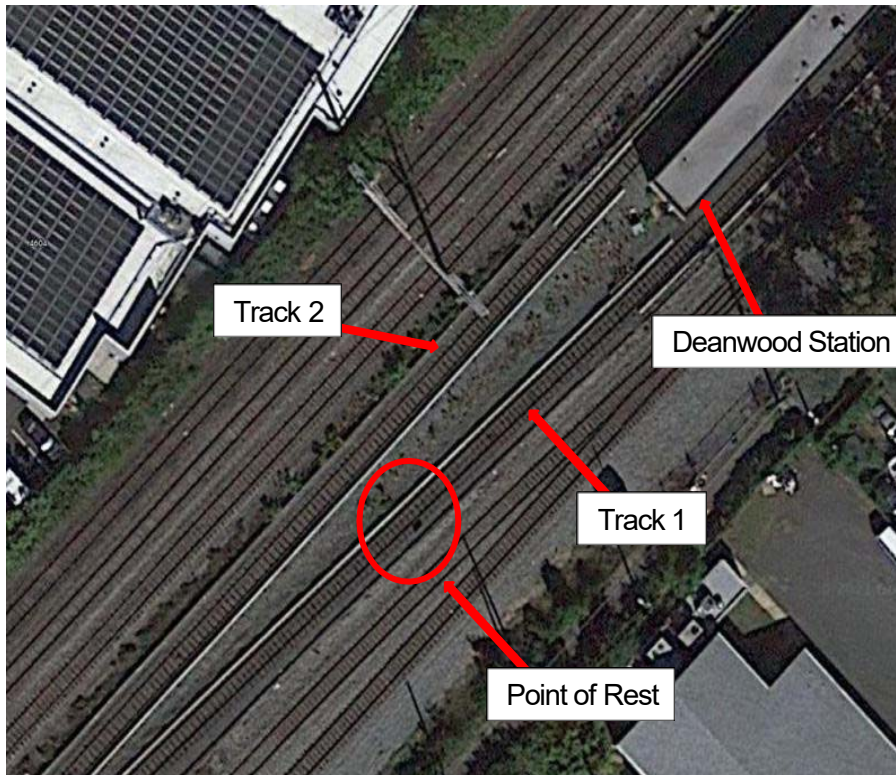
Figure 5: This image is an aerial view of the point of rest.

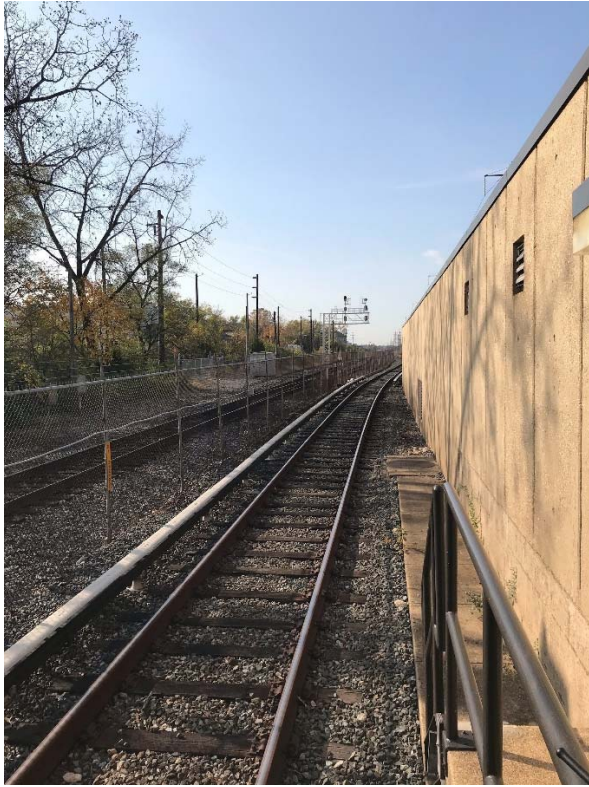
- The observed rail rate of climb for Curve 343 was 3.24%, which exceeds the design rail rate of climb of 2.92% but is not significant enough to result in a travel mode derailment for this vehicle.

Figure 6: This image is the inbound view of Curve 343 at Deanwood Station.

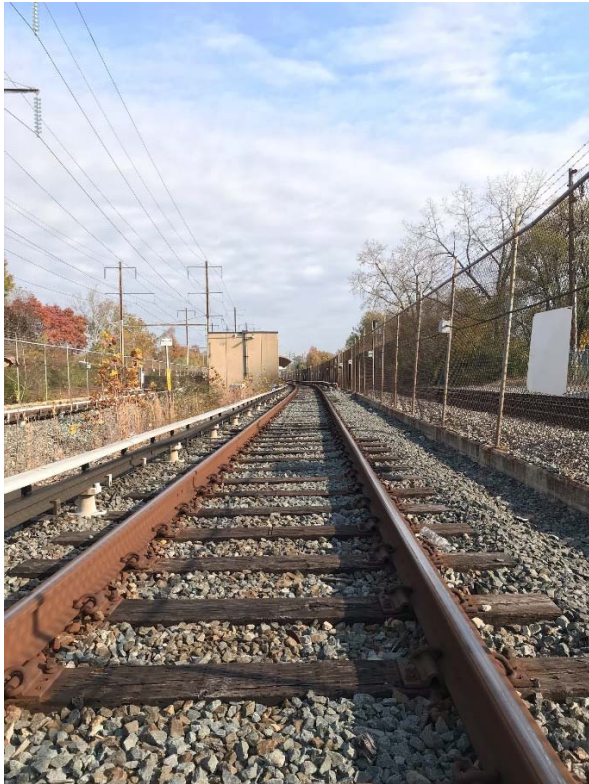
Figure 7: This image shows the outbound view of Curve 343 at Deanwood Station.

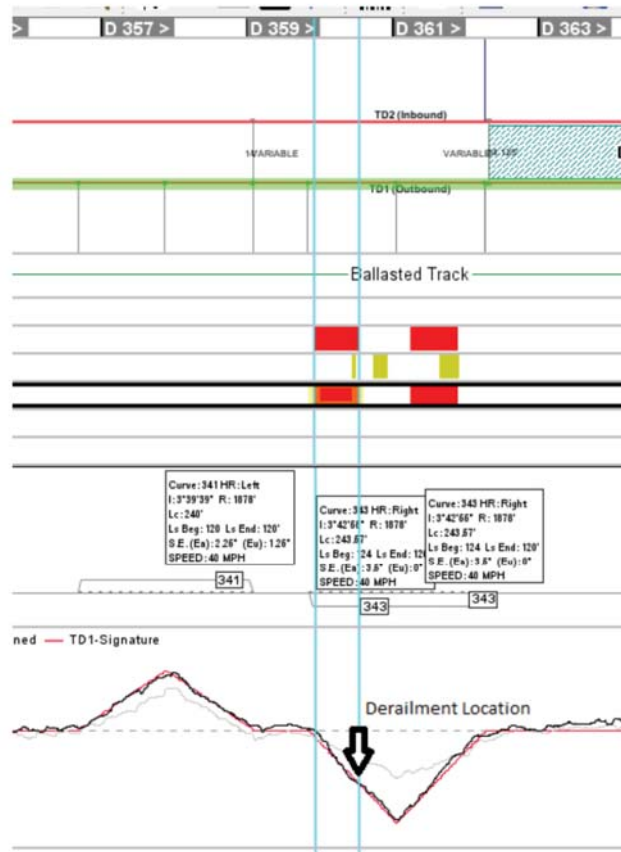
spiral (left portion of the V shaped geometry measurement) a section with a deviation slightly higher than $\frac{1}{4}$ " from the design.

The curve spiral is a transitional track geometry where super elevation and curve radius gradually and consistently increases or decreases to meet the curve design. The combination of lower cross level than design followed by a higher cross level than design and vice versa within the spiral can create a

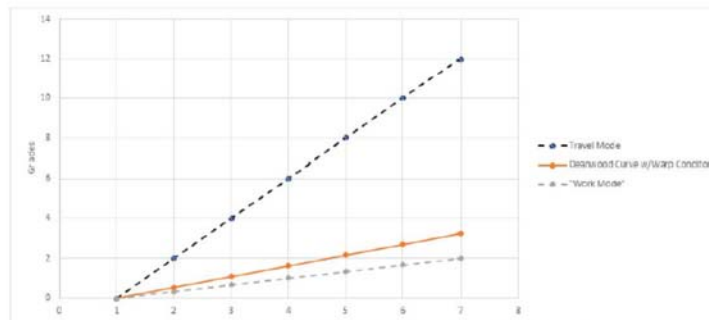
Figure 2-TR05 Suspension Limits

- In travel mode, TR05's air suspension would allow it to safely navigate a curve with a rail rate of climb of 12%, significantly higher than the observed condition of 3.24%.

- In Work mode, TR05 air suspension would only allow it to safely navigate a curve with a rail rate of climb of 2%, which is lower than the observed condition of 3.24%.

Rail rate of climb is a measurement that normalizes rail geometry with that of the vehicle suspension and car body stiffness. It is calculated by dividing the vertical difference in rail elevation or wheel displacement, by the horizontal distance over which the vertical displacement occurs, multiplied by 100, to achieve a percentage value. These calculated values are shown in *Figure 2*, where the rate of climb ability of TR05 in travel mode and work mode is shown in dotted blue and grey lines respectively. Curve 343's rail rate of climb inclusive of geometry exceptions is shown in orange and is well beneath TR05's suspension abilities in travel mode but is a little steeper than the suspension abilities in work mode. It is not believed that the existing track conditions alone on curve 343, would cause a derailment of TR05 when operating in travel mode.
