WMSC Commissioner Brief: W-0149 – Collision – Shady Grove Yard – November 15, 2021

Washington Metro Area Transit Authority
Department of Safety and Environmental
Management (SAFE)
FINAL REPORT OF INVESTIGATION A&I E21584

Shady Grove Yard – Collision

November 15, 2021

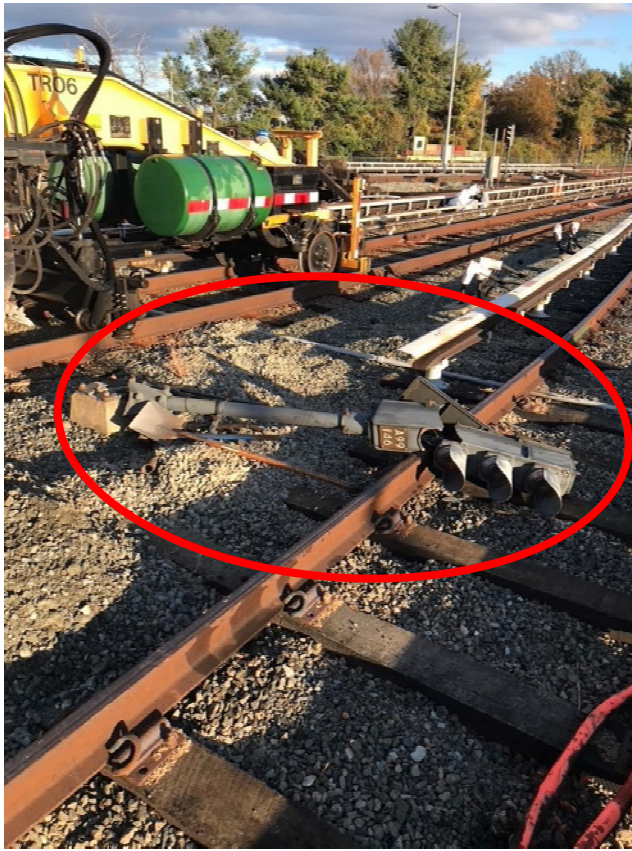
Figure 1: This image shows A99-146 signal's resting position after being hit by TR06.

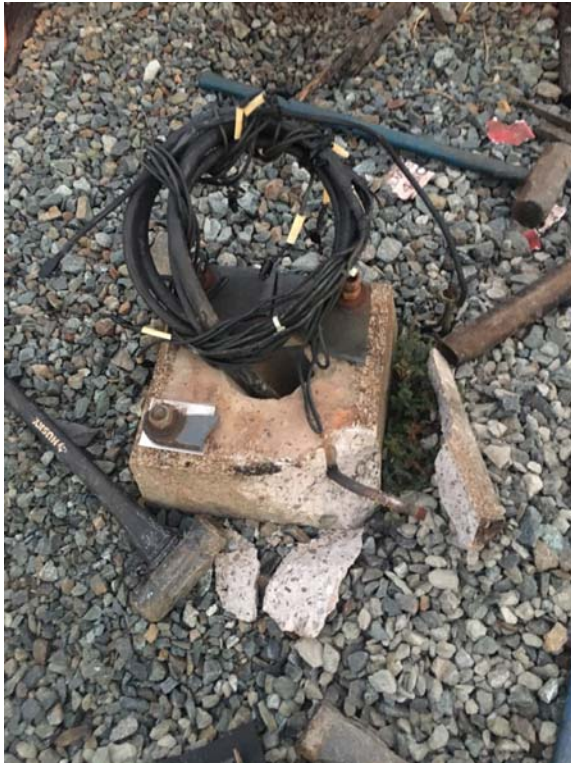
Figure 2: This image shows the base of A99-146 signal, which will need to be completely replaced.

A99 crew found that A99 146 Signal had been knocked down. We disconnected the wiring, taped the ends and wrapped them up. The broken parts are located at TCR #2, outside. The foundation base was destroyed and will need to be replaced along with the mounting flange, the pole, and the Signal Head. The wiring itself appears to be okay.
