**WMSC Commissioner Brief: W-0150 – Collision, Evacuation – Blue/Orange/Silver Line – November 12, 2019**

Washington Metro Area Transit Authority  
Department of Safety and Environmental  
Management (SAFE)  
**FINAL REPORT OF INVESTIGATION A&I E21579**

**Federal Center SW Station  
Evacuation for Life Safety Reasons  
November 14, 2021**

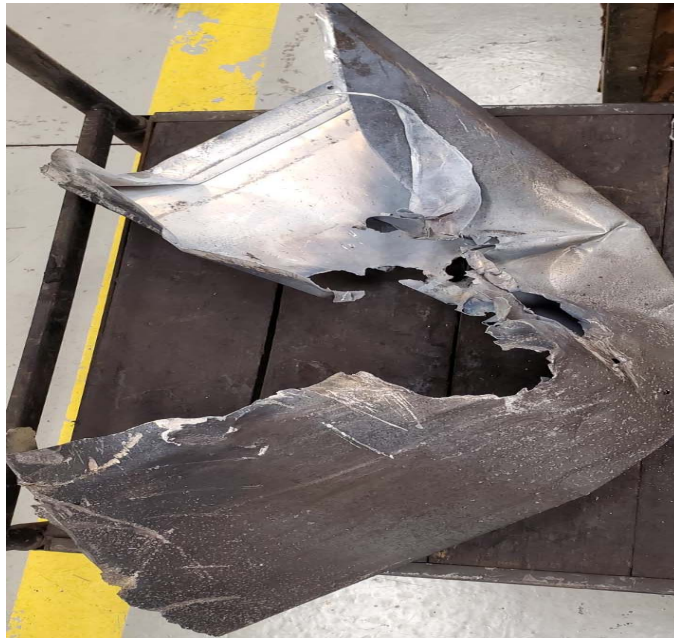
02:49:17 hours	<u>CMNT Road Mechanic:</u> Contacted Radio RTC and reported a metal object pinned between the third rail and the right-side collector shoe on Car 3105. Additionally, both collector shoe fuses were blown on the rear truck on Car 3105. Pictures have been taken, and they are about to remove the metal object. <u>Radio RTC:</u> Acknowledged. [Ops 2]

Figure 1 – The metal object that was pinned between the third rail and the right-side collector shoe on Car 3105.

02:51:41 hours	<u>CMNT Road Mechanic:</u> Contacted Radio RTC and reported that the metal object had been safely removed. <u>Radio RTC:</u> Acknowledged. [Ops 2]

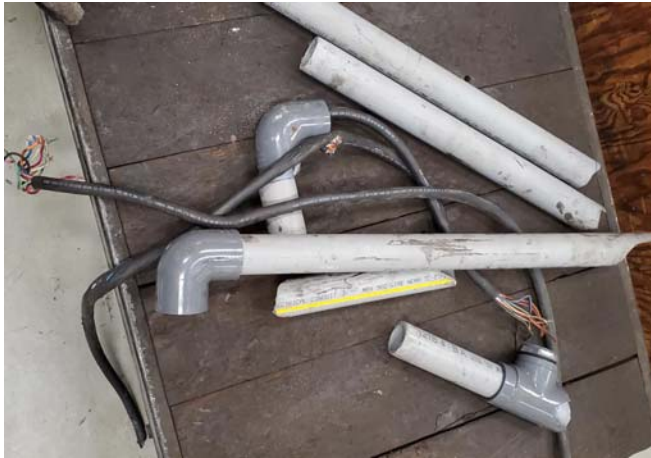
Track inspections after the event identified broken wires and PVC pipes on the roadway, likely caused by the train striking and dragging the metal object. These pipes and wires were part of a train to wayside communications antenna.

Time	Description
02:12:07 hours	<u>TRST Personnel:</u> Contacted Radio RTC and reported that broken PVC pipes plus wires were on the roadway at CM D1-54+00 and CM D1-51-00. <u>Radio RTC:</u> Acknowledged, [Ops 2]

Figure 2 – Broken Polyvinyl Chloride pipes plus wires found on the roadway at CMs D1-54+00 and D1-51-00.

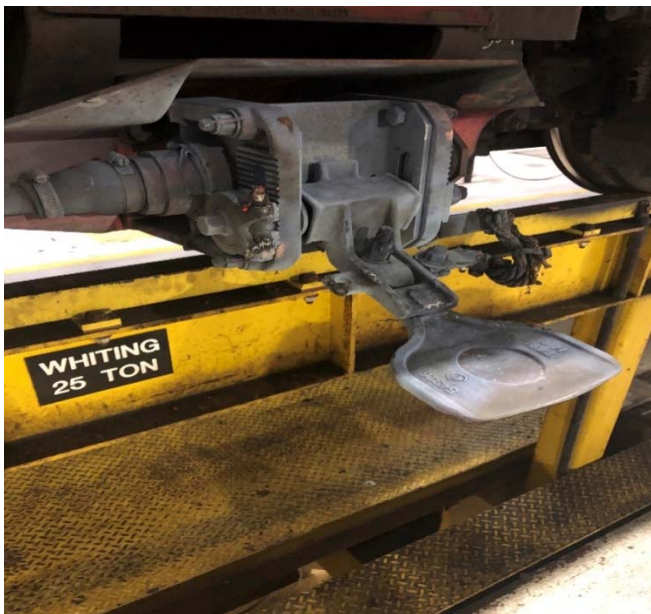
Figure 3 - Damaged rear collector assembly on Car 3105 due to the heat from the arc flash.

The probable cause of the Evacuation for Life Safety Reasons event on Train ID 405 at Federal Center SW Station was that the consist encountered a thin piece of sheet metal, conduit and mating wires that resulted in an arc flash and smoke emitting from Car 3105.

REPLACED COLLECTOR ASSEMBLY AND FUSE WITH NEW, ADJUSTED COLLECTOR TO SPEC.						
000-300-K08 TRUCK&SUSPENSION: CURRENT						
Component: COLLECTOR ASSY: TRUCK: 2K/3K/6K/7K	Work Accom: REPLACED NEW	Reason: FLASHED	Status: CLOSE	Position: 3	Warranty?: N

Actual Labor									
Task ID	Labor	Start Date	End Date	Start Time	End Time	Approved?	Regular Hours	Premium Hours	Line Cost
Total Actual Hour/Labor:							09:30	00:00	\$376.53
Actual Materials									
Task ID	Item	Assetnum	Description	Storeroom	Trans Date	Issue Unit	Quantity	Unit Cost	Line Cost
	R18350018		FUSE:COLLECTOR SHOE	259	11/14/2021	EA	1	\$621.41	\$621.41
Total Actual Materials:									\$621.41
Related Incidents									
Ticket	Description			Class	Status		Relationship		
8570590	D04-D1 SMOKE ON TRAIN #405			SR	CLOSED		ORIGINATOR		
Failure Reporting									
Cause		Remedy			Supervisor			Remark Date	
2349	MATERIAL FAILURE		0004	REPLACED				11/16/2021	
Remarks: REPLACED #3 COLLECTOR SHOE ASSEMBLY (PART FROM MRO STOCK), GOOD OPS CHECK.

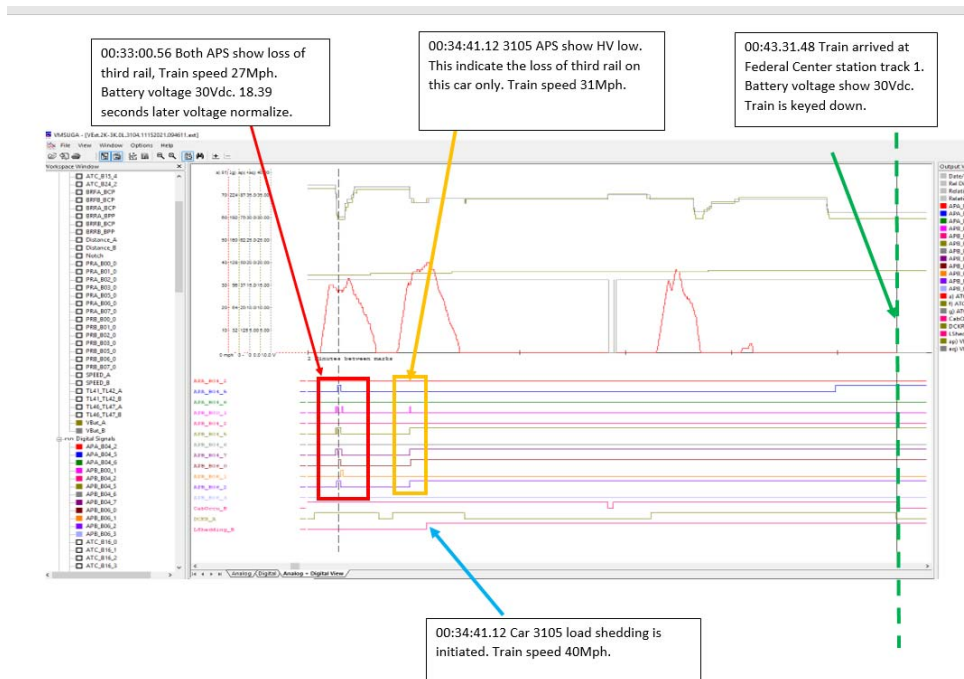
00:34:23 hours	Car 3105 APS showed that the HVAC system was low caused by the loss of the third rail approximately 416 feet after departing Smithsonian Station, Track 1. (CMOR IIT reported that this was assumed to be the location where the vehicle shoe fuses opened due to the FOD). The consist speed was 31 MPH, and the battery voltage showed 34 VDC.

00:34:41 hours	Car 3105 load shedding was initiated due to the loss of third rail voltage at this time. Therefore, emergency lights turned on approximately 623 feet from L'Enfant Plaza Station, Track 1, with a train speed of 40 MPH.

Diagram – ER Graphical Analysis.
