WMSC Commissioner Brief: W-0151 – Improper Movement, Red Signal Overrun – Alexandria Rail Yard – October 19, 2021

Washington Metro Area Transit Authority
Department of Safety and Environmental
Management (SAFE)
FINAL REPORT OF INVESTIGATION A&I E21510

Alexandria Rail Yard – Red Signal Overrun

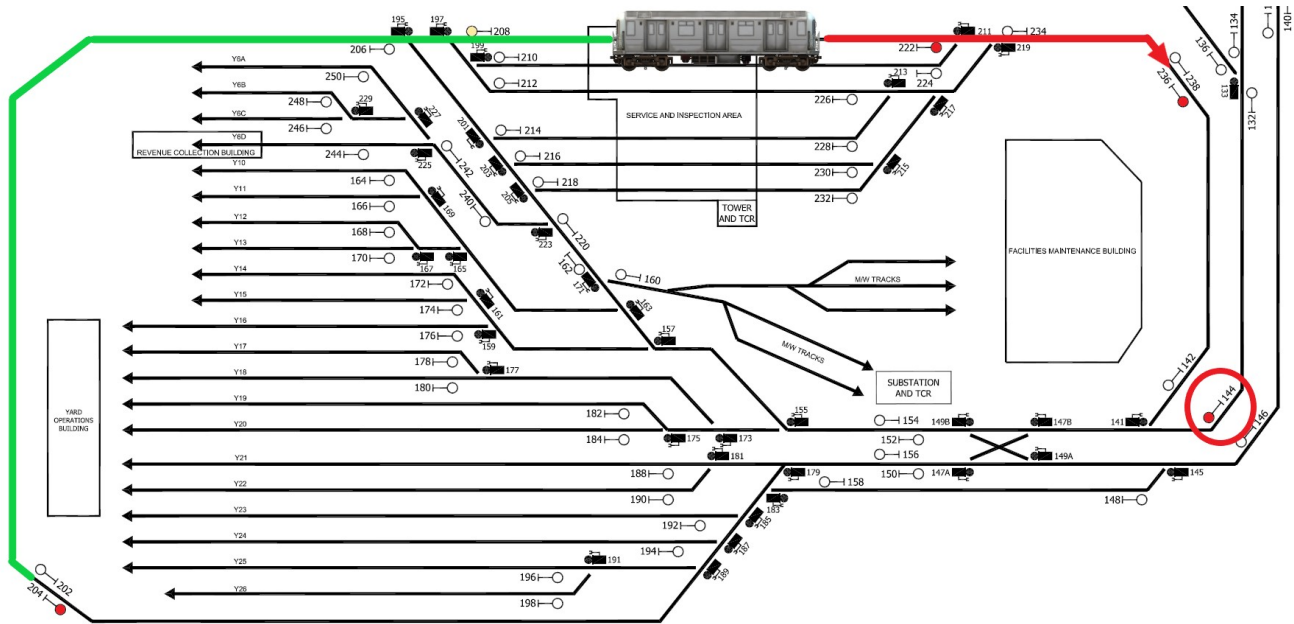
Image 1 – Map of Alexandria Rail Yard depicting the incident route, the instructed route from the Interlocking Operator from C99-208, and the location of C99-144 signal.

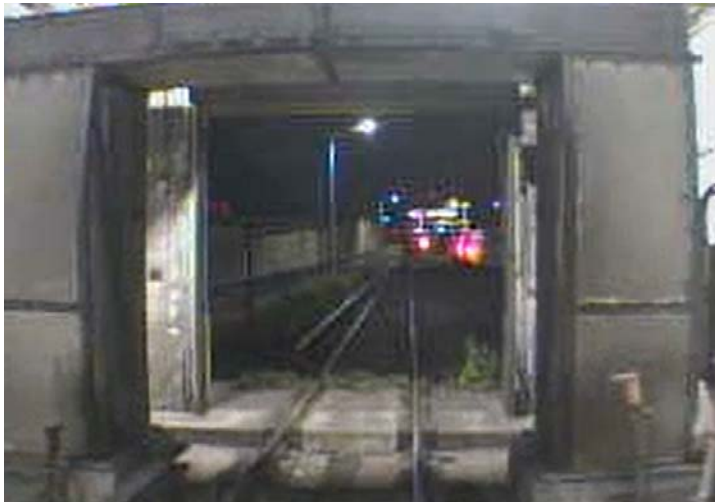
Figure 1 – 4-Car Consist leaving the car wash eastbound, approx. 05:14 hours.

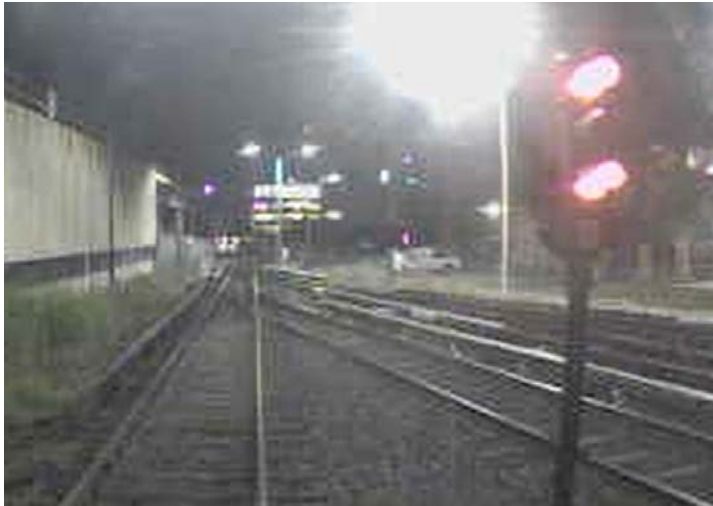
At approximately 05:14 hours, the Train Operator began to exit the car wash moving the train eastbound, in approach of C99-222 signal red. At approximately 05:17 hours, the train stopped approximately 11 feet ahead of C99-222 signal red for approximately 5 seconds. The train then continued, passing C99-222 signal red, trailing switch 211, before coming to a stop at the C99-236 signal. This action is a violation of the Metro Rail Safety Rules and Procedures Handbook (MSRPH) – Sec. 3 OR 3.67, which states “Rail vehicles shall not be operated past or closer than

Figure 2 – 4-Car Consist stopped at C99-222 signal red, approx. 05:17 hours.

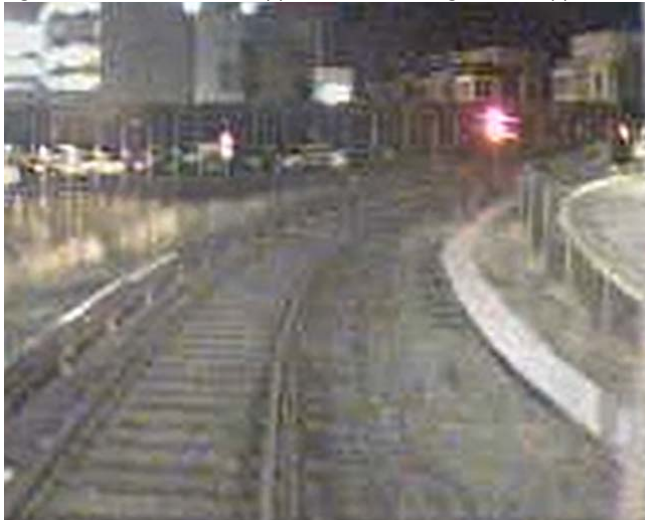
Figure 3 – 4-Car Consist approaching C99-236 signal red, approx. 05:18 hours.

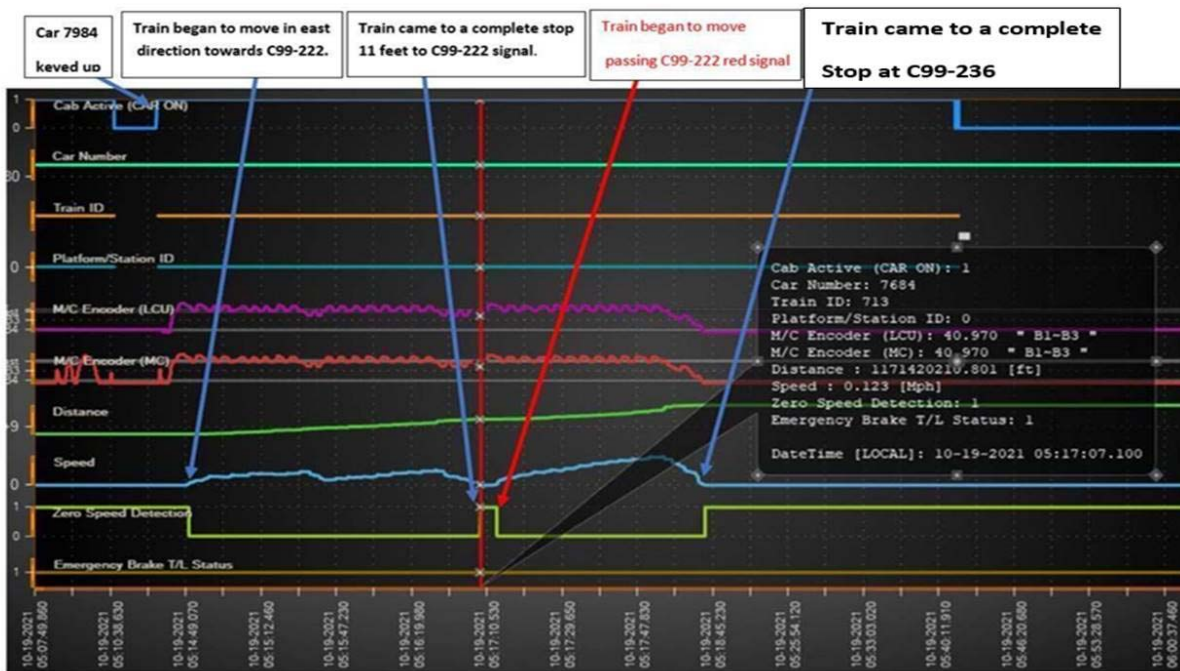
Figure 4 – Event Recorder Graphical Analysis

IIT has completed the data downloads and analyzed the data retrieved from the cars in question. Per the Network Video Recording (NVR) and ER data, R7684 was parked inside C99 wash track #1. At 05:14:28 the train keyed up and began to move east towards interlocking signal C99-222. The train stopped 11 feet from C99-222 red signal for 5 seconds and continued to move passing C99-222 red signal and trailed switch 211. The train came to a complete stop at C99-236.

Based on the ER data and VMDS logs, there were no faults with the train during the reported incident time that contributed to the cause of this incident. The train performed as designed.

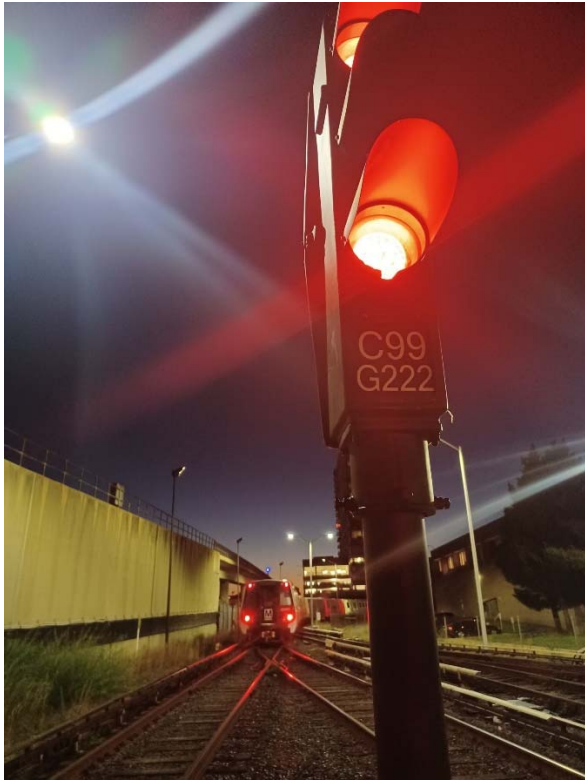
Image 2 - 4-Car Consist stopped C99-236 signal after passing C99-222 signal red and trailing switch 211.

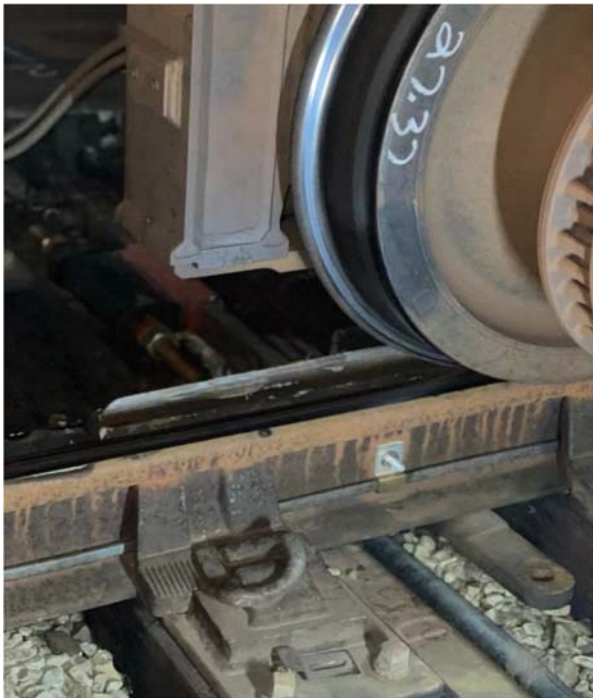
“Switch 211 was trailed, exercised and in correspondence both Normal and Reverse positions. Both switches passed the obstruction test.”

Image 3 – Switch 211, trailed when the 4-car consist passed C99-222 signal red.

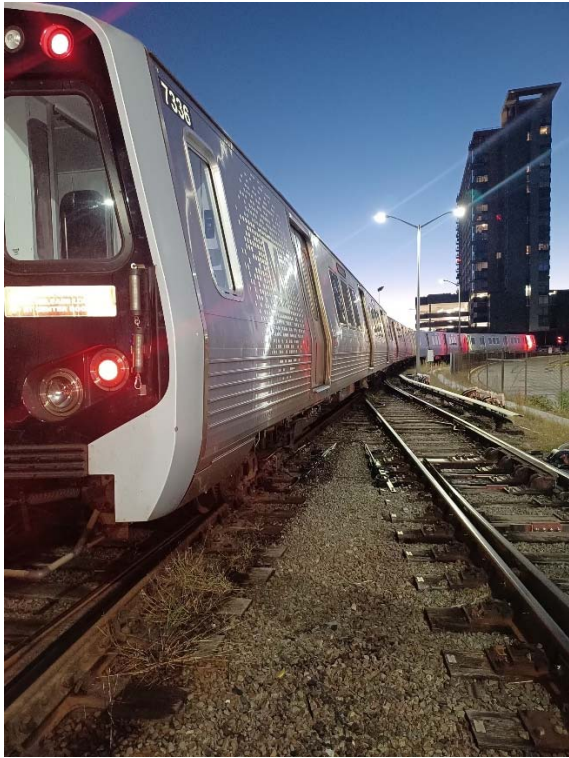
Image 4 - 4-Car Consist stopped C99-236 signal red, after passing C99-222.
