WMSC Commissioner Brief: W-0152 – Collision – Greenbelt Yard – November 16, 2021

FINAL REPORT OF INVESTIGATION A&I E21583

Greenbelt Yard – Collision

November 16, 2021

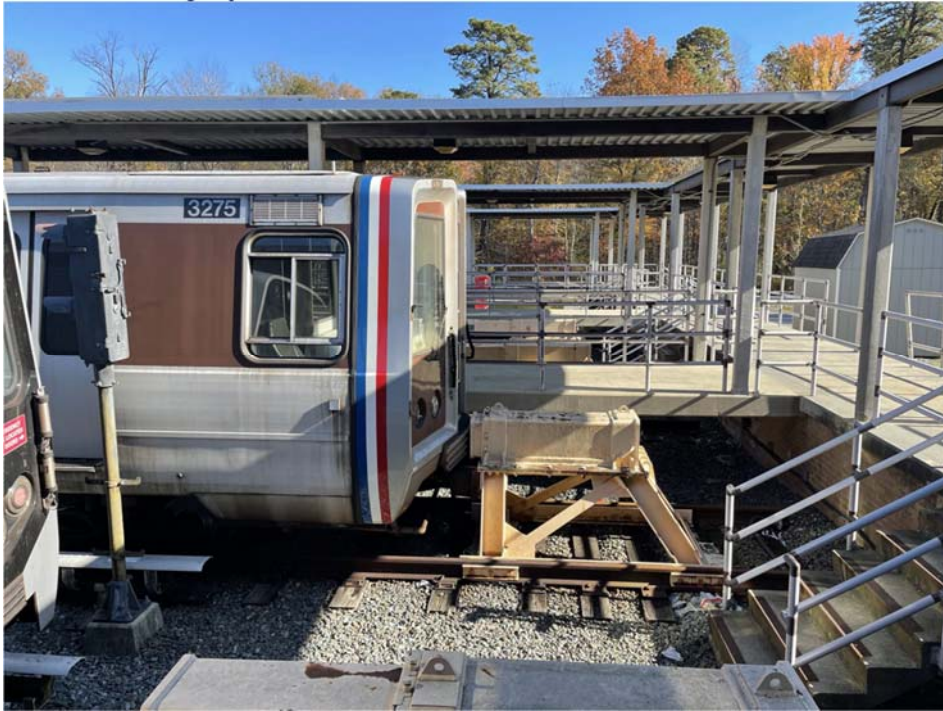
Train ID 503 made contact with the bump post at 6 mph. The train pushed the bump post in 3 feet, then came to rest. The emergency brake push button was activated subsequently de-energizing the emergency relay after R3275 made contact with the bump post at approximately 01:03 hours according to the VMS, however ARS playback indicates an incident time of approximately 01:18 hours. Video playback of the event was not available due to a lack of camera views of the bump post area.

Figure 1 - Car 3275 and bump post Collision with spring-loaded barrier pushed into the housing.

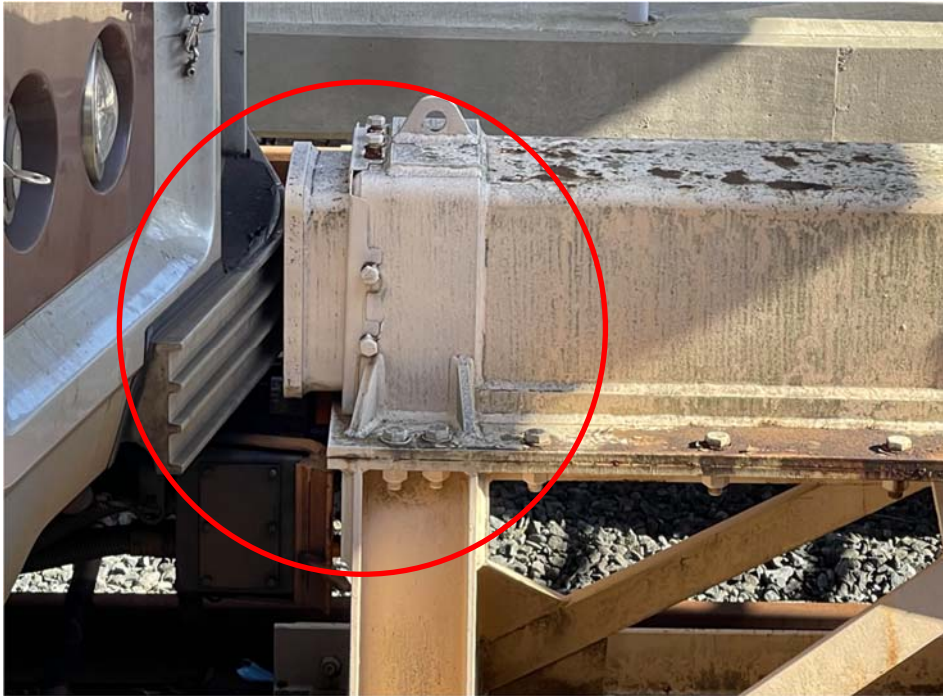
Figure 2 - Close-up photo of bump post and anti-climbers mating surface.

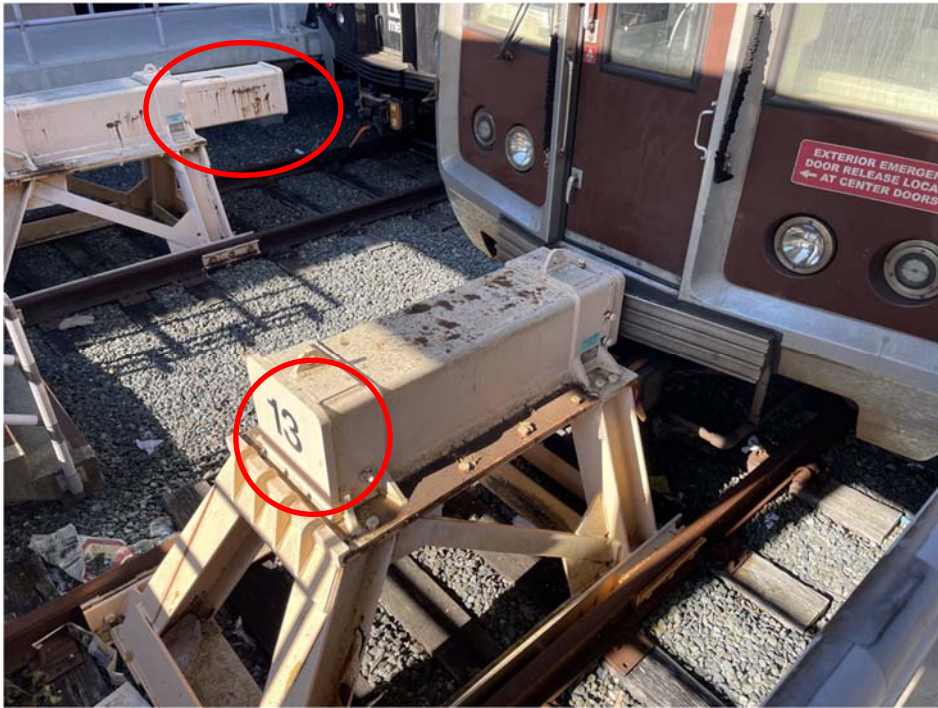
Figure 3 - Shows Track 13 and a comparison of an uncompressed spring-loaded bumping post to the left.

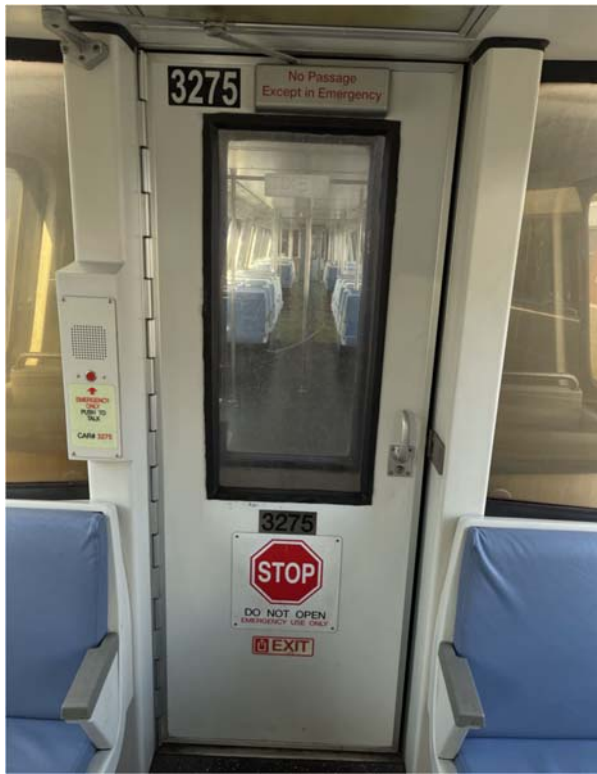
SAFE conducted an on-site yard inspection with the Office of Car Maintenance (CMNT) and CMOR IIT and identified married pair [3275-3274] lead car 3275 coupler head damage and shear bolts broken. Car 3274 Drawbar damage and all cap screws came off; both A-car and B-car shock absorbers joined together. Car 3067 shear bolts broken with cap screws came off. CMOR IIT found Cars 3066, 3067, 3275, and 3275 front and rear floorboards not dislodged from their original orientation on the train.

Figure 4 - Car 3275 rear bulkhead door heading into car 3274.

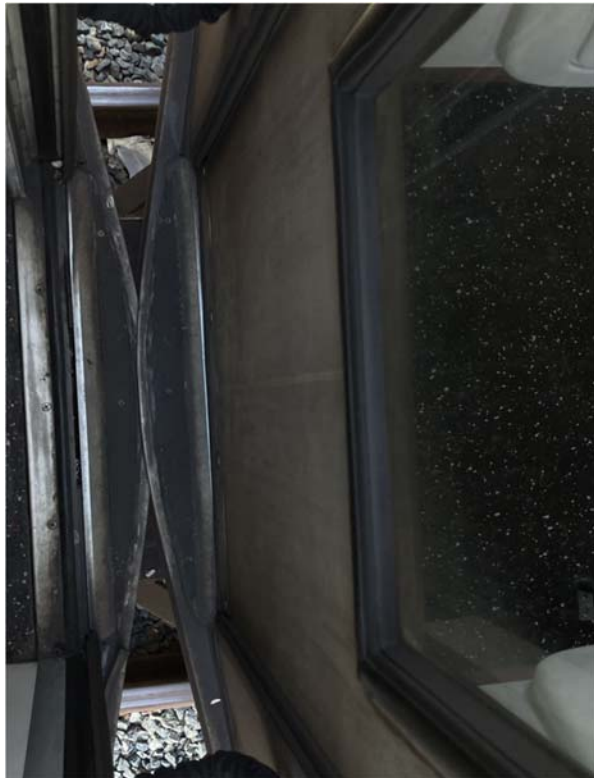
Figure 5 – Cars 3275 and 3274 showing anti-climbers touching, which indicates shear bolts are broken.

Shear bolts [emergency release bolts] are installed on the body of the semi-permanent drawbars and front couplers shaft housing. These bolts shear as a safety function at approximately 125,000 lbs. of force to help minimize the damage to the coupler system and reduce impact.

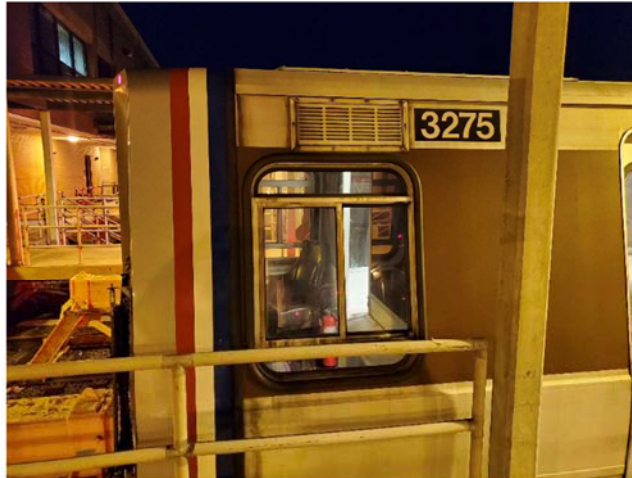
Figure 1. Car 3275 on yard track 13

Figures 1 and 2 below show car 3275 contacting the bumping post at Greenbelt yard track 13. The train consist was inspected in the yard to ensure cars were able to move safely to the workshop. All cars were moved from the yard to the workshop to start the incident investigation and perform further inspections on all cars of the train consist.

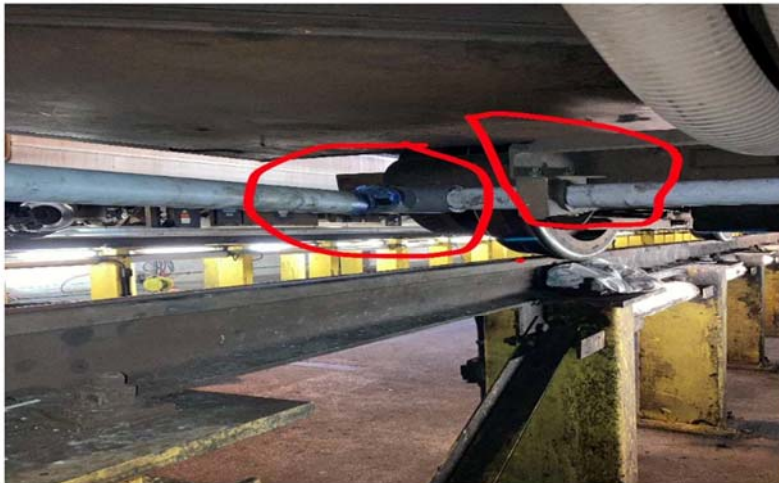
Figure 4. Car 3067 TWC antenna and bracket

1. Performed under car inspection. TWC antenna was broken. The TWC antenna mounting brackets were deformed and the front and rear coupler shear bolts were activated. Refer to Figures 4 and 5 below.

1. Replace TWC antenna and mounting hardware in car 3067.
2. Overhaul or replace Front and Rear Couplers from cars 3274-3275 and 3066-3067.
3. Inspect brake discs for heat cracks and worn surface conditions, recondition or remove and replace all brake discs of car 3067 as required.

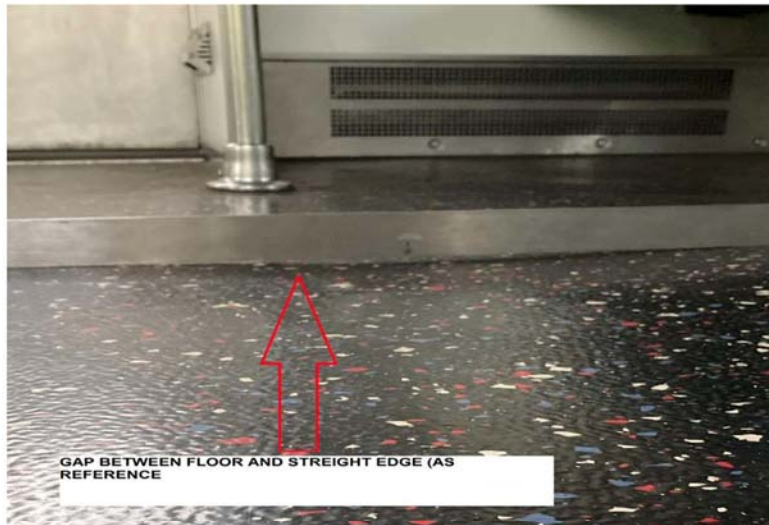
Figure 6. Car 3067 Nora Flooring

2. Inspected under car structure and equipment brackets. No anomalies found.
3. Inspected car interior flooring. Minor floor deformation along the surface at the cab area observed requiring evaluation for future replacement as needed. Refer to Figures 6 and 7 below.

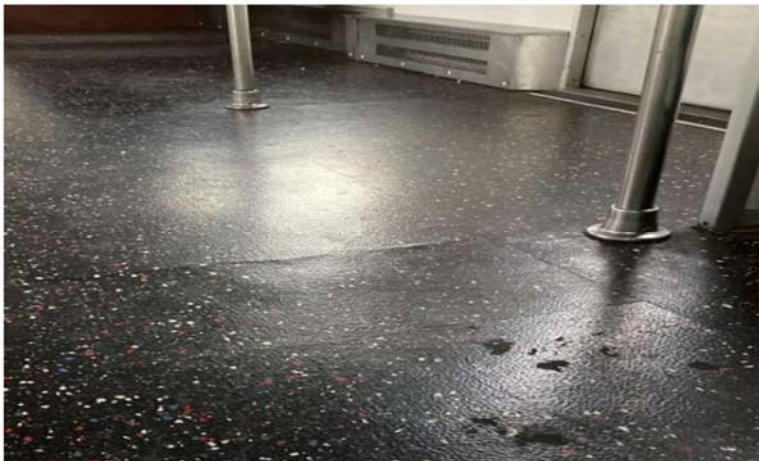
Figure 7. Car 3067 flooring deformations

The protrusions and deterioration observed in the floor surfaces of cars 3274-3274 and 3066-3067 appear to be caused by water intrusion and corroded hardware. Flooring deformation was also observed in non-contact cars which most likely is a result of moisture and deterioration of the plymetal.

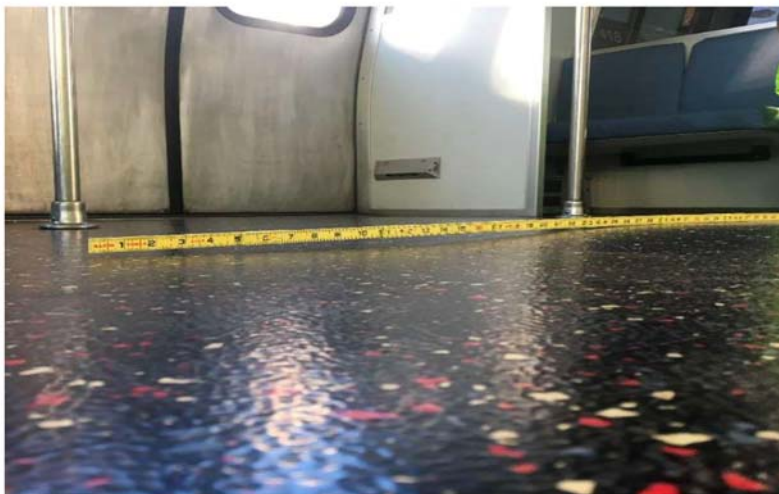
Figure 8. Car 3066 Flooring

1. Performed under car inspection. The front and rear coupler shear bolts were activated.
2. Inspected under car structure and equipment brackets. No anomalies found.
3. Inspected car interior flooring. Floor deformation along the surface at the cab area observed requiring evaluation for future replacement. Refer to Figure 8 below.

10. During interior inspections, swollen flooring in the walkway area between doors 1-2 and 7-8 of car 3066 (belly position during incident) was observed. Further evaluation for future floorboards replacement is recommended.

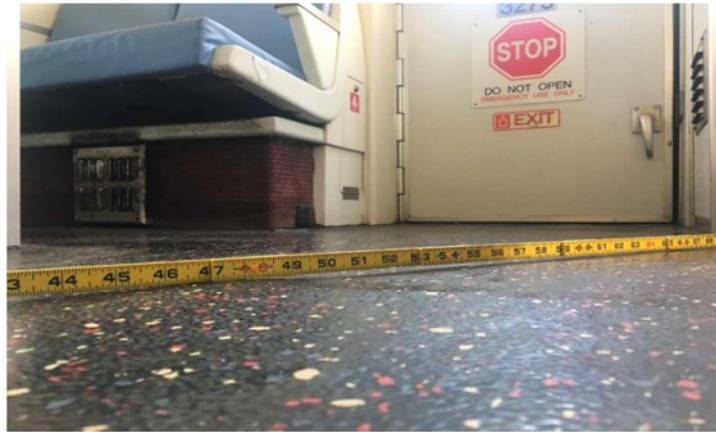
Figure 9. Car 3275 Flooring

1. Performed under car inspection. The front and rear coupler shear bolts were activated.
2. Under car visual inspection did not reveal structural damage. No damage observed on under car equipment mounting brackets.
3. Rail car interior flooring deformed in the cab area from bulkhead door to the passenger doors 1-2 and 6-7 sections requiring inspection for evaluation of subfloor integrity. CENV requested that CMNT remove pieces of Nora flooring for inspection of flooring. Refer to Figure 9 below.

8. Replace cracked glass in divider panel at doors 3 and 4 of car 3275.
9. Replace all floorboards and all hardware removed from car 3275 for the inspection.

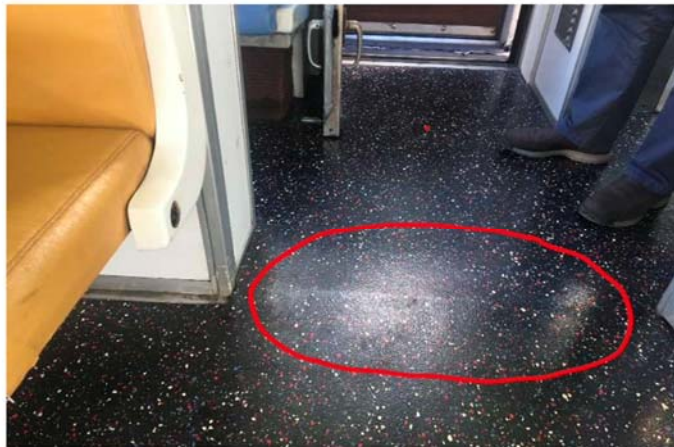
Figure 10. Car 3274 Interior Flooring

1. The front and rear coupler shear bolts were activated.
2. Under car visual inspection did not reveal structural damage. No damage observed on undercar equipment mounting brackets.
3. Interior flooring deformed in the cab area section requiring inspection for evaluation of subfloor integrity. Refer to Figure 10 below.

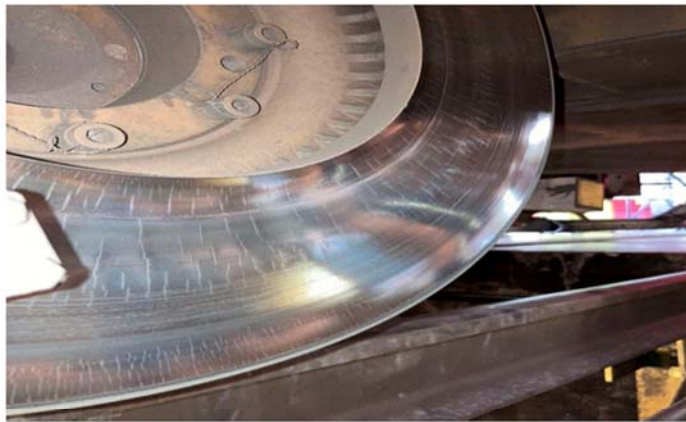
Figure 11. Brake Discs from car 3067 trucks (F/R)

1. Under car inspections revealed brake discs with heat cracks and worn surface on brake discs 1 and 4. Refer to Figure 11 below.

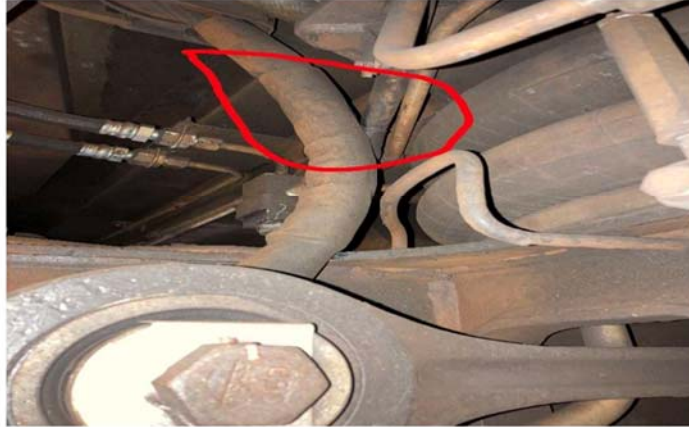
Figure 12. Truck securing cable

2. Rear Truck, on the left side, securing cable is contacting leveling valve air pipe as shown in Figure 12. Correction of securing cable routing required to prevent chafing.

4. Replace or adjust orientation of securing cable in rear truck (left side) of car 3067 to prevent chafing against leveling valve air pipe.
5. Inspect brake discs for heat cracks and worn surface conditions, recondition or remove and replace all Brake discs of car 3066 as required.

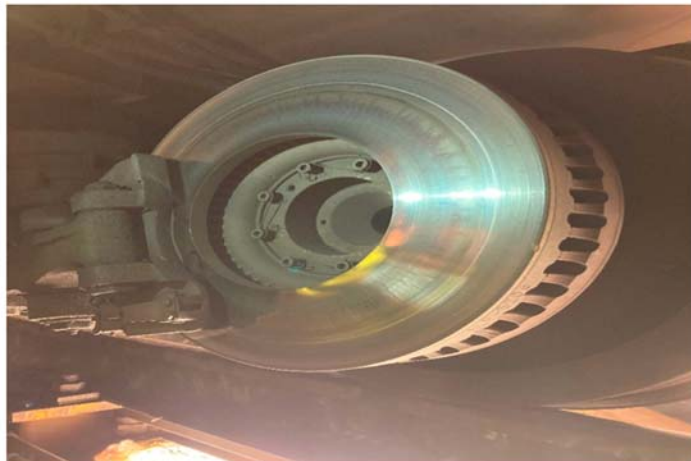
Figure 13. Worn Brake discs with evidence of heat cracks

1. All brake discs of this car (Front and Rear Trucks) have heat crack and worn surfaces. An example of the condemned brake disc is shown in Figure 13 below.

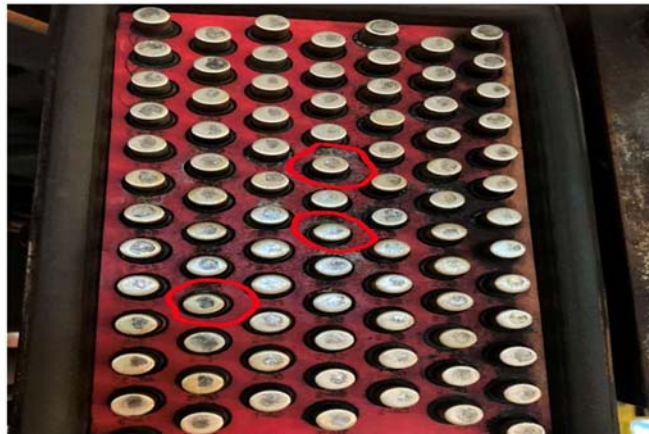
Figure 14. RH Front-end electric coupler head

1. The right hand (RH) front end electric coupler head contacts were found with corrosion and some contact pins pushed in. No physical damage to coupler case structure, door, insulation block or gasket was found. See Figure 14 as illustration.

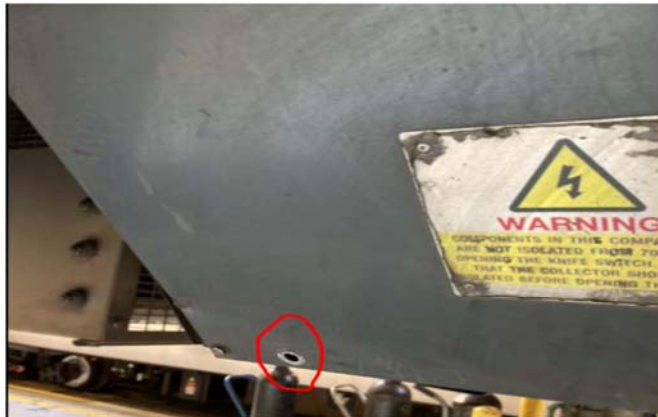
Figure 15. Rear PCC unit

2. Rear Propulsion Common Case cover missing securing bolt as shown in Figure 15 below.

6. Check the front and rear propulsion common case units and install missing securing hardware in the covers of cars 3274 and 3275.
7. Repair broken bracket on the rear truck of car 3275.

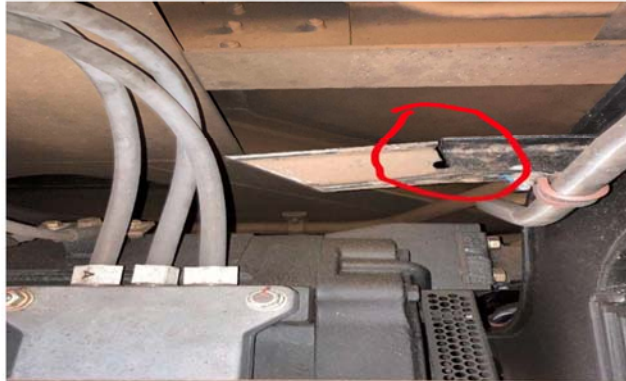
Figure 16. Rear Truck bracket broken

3. Rear Truck, parking brake bracket is broken. Refer to Figure 16 below. Refer to Figure 16 below.

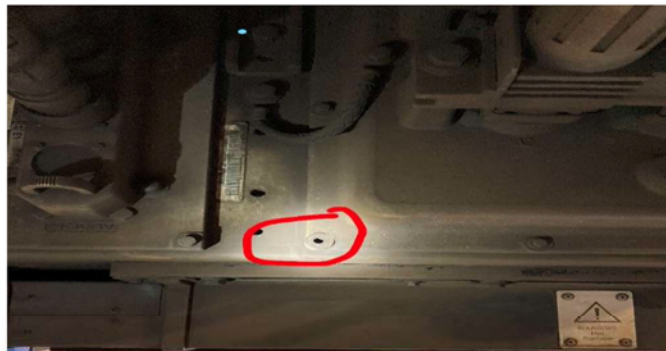
Figure 17. HV Cover Plate

1. Front Propulsion Common Case Unit, HV Cover Plate has missing securing bolt. Refer to Figure 17 below.

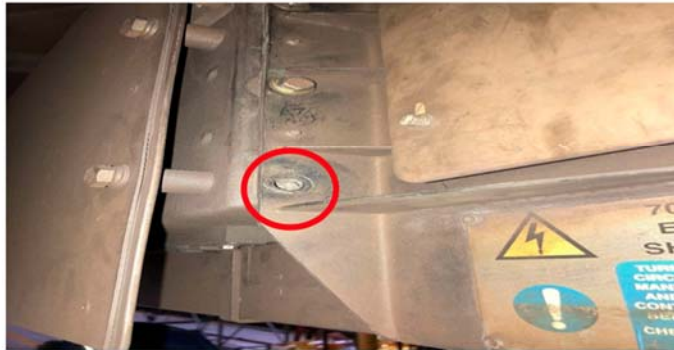
Figure 18.PCC Blower Cover

2. Front and Rear Propulsion Common Case blower covers missing one securing bolt each. Refer to Figure 18 below as an example.
