WMSC Commissioner Brief: W-0153 – Improper Movement – near Twinbrook Station – November 4, 2021

Prepared for Washington Metrorail Safety Commission meeting on March 8, 2022

Washington Metro Area Transit Authority
Department of Safety and Environmental
Management (SAFE)
FINAL REPORT OF INVESTIGATION A&I E21552

Twinbrook Station – Improper Train Movement

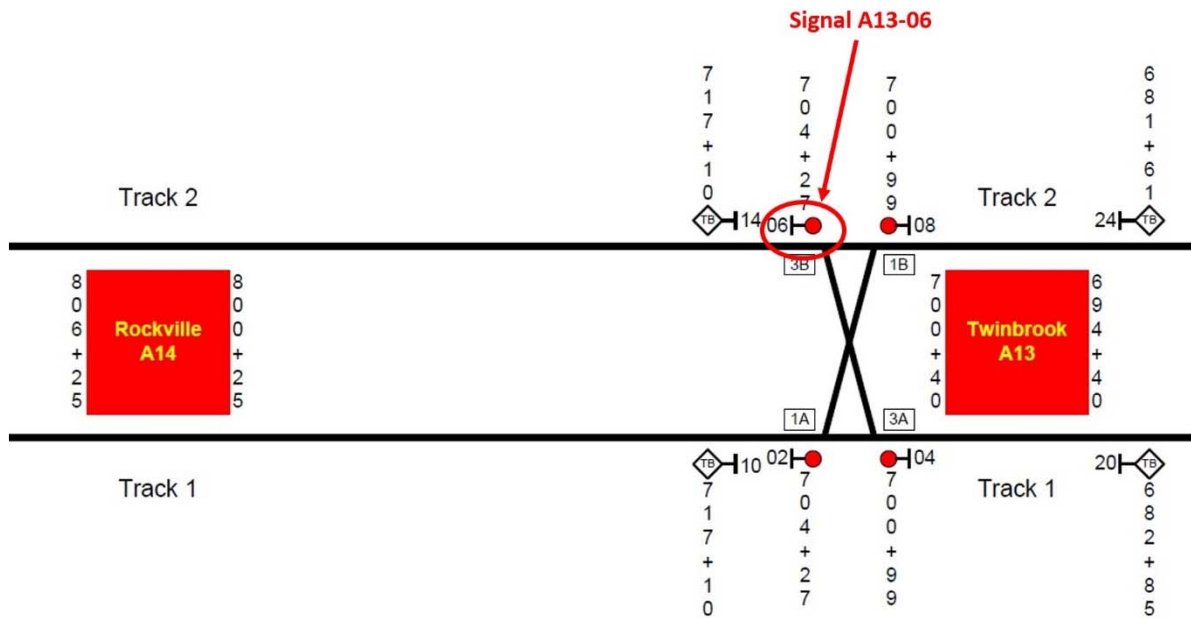
Field Sketch/Schematics

Twinbrook Station, Track 2, Signal A13-06

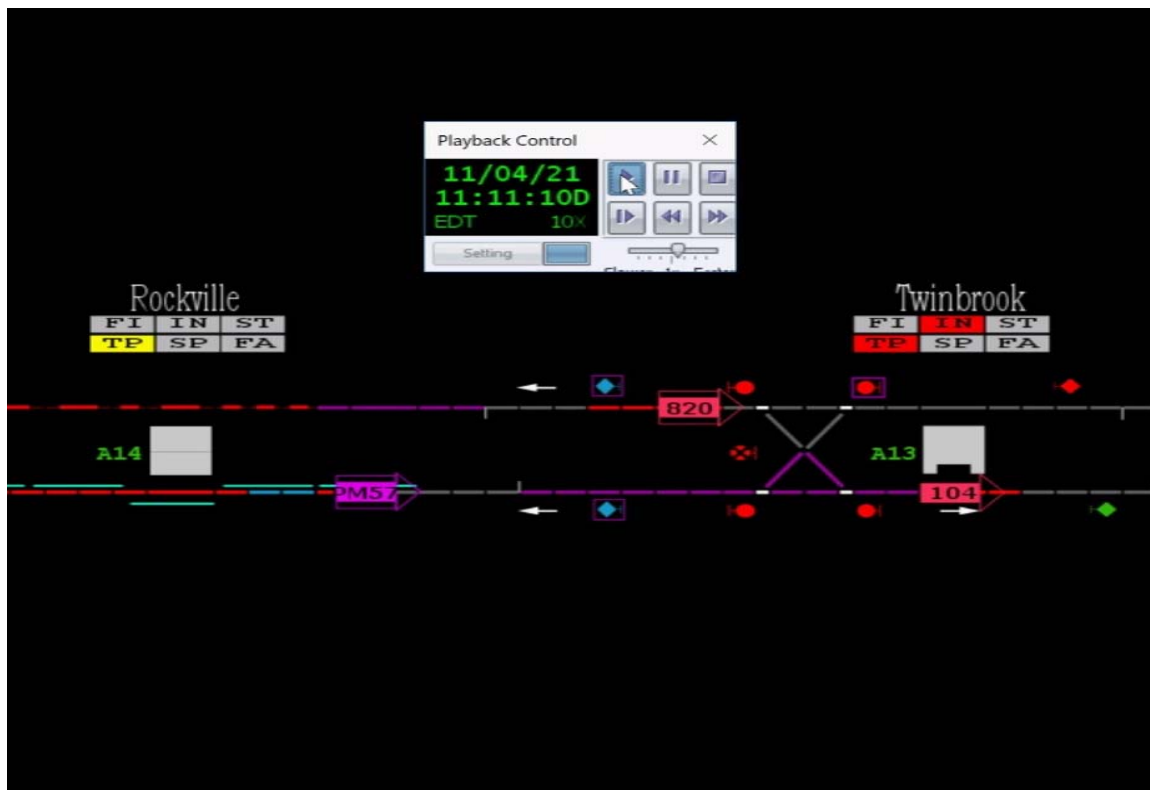
Diagram 1 – At approximately 11:11:10 hours, Train ID 820 approaches A13-06 red signal, Track 2.

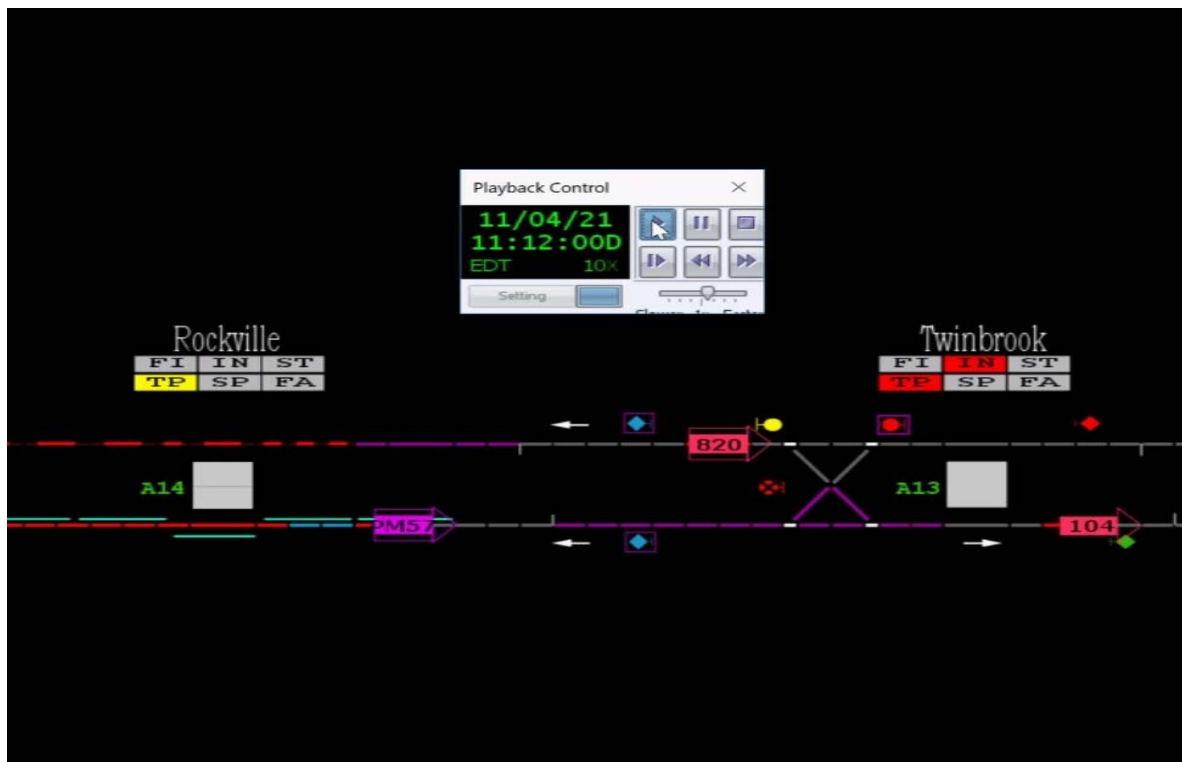
Diagram 2 – At approximately 11:12:00 hours, A13-06 signal changes aspect color(yellow).

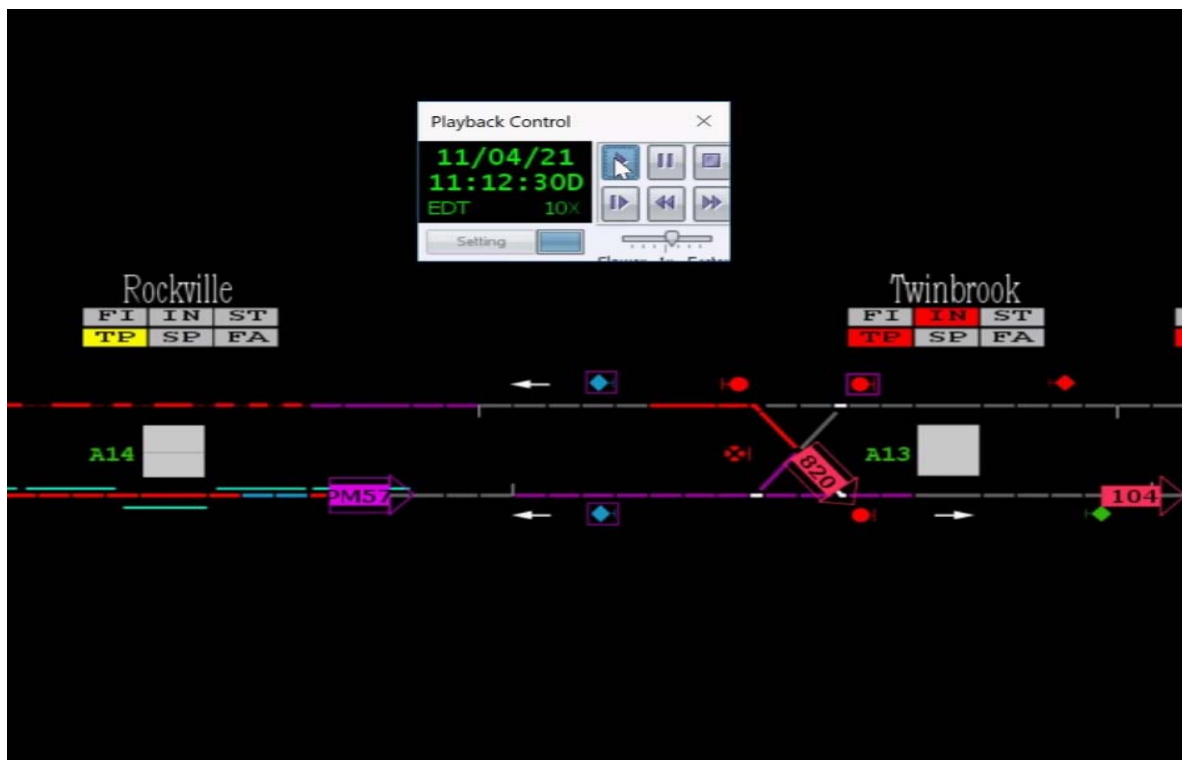
Diagram 3 – At approximately 11:12:30 hours, Train ID 820 passes A13-06 signal (changed to red as train occupied the track circuit) and crossed into the interlocking towards Track 1.

- During the move to the platform at Twinbrook Station, the Train Operator moved their consist with the trucks cut out and without a permissive block from ROCC.

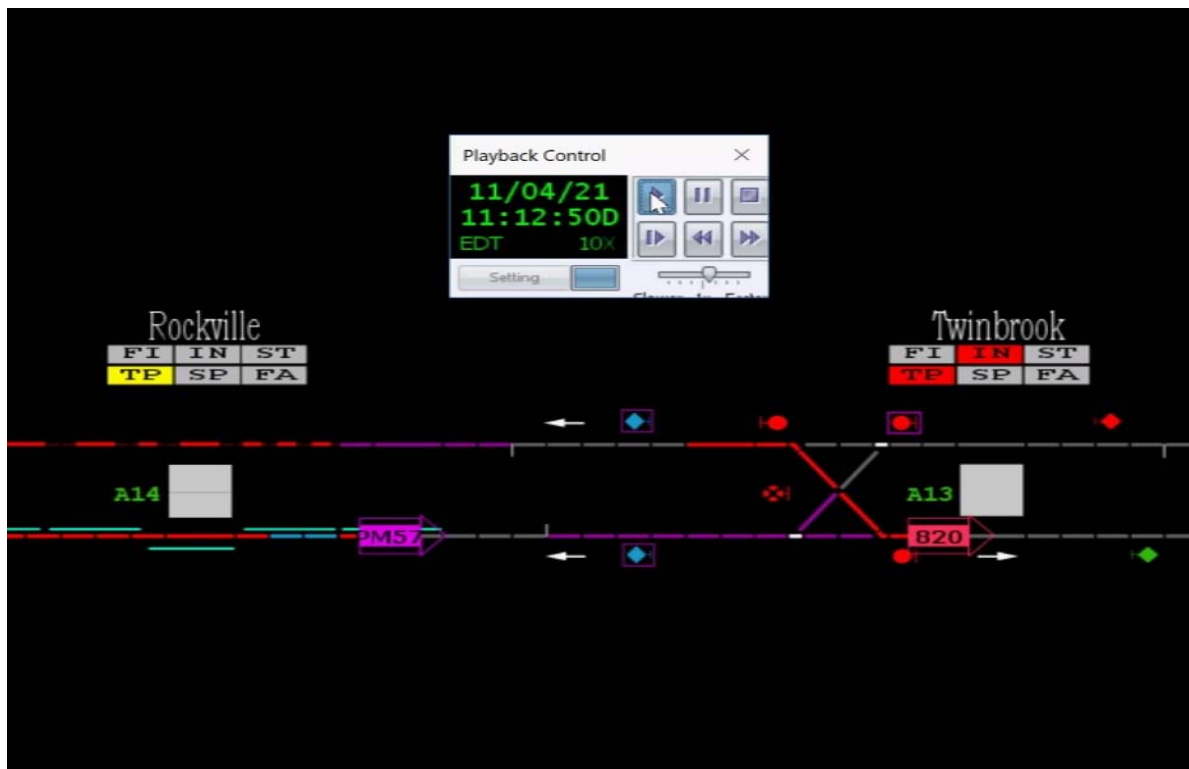
Diagram 4 – At approximately 11:12:50 hours, Train ID 820 approaches Twinbrook Station platform on Track 1.

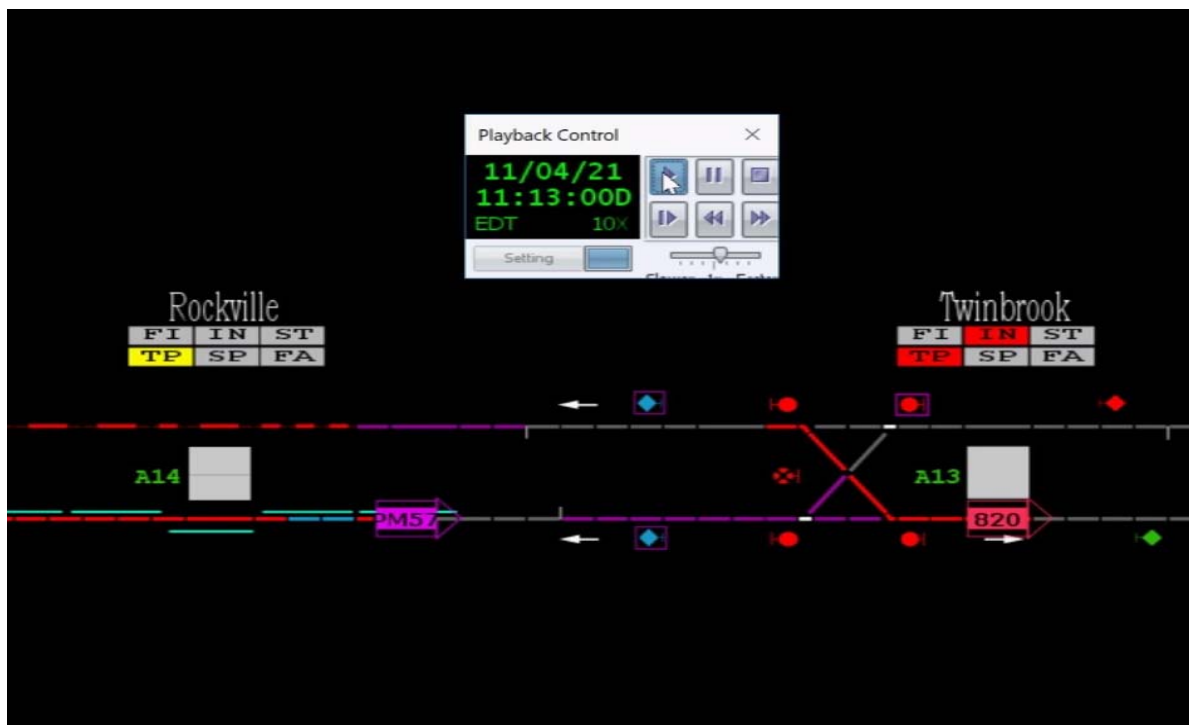
Diagram 5 – At approximately 11:13:00 hours, Train ID 820 is berthed at Twinbrook Station, 8-car marker, Track 1.

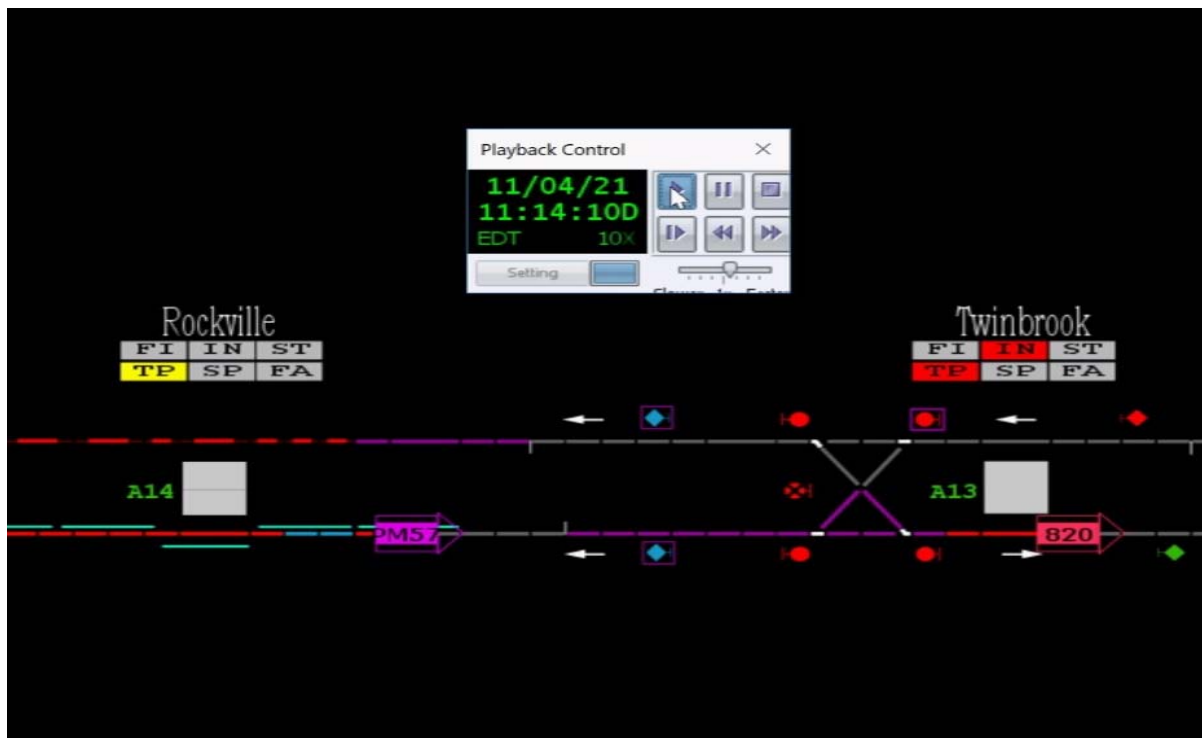
Diagram 6 – At approximately 11:14:10 hours, Train ID 820 departs Twinbrook 8-car marker, Track 1, with a new Train Operator.

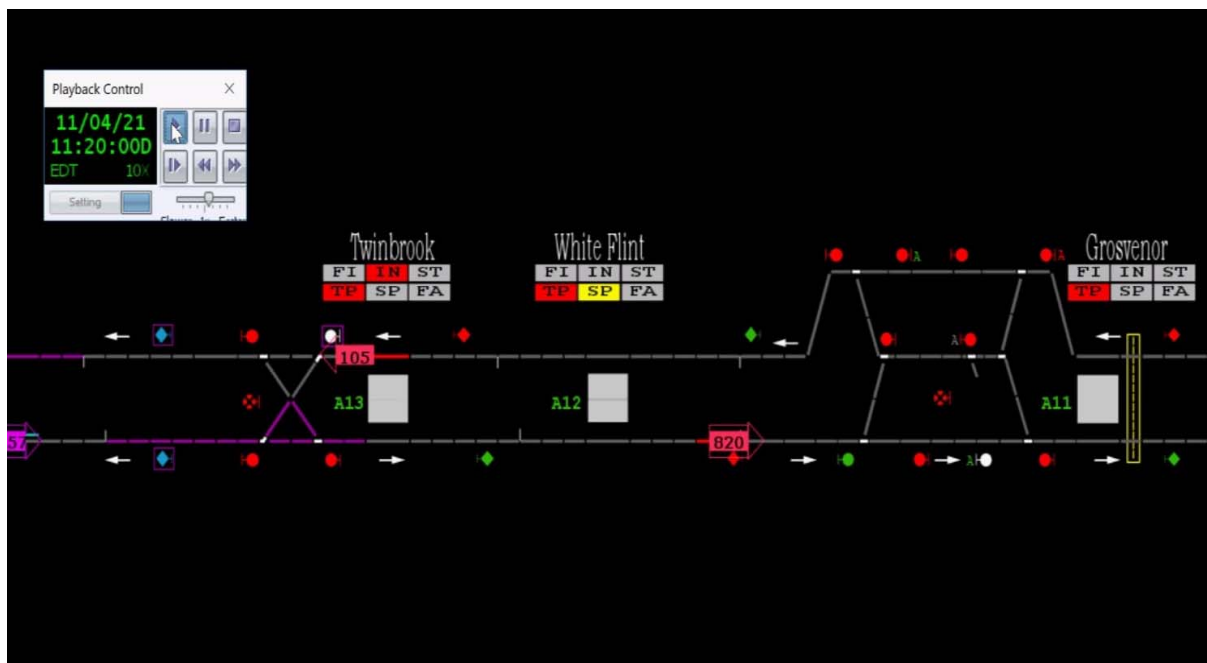
Diagram 7 – At approximately 11:20:00 hours, Train ID 820 continues towards Grosvenor Station, Track 1.

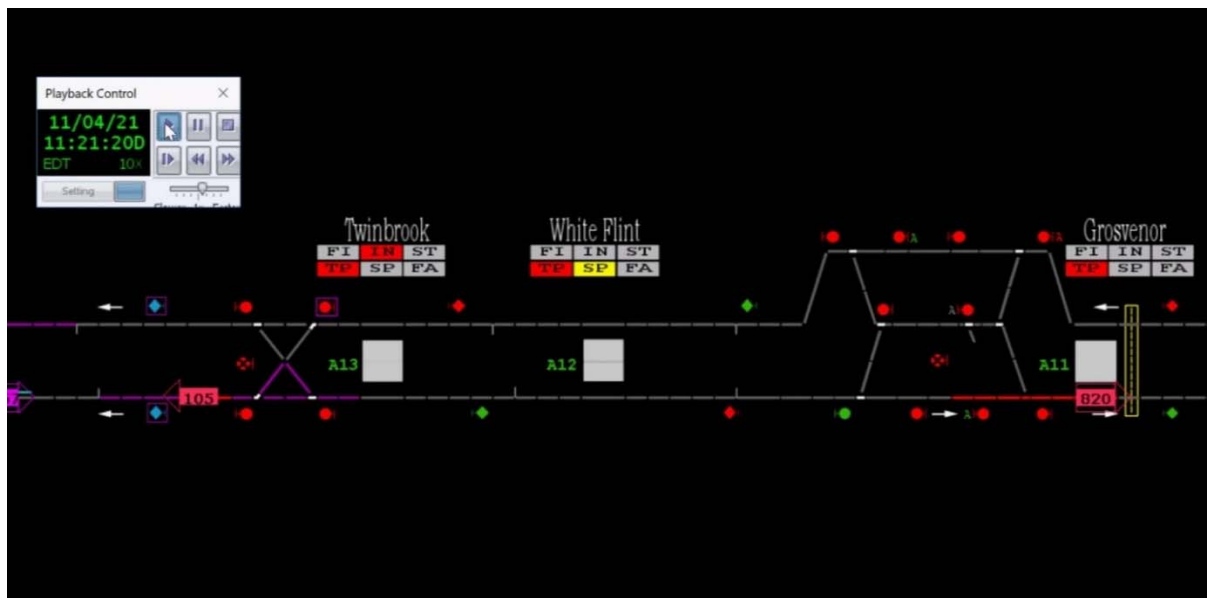
Diagram 8 – At approximately 11:20:20 hours, Train ID 820 approaches Grosvenor Station, 8-car marker Track 1.

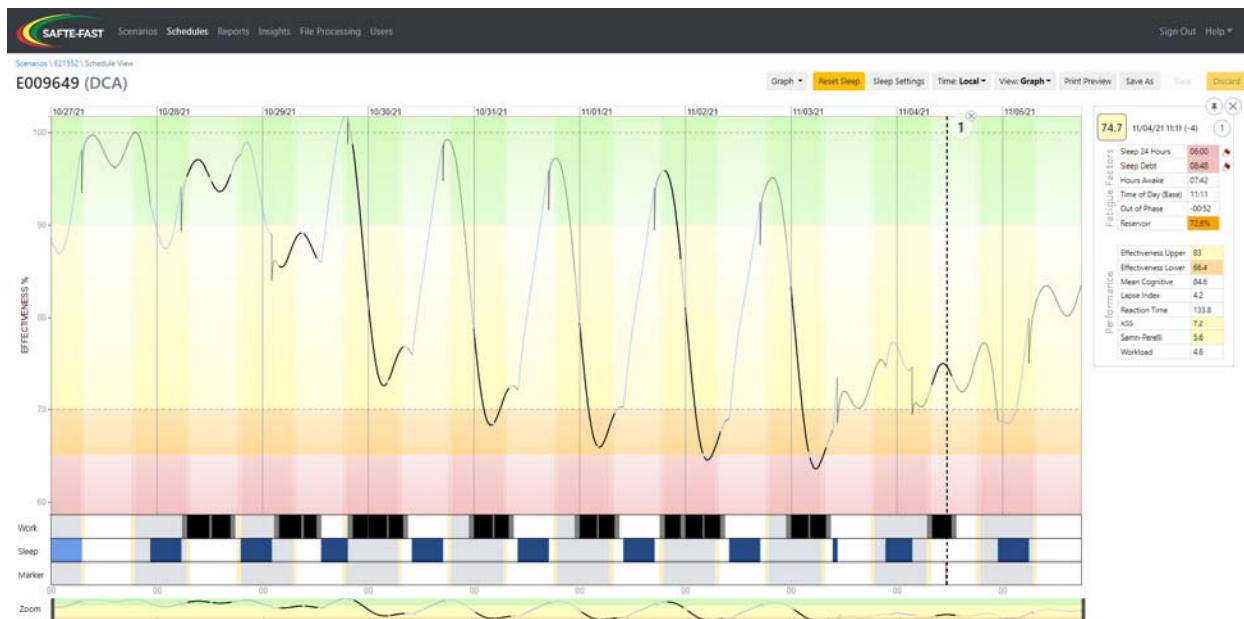
A biomathematical fatigue modelling application (SAFTE-FAST WebSFC) was used to further evaluate fatigue risk factors that may have been present in the Train Operator’s schedule. The analysis was based on the Train Operator’s work schedule, reported sleep from the day before the incident, and reported habitual sleep durations. Estimated performance effectiveness at the time of the incident was 74.7%. Specifically, the analysis identified sleep debt (inferring accumulated sleep loss of more than 8 hours) as a factor contributing to an increased risk of fatigue at the time of the incident.

Modeling analysis output shows estimated performance effectiveness during the incident work shift and for the week leading up to the work shift, based on the employee work and reported sleep schedule. Estimates were based on the Train Operator's work schedule, reported sleep from the day preceding the incident, and reported habitual sleep durations (7 hours a day). Bold portions of the modeled curve show work (in black) and sleep times (in blue). Effectiveness is shown on the vertical axis, with colored fields in the chart background signifying ranges of effectiveness scores including high effectiveness (>90%) in green, and low effectiveness (<65%) in red. Time is shown on the horizontal axis. Markers for work and sleep times are shown in the lanes above the time of day on the horizontal axis.

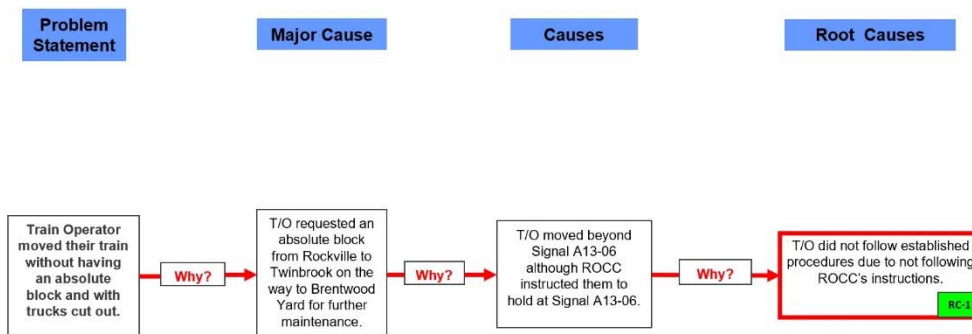
Appendix E – Root Cause Analysis

The probable cause of the incident was a failure to follow established procedures as the Train Operator failed to request or receive an updated block and perform a 100% repeat back of instructions given from the ROCC prior to moving their consist. No mechanical or procedural deficiencies were identified during the investigation.

| Corrective Action Code | Description | Responsible Party | Due Date |
|---|---|---|---|
| 95097_SAFE CAPS_RTR A_001 | (RC-1) RTRA will ensure the Train Operator receives refresher training regarding radio communications and train operations when blocks are cut out. | RTRA SRC | Completed |
