WMSC Commissioner Brief: W-0156 – Serious Injury – Navy Yard Station – December 4, 2021

FINAL REPORT OF INVESTIGATION A&I E21631

Date of Event:	12/04/2021
Type of Event:	Serious Injury
Incident Time:	05:51 hours
Location:	Navy Yard Station, Escalator W02
Time and How received by SAFE:	06:00 hours via IMO Notification
WMSC Notification Time:	06:48 hours
Responding Safety Officers:	WMATA: No WMSC: No Other: N/A
Rail Vehicle:	N/A
Injuries:	Two contractors: one major injury, one minor injury
Damage:	None
Emergency Responders:	DCFEMS

Navy Yard Station – Serious Injury

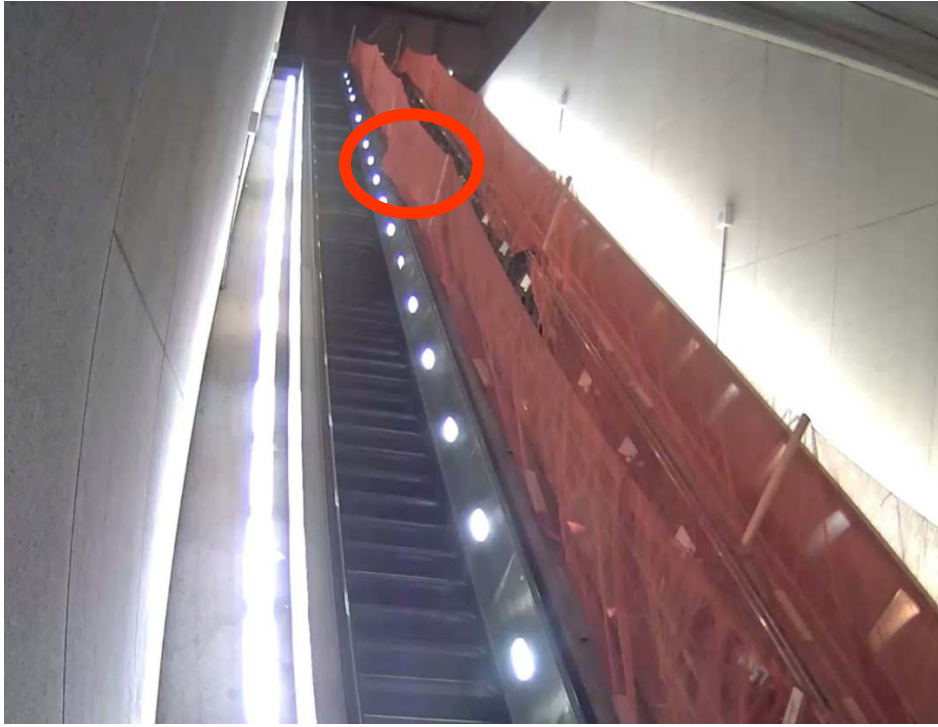
Diagram 1 – CCTV playback displaying the contractor fallen into the construction netting after being struck by the work sled at approximately 05:51:29 hours.

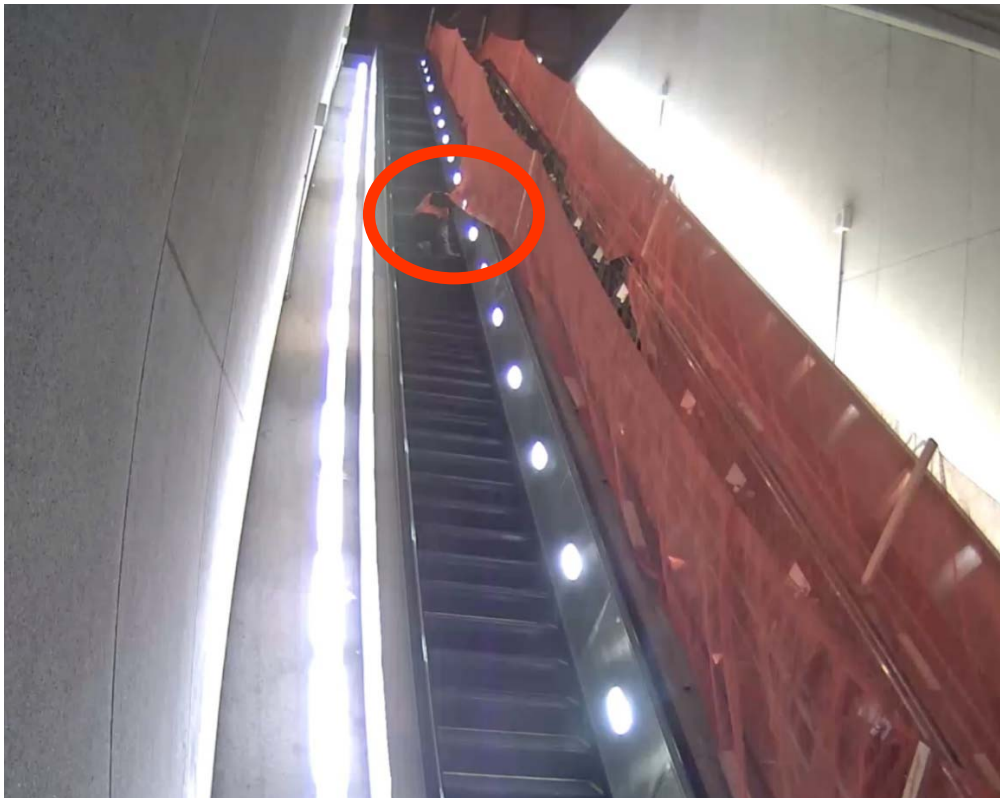
Diagram 2 – CCTV playback displaying the contractor crawling out of work area onto to adjacent, stopped escalator at approximately 05:52:05 hours.

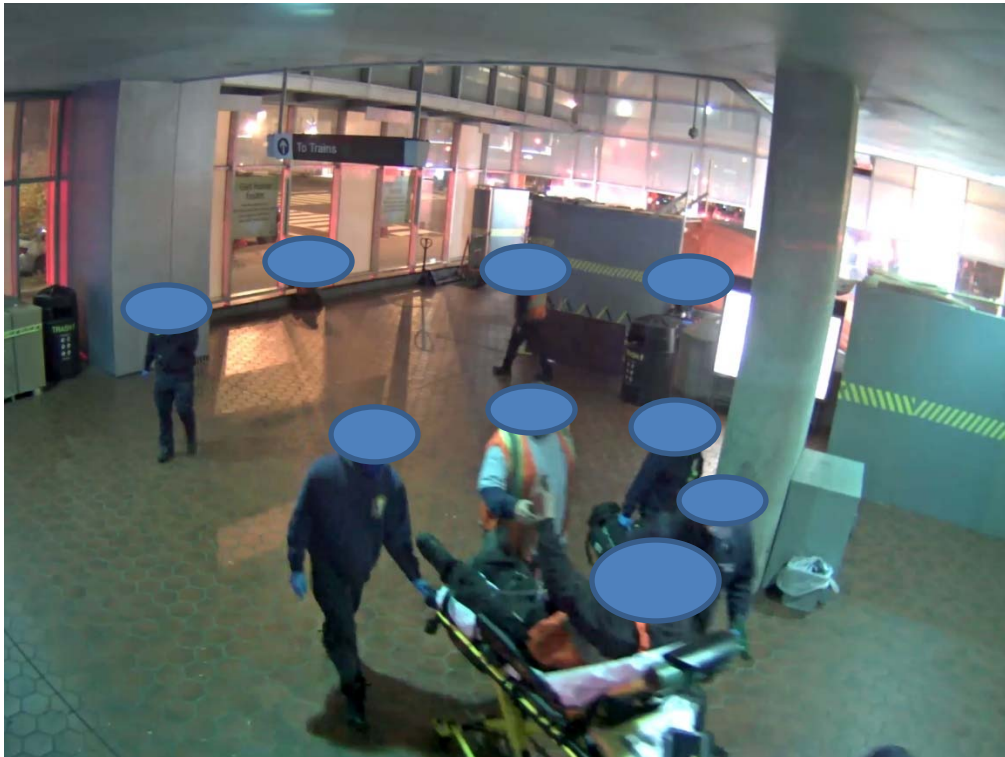
Diagram 3 – CCTV playback displaying the contractor being transported away from the incident scene at approximately 06:06:16 hours.

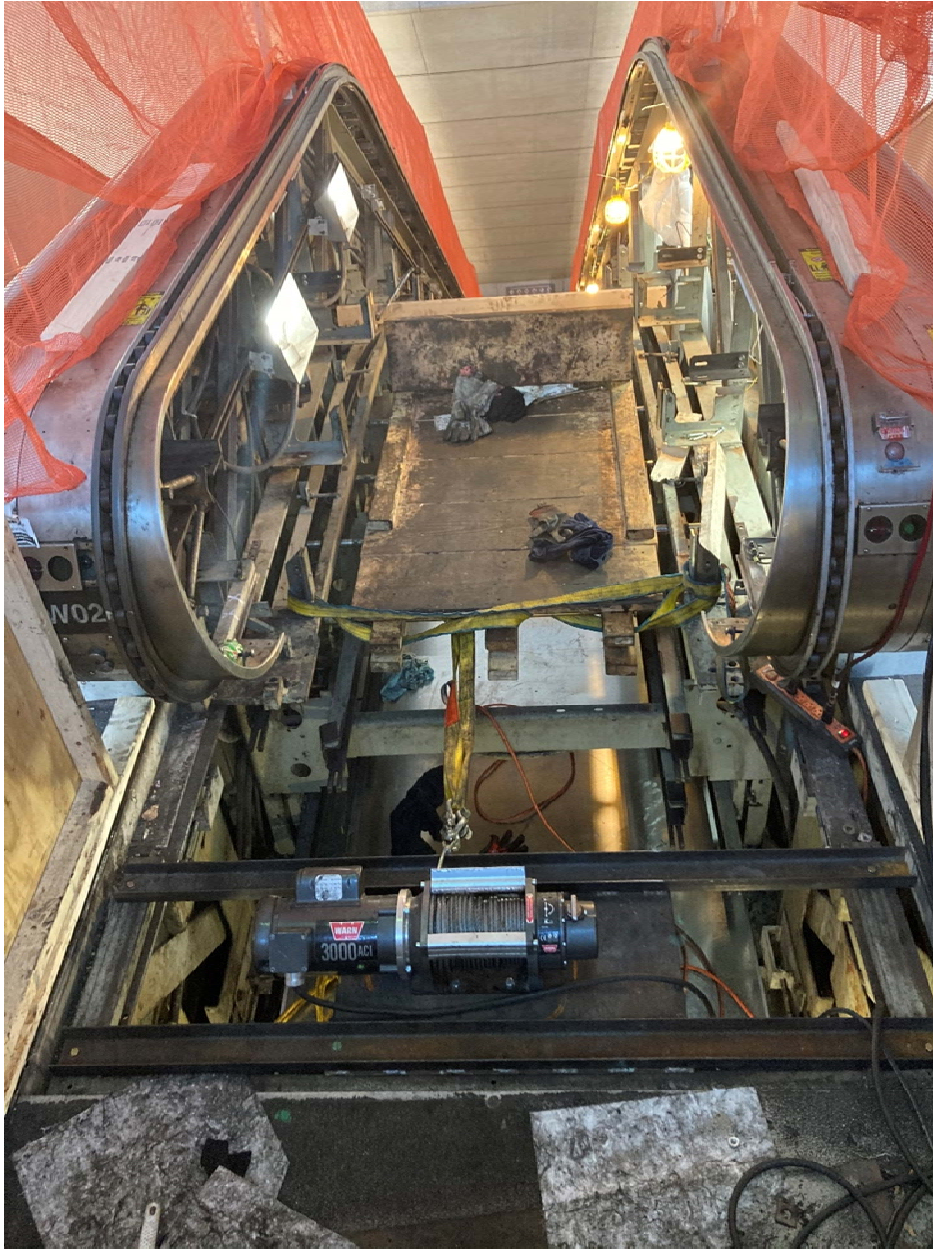
- ELES Inspector was not present for the Job Safety Briefing conducted prior to work commencing, but was present throughout the shift.
- Work sled in use was assembled by personnel prior to the incident date for the work task.
- The winch being used to hoist the work sled did not contain a safety guard for the quick release function.
- The work sled did not have a safety line attached.
- The sling became detached from the retaining hook during the hoisting operation.
- Work Sled operations were not governed by a work instruction or job hazard analysis (JHA).

Photograph 1 – Top view of Escalator W02 displaying the winch and work sled setup.

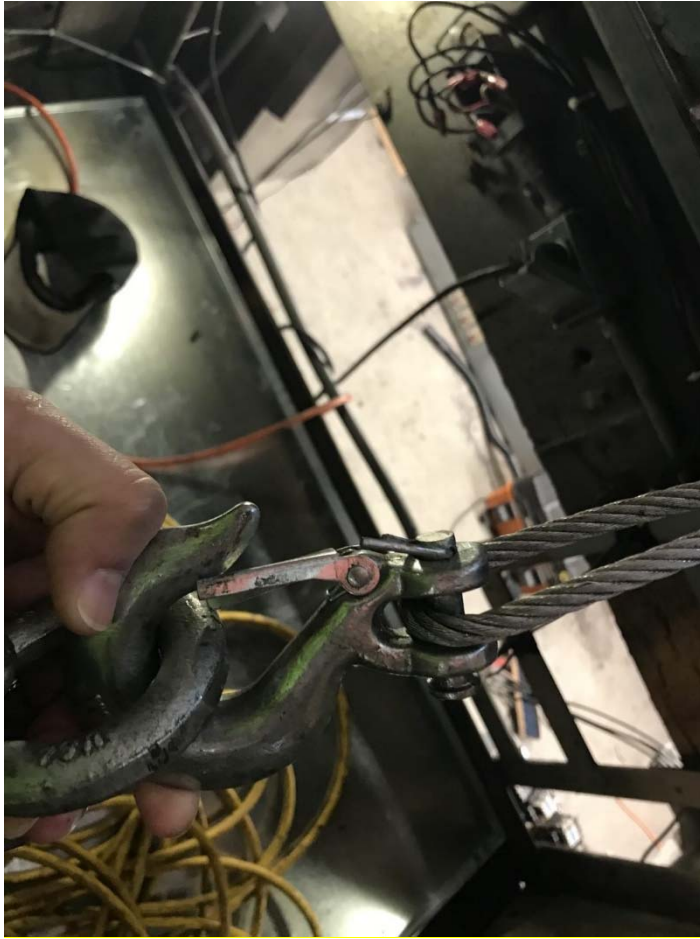
The probable cause of the serious injury event was inadequate equipment design. The design of work sled and hoist connection was built by contractor personnel specifically for this task. It was not engineered with adequate safeguards to prevent unintentional disconnection to the hoisting winch. A contributing factor to the incident was a missing work procedure that explained the hazards and preventive measures necessary to remove personnel from the dynamic envelope of the work sled while it was in hoisting operation.

Photograph 2 – Close up view of hoist connection.

Corrective Action Code	Description	Responsible Party	Estimated Completion Date
97187_SAFE CAPS_ELES_001	(RC-1, CF-1) Mid-American Elevator management will conduct a safety stand down related to construction hazard identification, rigging and working around hoisted equipment.	ELES/SAFE SRC	Completed
97187_SAFE CAPS_ELES_002	(RC-1, CF-1) Mid-American Elevator management will designate a qualified person (Safety Superintendent) to inspect all equipment prior to being used.	ELES/SAFE SRC	Completed
97187_SAFE CAPS_ELES_003	(RC-1, CF-1) Mid-American Elevator management will ensure all work sleds are engineered for their specific purpose prior to being approved for use.	ELES/SAFE SRC	Completed
97187_SAFE CAPS_ELES_004	(RC-1, CF-1) Mid-American Elevator management will ensure job safety briefings are conducted using an approved Job Hazard Analysis (JHA) prior to work commencing.	ELES/SAFE SRC	Completed

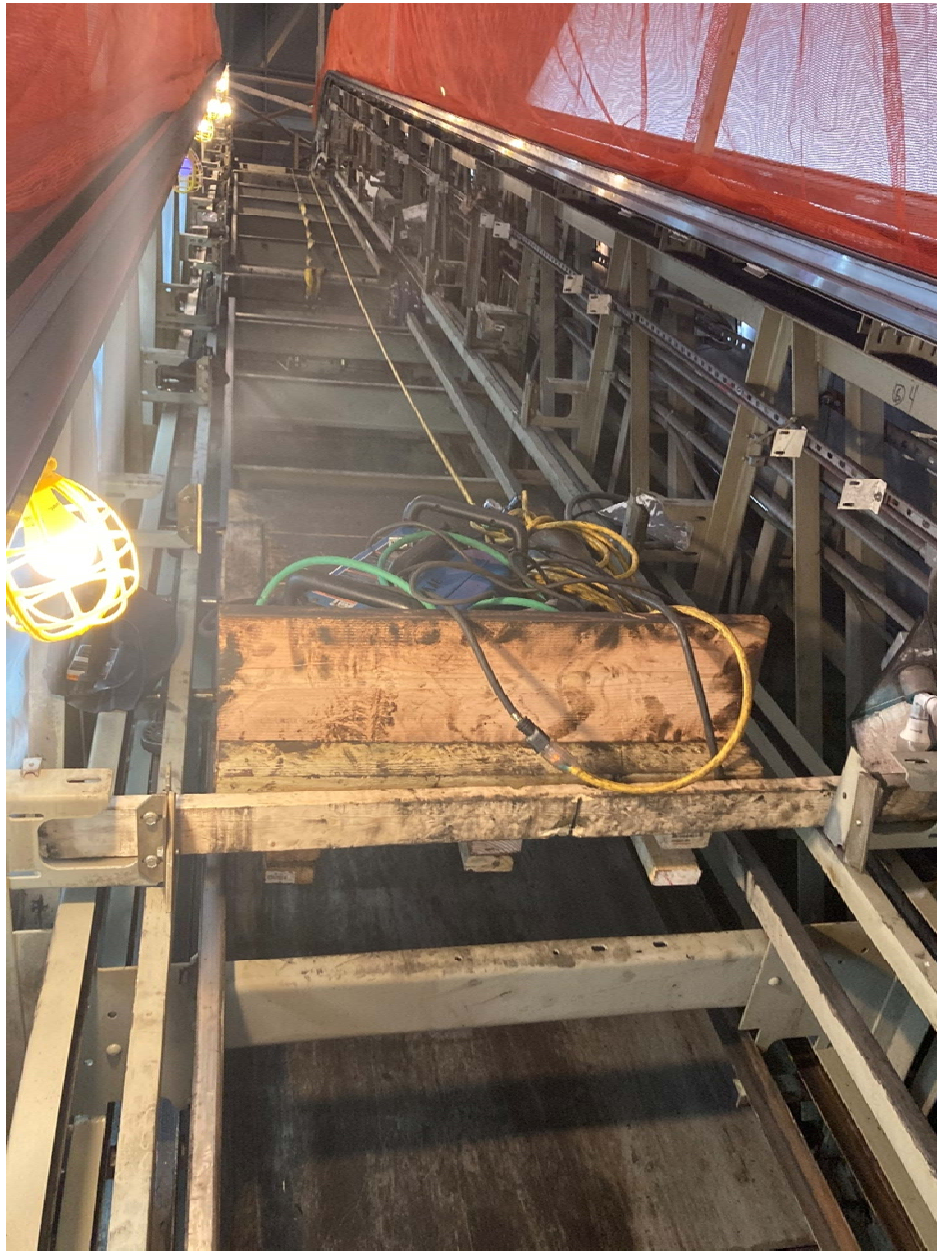
Photograph 3 – Bottom view of work sled in escalator truss.

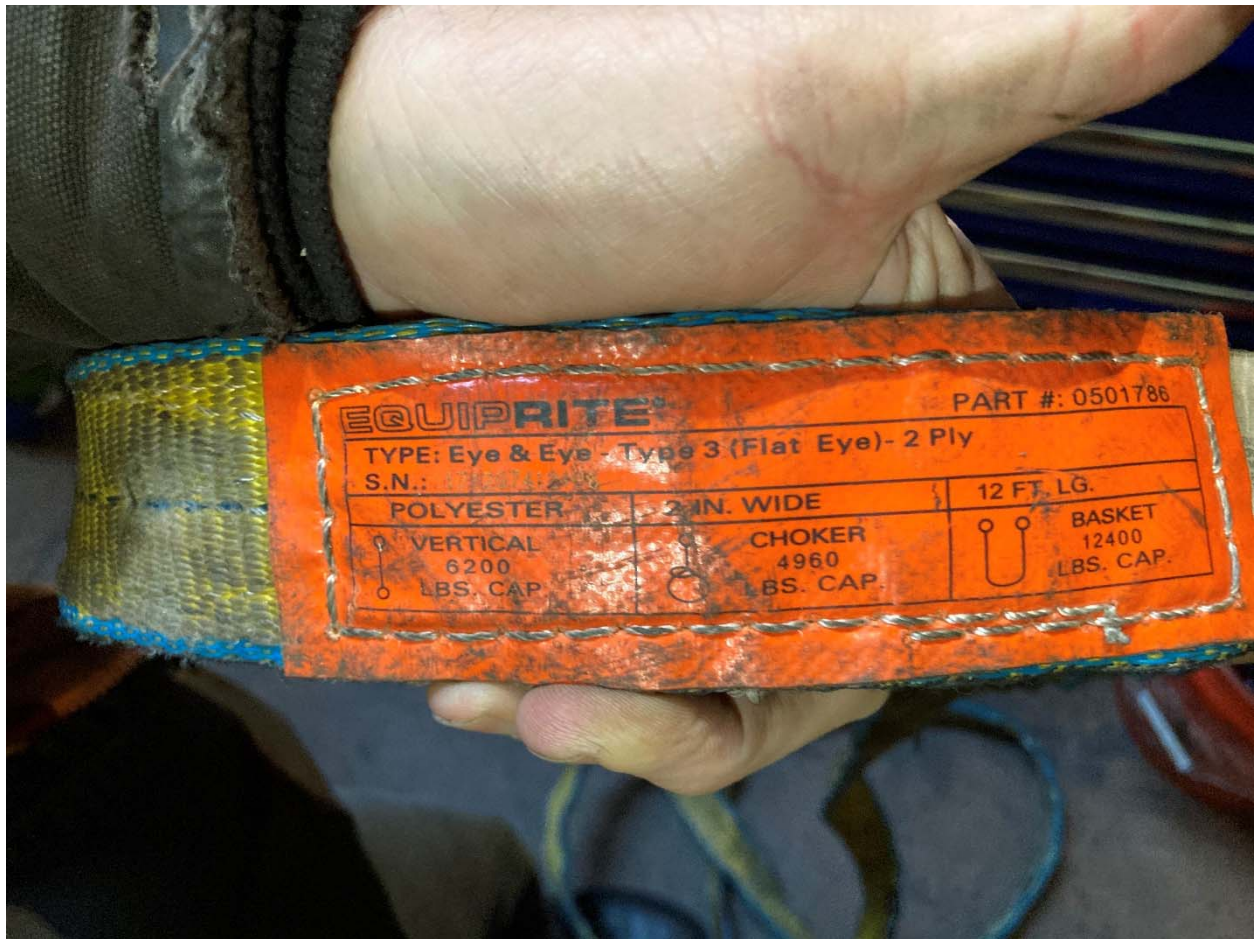
Photograph 4 – Photograph of sling in use during incident.
