WMSC Commissioner Brief: W-0157 – Serious Injury – Shady Grove Station – December 1, 2021

Washington Metro Area Transit Authority
Department of Safety and Environmental
Management (SAFE)
FINAL REPORT OF INVESTIGATION A&I E21620

Shady Grove Station – Serious Injury

December 1, 2021

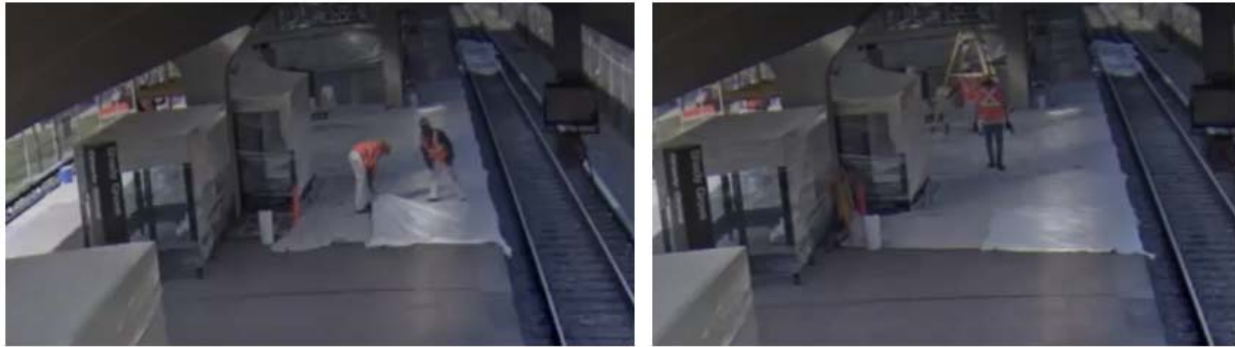
Image 1 – Sparrow Painting contractors preparing an area for paint and positioning of the ladder.

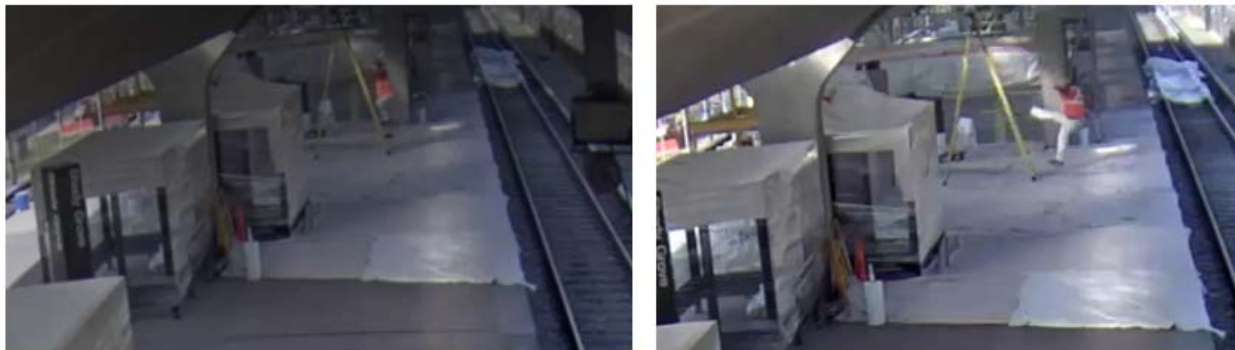
Image 2 – The painter ascending the ladder on the left and falling from the ladder as they descended on the right.

At approximately 12:05 hours, the painter takes a step to descend the ladder with equipment in hand, taking an initial step with their left foot securing placement on the ladder rung. Next, the painter loses their footing when they stepped down attempting to place their right foot on the ladder rung. The painter released their hands from the ladder falling onto their back without any witnesses. An employee of Sparrow Painting was nearby and immediately offered aid to the painter.

- The injured party failed to maintain three points of contact while working on the ladder. A moving scaffold was available as an alternative work platform.

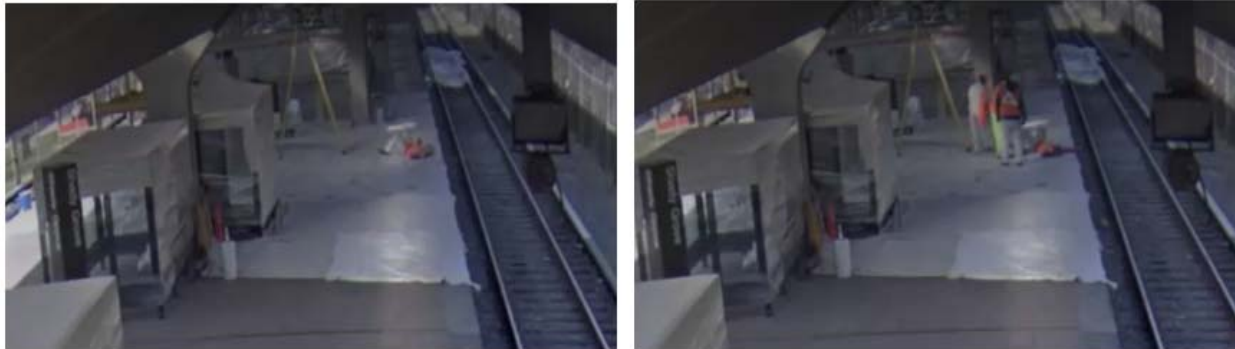
Image 3 – The painter after falling from the ladder on the left and the personnel offering aid to the painter on the right.

The Safety Attendant immediately removed the ladder and inspected the ladder for damage. The remaining Sparrow Painting employees moved a rolling scaffold in the place of the ladder and completed the painting duties.
