#### WMSC Commissioner Brief: W-0158 – Fatality – Franconia-Springfield – December 18, 2021

## FINAL REPORT OF INVESTIGATION A&I E21666

## Franconia-Springfield – Fatality

### December 18, 2021

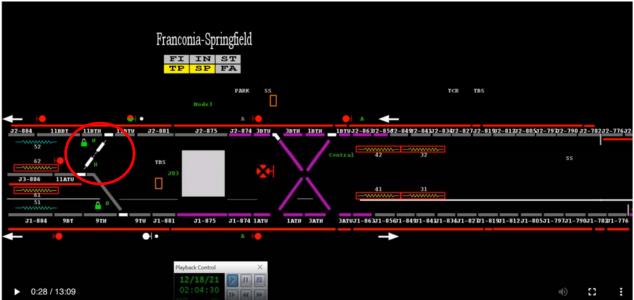
Figure 1 - AIMS Playback showing down track circuit.

Based on review of the Advanced Information Management System (AIMS), the tail track interlocking showed a down circuit at 02:03 hours, which is in line with the CCTV viewing of a fire plume at the same time. The circuit remained down from 02:03 hours until repairs were made to the affected components.

On Saturday, December 18, 2021, at approximately 02:04 hours, the AIMS playback showed a down track circuit in the Franconia-Springfield Tail Track.

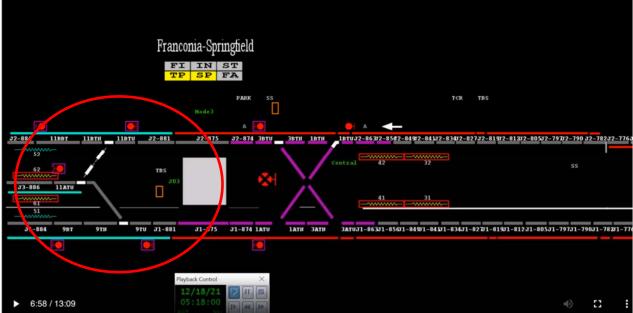
Figure 2 - AIMS Playback shows third rail power de-energized at 05:18 hours.

AIMS playback shows ROCC de-energized third rail power at approximately 05:18 hours.

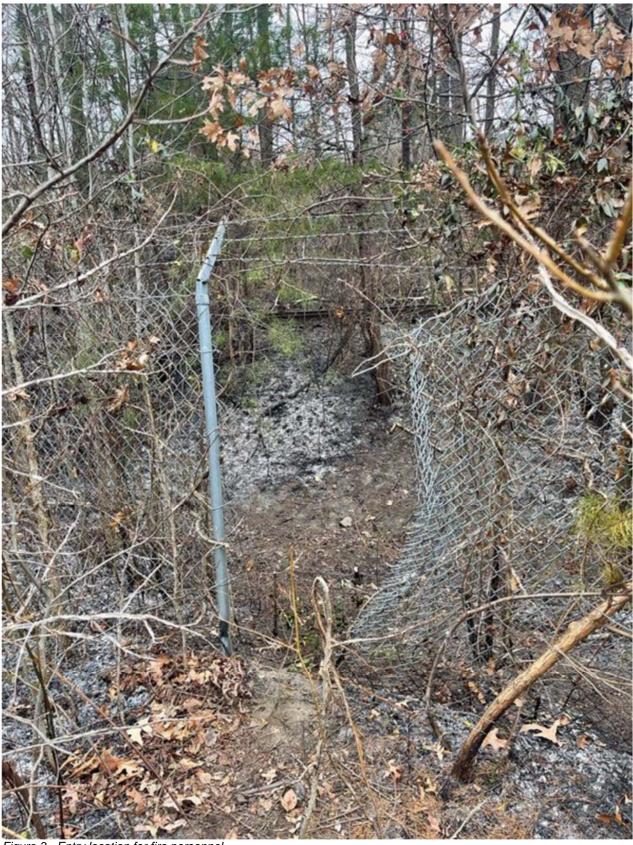
Figure 3 - Entry location for fire personnel

At approximately 06:51 hours, FCFRD gained access by cutting the fence in the tail track area to support MTPD Detectives and personnel access to the scene to deploy WSAD's and extinguish the small fire.

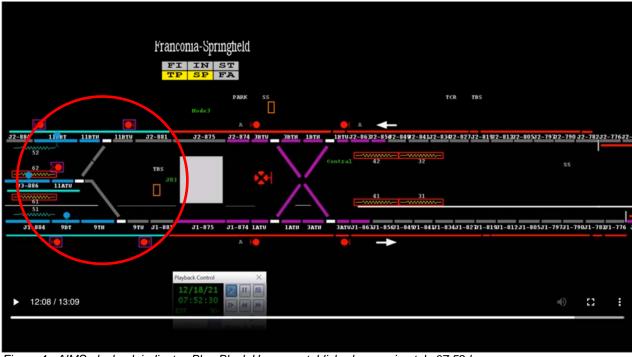
Figure 4 - AIMS playback indicates Blue Block Human established approximately 07:52 hours.

AIMS review also indicated Blue Block and Human Form were not established until approximately 7:52 a.m., an hour after the first personnel entered the roadway. Blue Block and Human Form are indications on the AIMS screen that show personnel are on the roadway and that safety precautions are required. MTPD did not clearly communicate to ROCC Rail Traffic Controllers (RTC) when emergency personnel entered the roadway.

AIMS playback indicated Blue Block Human form established at approximately 07:52 hours.

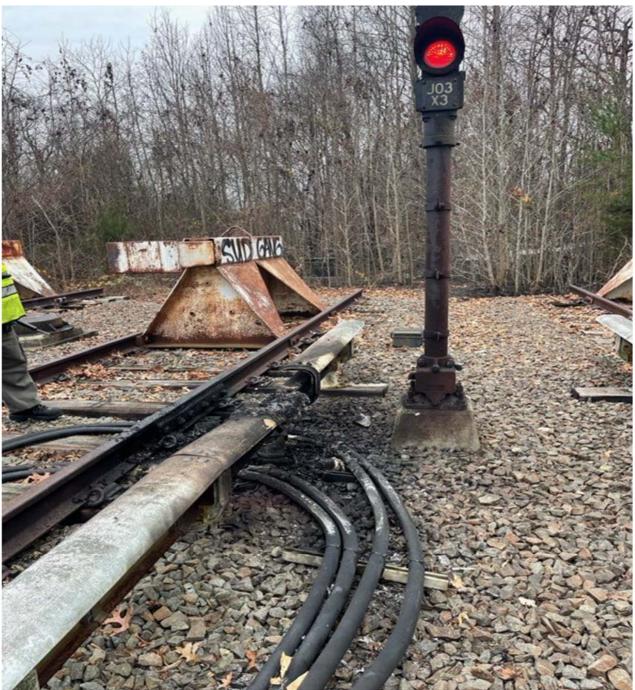
An inspection of the incident location showed the cover boards were in place at the time of the incident. Vandalism (graffiti) was observed on the bumping post; however, it has not been confirmed whether the decedent was responsible for this action.

Figure 5 - Incident location near J03 X3 signal. Graffiti visible on bump post

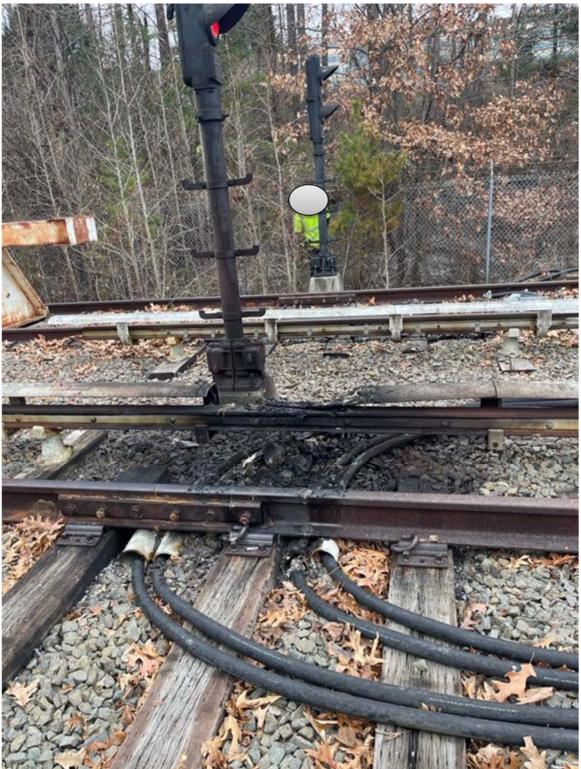
Figure 6 – Additional angle of incident location showing damage to ATC cables, third rail, cross ties, insulated joint bar and cover boards.
