## **WMSC Commissioner Brief: W-0161 – Improper Door Operation and Station OVERRUNS at Twinbrook Station – January 19, 2022**

**FINAL REPORT OF INVESTIGATION A&I E22040**

<b>Date of Event:</b>	01/19/2022
<b>Type of Event:</b>	Improper Door Operation and Station Overrun
<b>Incident Time:</b>	16:11 hours
<b>Location:</b>	Twinbrook, Track #1
<b>Time and How received by SAFE:</b>	16:11 hours, SAFE IMO
<b>WMSC Notification Time:</b>	17:10 hours
<b>Event Scene Release:</b>	16:15 hours, IMO
<b>Responding Safety Officers:</b>	WMATA SAFE: No WMSC: No Other: N/A
<b>Rail Vehicle:</b>	Train ID 102, L6173-6172.6059-6058.6067-6066T Train ID 108, L6103-6102.6091-6090.6117-6116T
<b>Injuries:</b>	None
<b>Damage:</b>	None
<b>Emergency Responders:</b>	None
<b>SMS I/A Incident Number:</b>	20220119#97958MX

Twinbrook Station – Improper Door Operation  
January 19, 2022

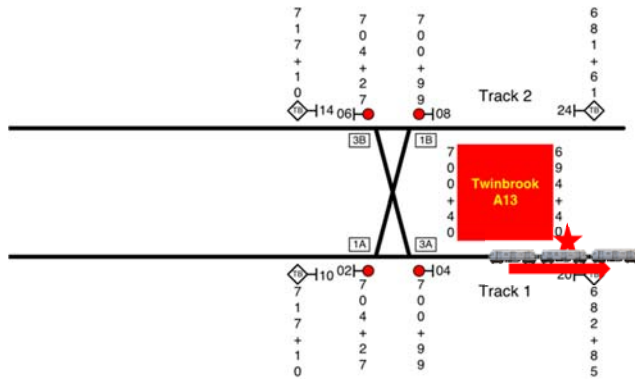
## Field Sketch/Schematics

Twinbrook Station, Track #1  
Ballast Track  
Elevation Change of 1.20 downgrade  
Outside Station  
Previous snowfall accumulations near running rail

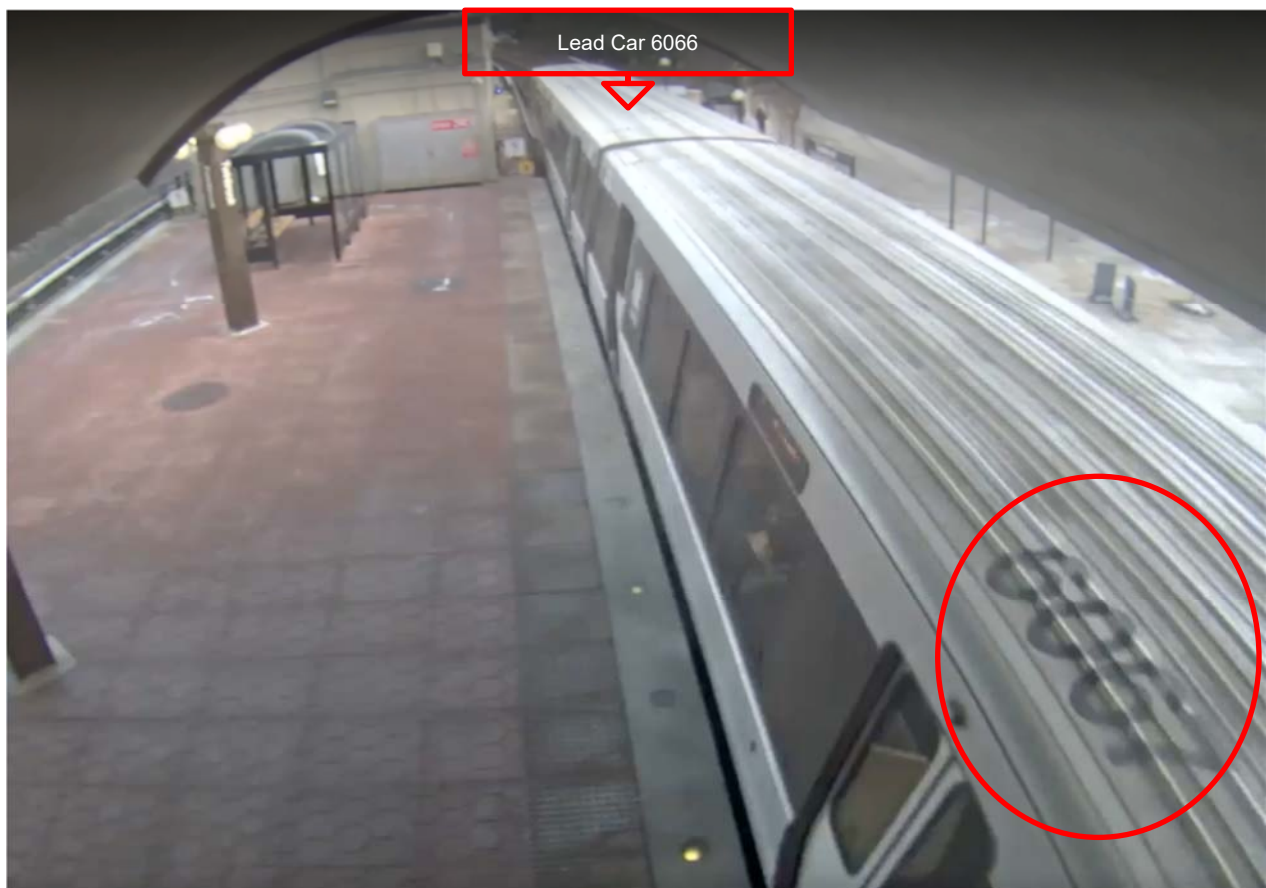
Figure 1 - Lead Car 6066 passing 8-Car Marker and continuing. This would be half of a car Station Overrun if the train stopped here.

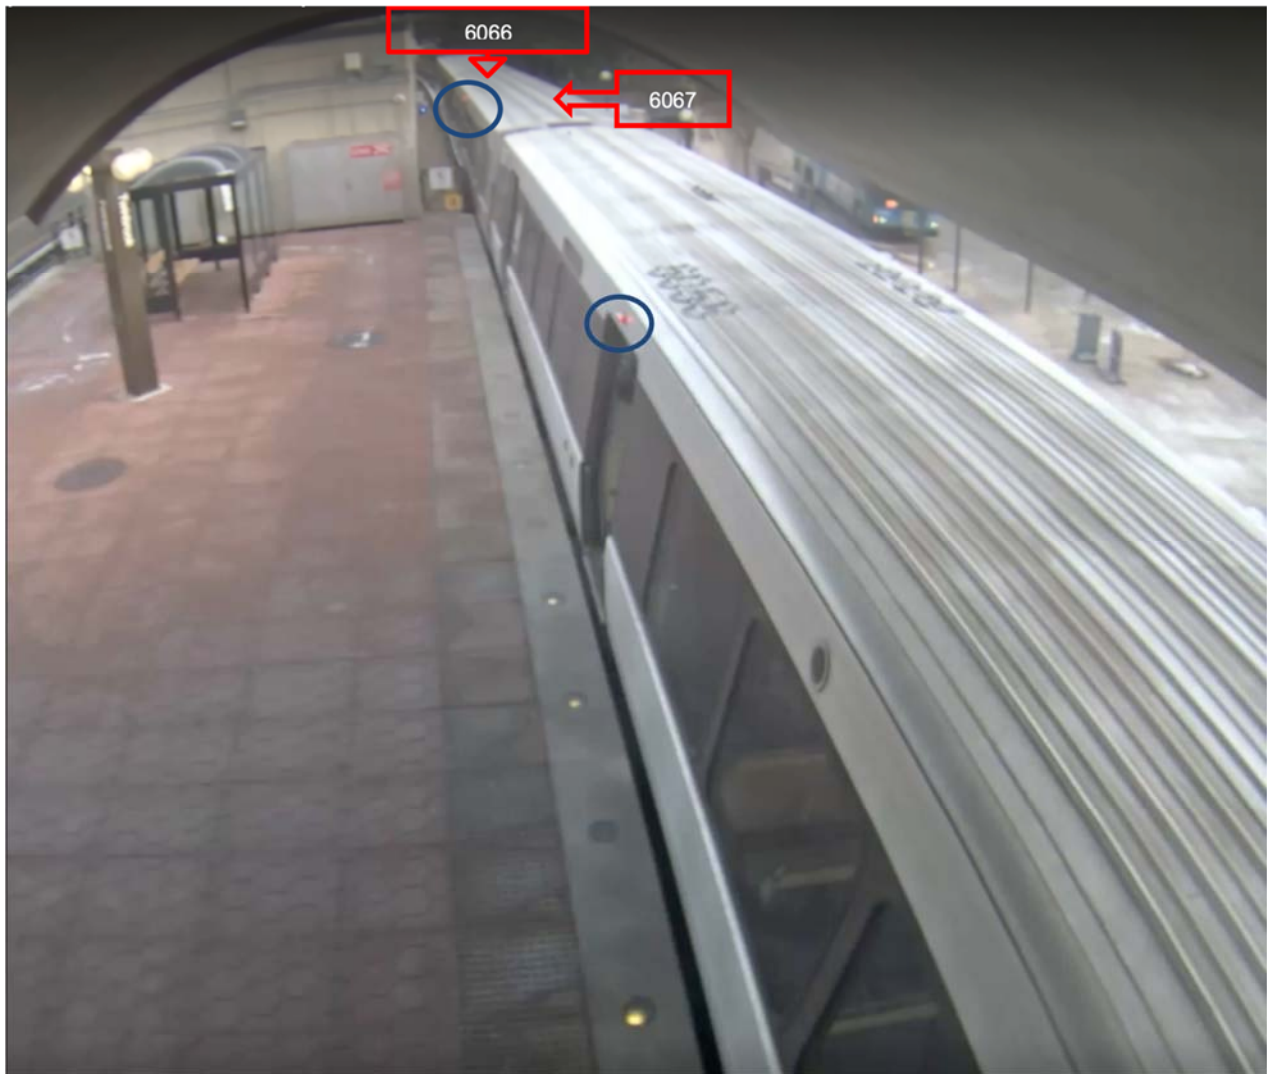
CCTV showed five railcars with active “Door Open” indicator lights illuminated, including railcar 6067, the second car in the consist. Railcar 6067’s stopped position resulted in two of the three doors being outside the platform limits.

Figure 2 – Train ID 102 stopped outside of Twinbrook Station limits. Railcars 6067 and 6068’s door indication lights illuminated. 6066’s (lead car) door light did not illuminate—no platform with guard rail observed near car 6067 doors 3,4,5 and 6.

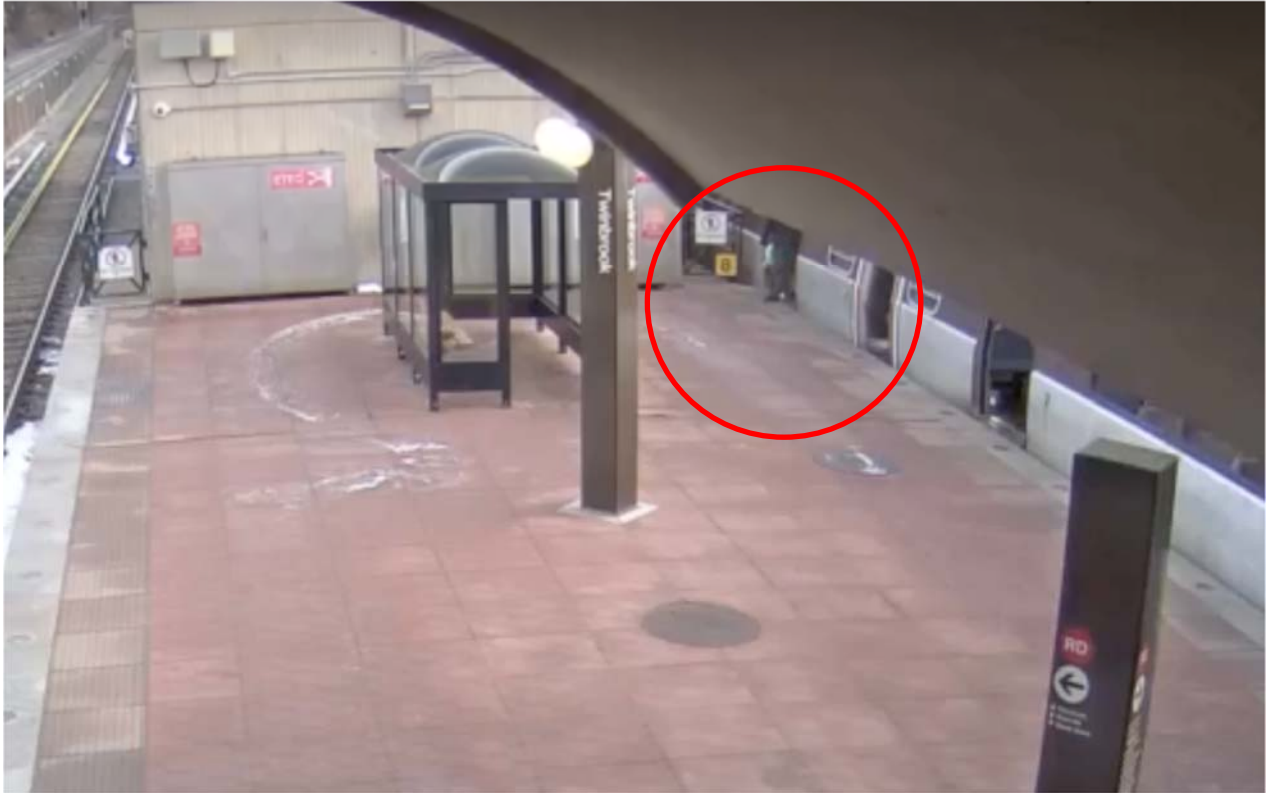
Passengers were observed alighting from railcar 6067 using the third set of doors.

*Figure 3 – Railcar 6067 of Train ID 102's last set of doors opened within the platform limits. Passengers alighted through this door.*

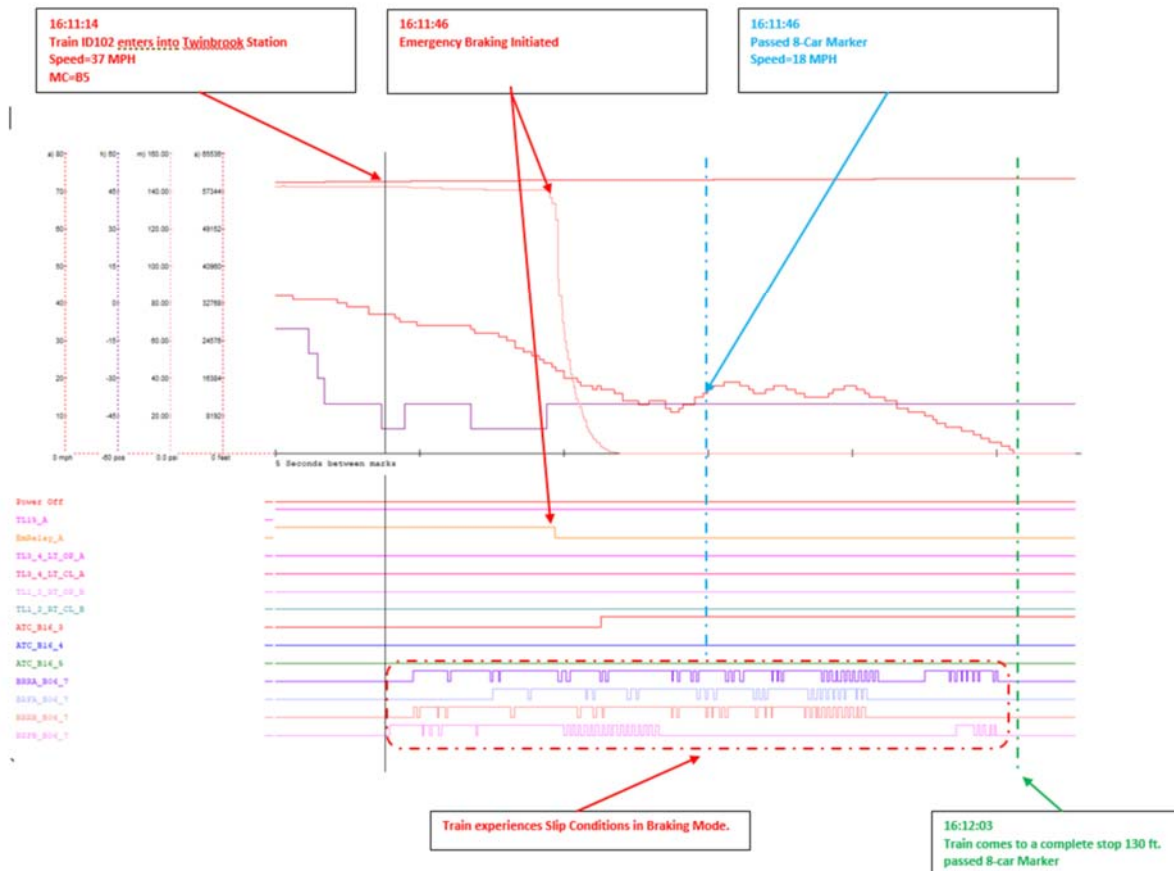
Figure 4 - Train ID 102 data sketch.

CMOR IIT completed an analysis of data retrieved from the consist. According to VMS data, Train ID 102 entered Twinbrook Station, track #1 at 37 MPH in a B5 Braking Mode. When the train was 9 feet within the platform limits, the train began experiencing slide conditions on the entire consist while in a braking mode. Emergency braking was initiated 274 feet within the Twinbrook Station platform. In emergency braking, the train passed the 8-Car Marker at 18 MPH, with slide conditions still present, coming to a complete stop 130 feet beyond the 8-Car Marker.

After coming to a complete stop, the Left Side doors were opened to service the station, then closed. The train then continued to the next station. When experiencing slide conditions, the train's friction brake slip/slide feature was initiated and performed as designed. Based on the VMS' calculated stop location of the train and platform video, the doors on the 2<sup>nd</sup> car were opened while not properly berthed on the platform. There was no fault observed with the VMS data that may have contributed to the cause of this incident.

- MC checks and Brake Rates on operating car on ID 102 (6066).
- Comply with CMOR SI #G2, Station Overrun Inspection Requirements.
- Verify proper function and communication with the VMS on car 6066 and its respective subsystems.
- Document all inspections, findings, and corrective actions in Maximo.

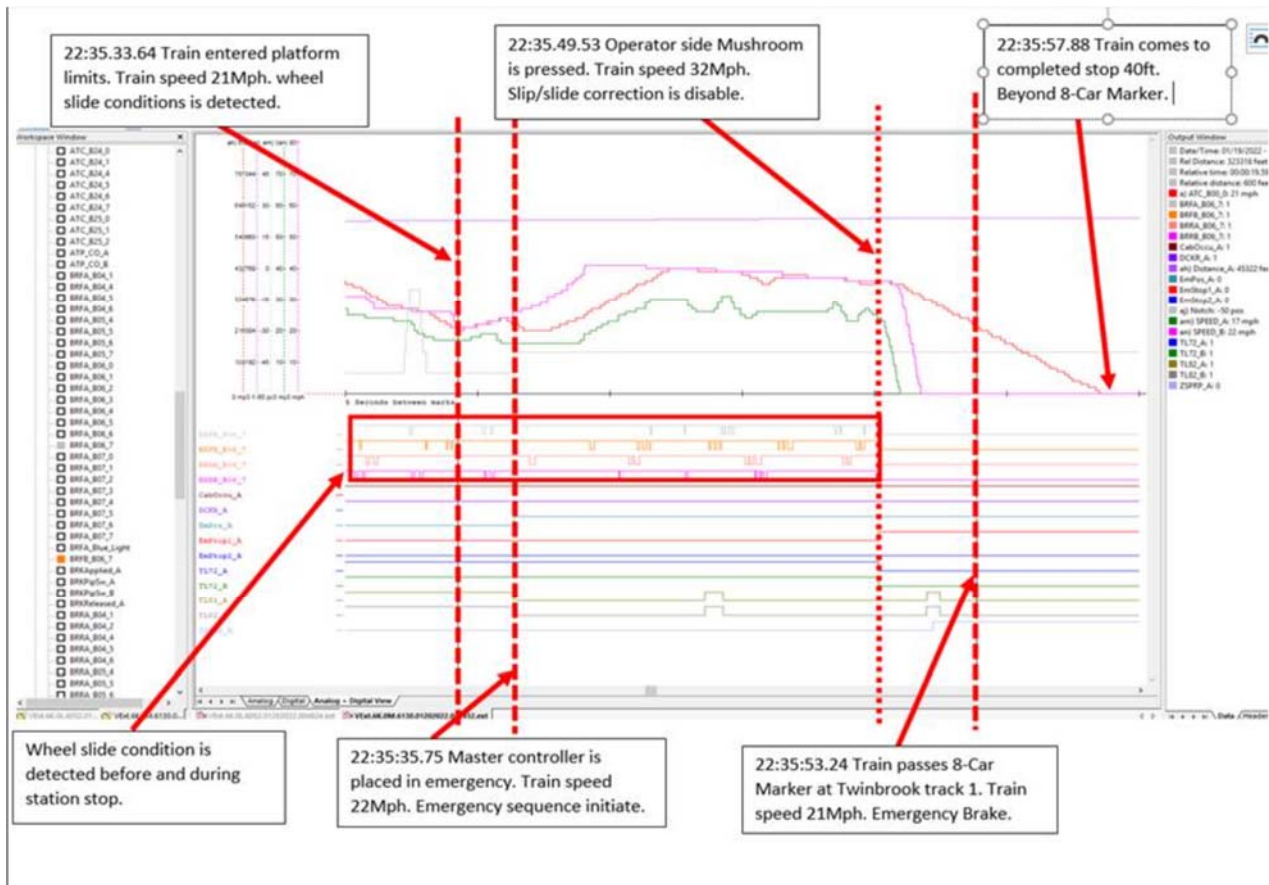
Figure 5 - Train ID 108 data sketch.

Time	Description of Events
22:35:33 hours	Train ID 108, lead car 6030, Entered Twinbrook Station, track #1, Train Speed was 21 mph, MC was in the B5 Braking Mode. Wheel slide conditions can be seen before entering platform limits.
22:35:35 hours	MC is placed in an Emergency Position. Emergency Braking was initiated, causing Brake Pipe to Dump; Train speed was 22 mph, 543 feet from 8-Car Marker. The train continues experiencing slide conditions.
22:35:49 hours	Emergency Mushroom one (Operator side) is pressed—train speed 32Mph. Slip/slide correction is disabled. TL/72 de-energized 34 feet from the 8-Car Marker.
22:35:57 hours	The train comes to a complete stop 40 feet beyond the 8-Car Marker at Twinbrook, Track #1.
22:40.06 hours	Left Door Open Pushbutton was depressed, opening Left Side Doors
22:42.49 hours	Train 6130 is keyed down.

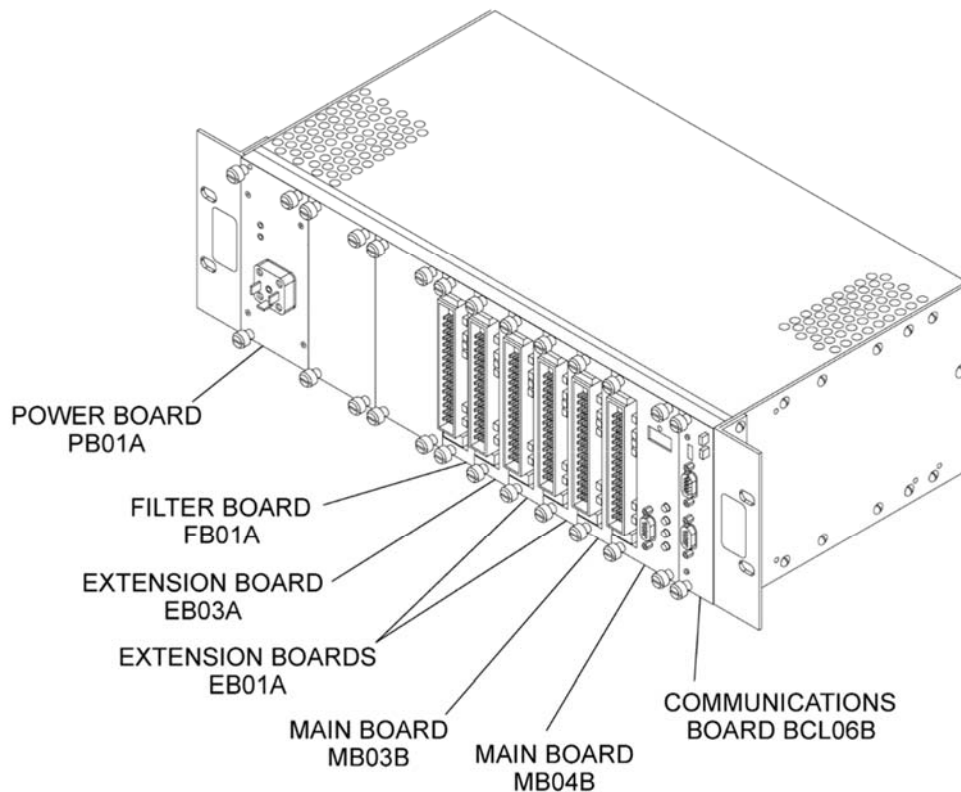
Figure 6 - Picture of an FBECU and location of boards.

CMNT personnel replaced the front Friction Brake Electronic Control Unit (FBECU) on car 6066 due to failed MB03 and MB04 boards failures. The remainder of the cars' control boards and brake rates were found to in proper working order and the entire consist experienced the slip-slide condition. These facts support that the MB03 and MB04 board failures were not a contributing factor to the Station Overrun.

The MB04B board controls brake cylinder pressure, and the MB03B board provides wheel slide protection. Each FBECU containing these boards works independently on each truck on a rail vehicle.

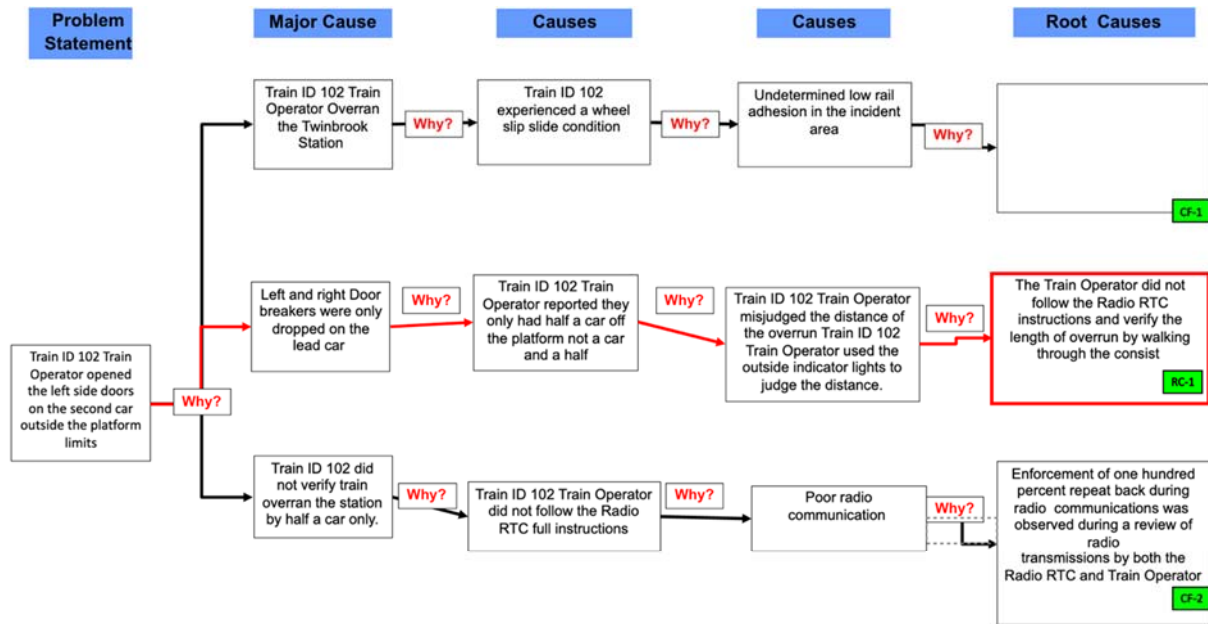
Attachment 1 – Root Cause page 1 of 1.

The probable cause for the Station Overrun and subsequent Improper Door Operation on January 19, 2022, was an undetermined low rail adhesion that degraded its stopping performance while traversing Twinbrook Station, resulting in Train ID 102 Train Operator overrunning the station by 130 feet. After the Station Overrun, Train ID Train Operator experienced a human factors failure, possibly due to pressure of the Station Overrun and failed to complete the overrun length verification prior to exercising the door operation. A Contributing Factor to the incident was an improper repeat-back by the Train Operator that was not enforced by the Radio RTC.
