## **WMSC Commissioner Brief: W-0162 – Improper Door Operation – Fort Totten Station – January 7, 2022**

**FINAL REPORT OF INVESTIGATION A&I E22015**

# Fort Totten Station – Improper Door Operation

January 7, 2022

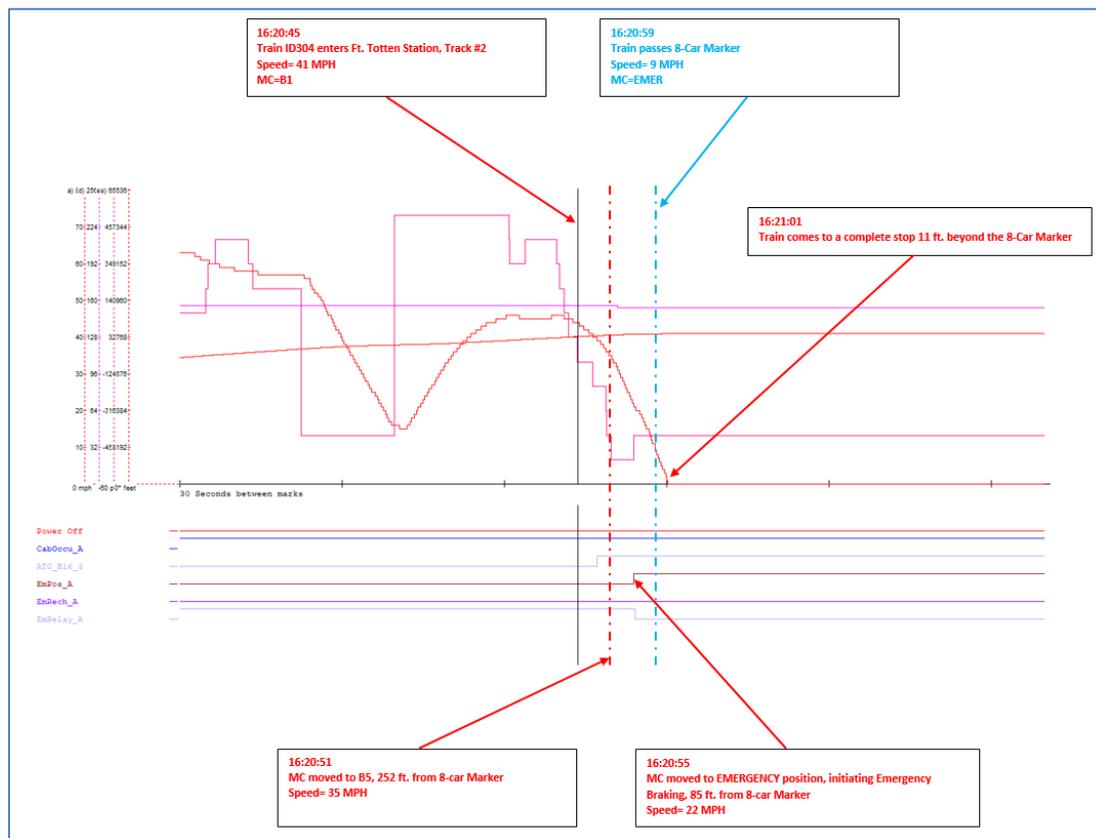
IIT CMOR analysis of the VMS data found that the train entered Fort Totten Station, Track 2 in a "B1" Braking mode at a speed of 41 mph. The Master Controller (MC) was moved to the emergency position, initiating emergency braking approximately 85 feet from the 8-Car Marker. The train overran the station by passing the 8-Car marker at approximately 9 mph with the MC in the Emergency Position. The train came to a complete stop after traveling approximately 11 feet beyond the 8-Car Marker.

Figure 1 – IIT CMOR VMS analysis showing Train Operator's actions.

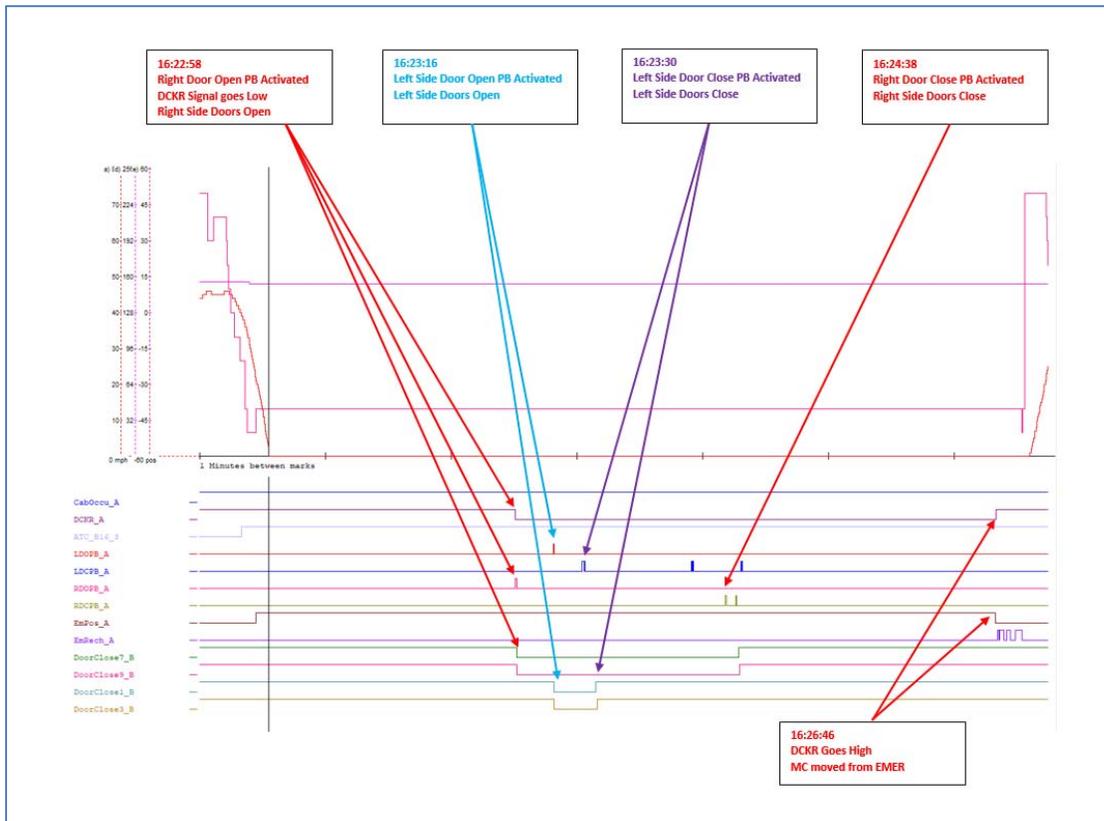
After coming to a complete stop, the VMS data revealed the Right-Side Door Open Push Button signal triggers high, then the Left-Side Door Open Push Button signal goes high, indicating both side doors were commanded to open. The VMS data also illustrated the Door Close Signals on both sides going low after the Left and Right Door Open Push Buttons were activated, indicating the doors on both sides were opened simultaneously.

The Door Close Push Buttons were activated first on the Left-Side, then the Right-Side and doors closed. Once the brake pipe was charged and all doors closed, locked indication (DCKR) was achieved, and the MC was moved to a "P5" power mode. The train continued on to the next station.

Figure 2 – IIT CMOR VMS analysis showing Train Operator's door actions.

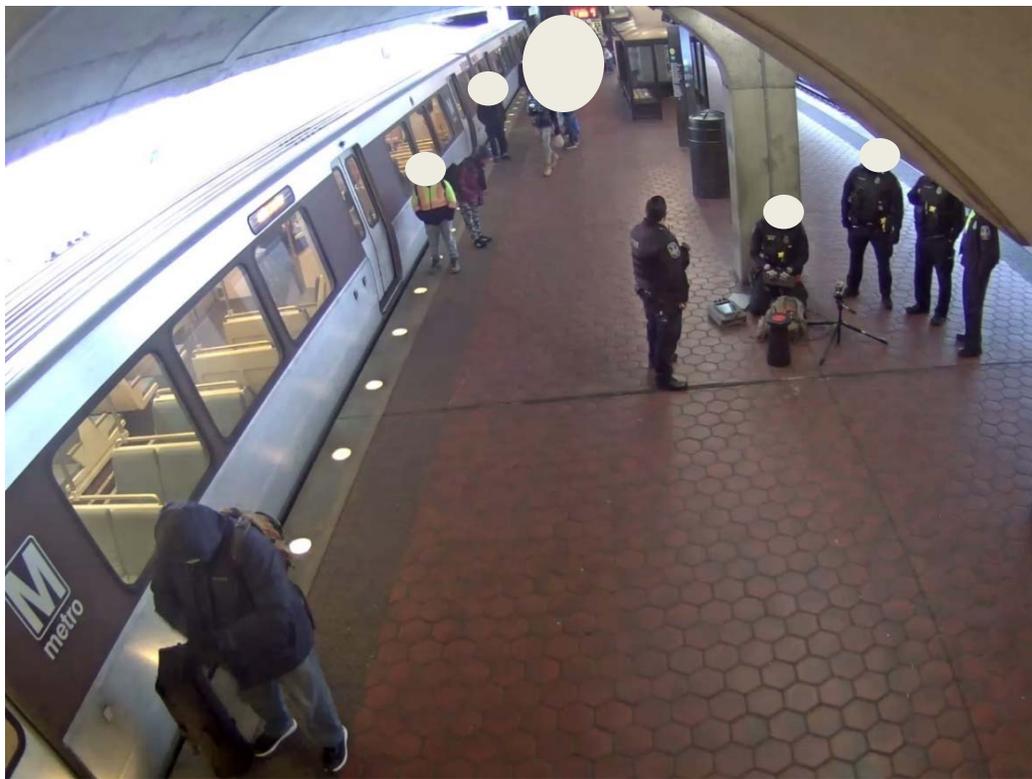
Image 1 – Train ID 304 properly berthed at Fort Totten Station, Track 2, at approximately 16:24:16 hours.

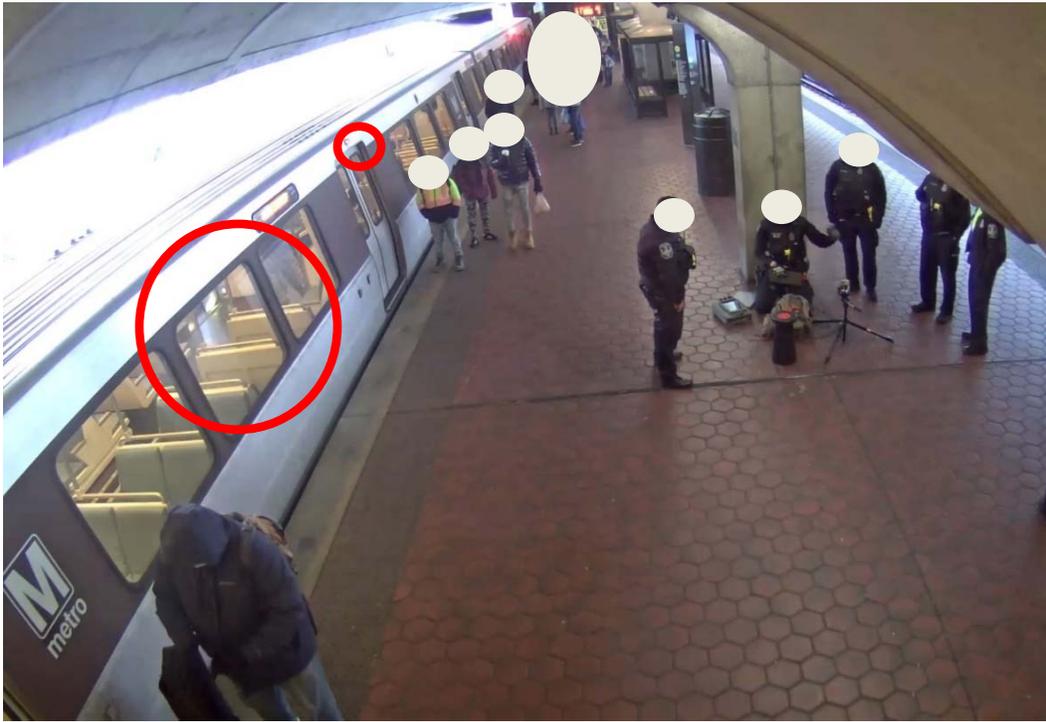
Image 2 – Train ID 304 right side doors (non-platform side) begin to open at Fort Totten Station, Track 2, at 16:24:22 hours. Door Open indicator light is illuminated.

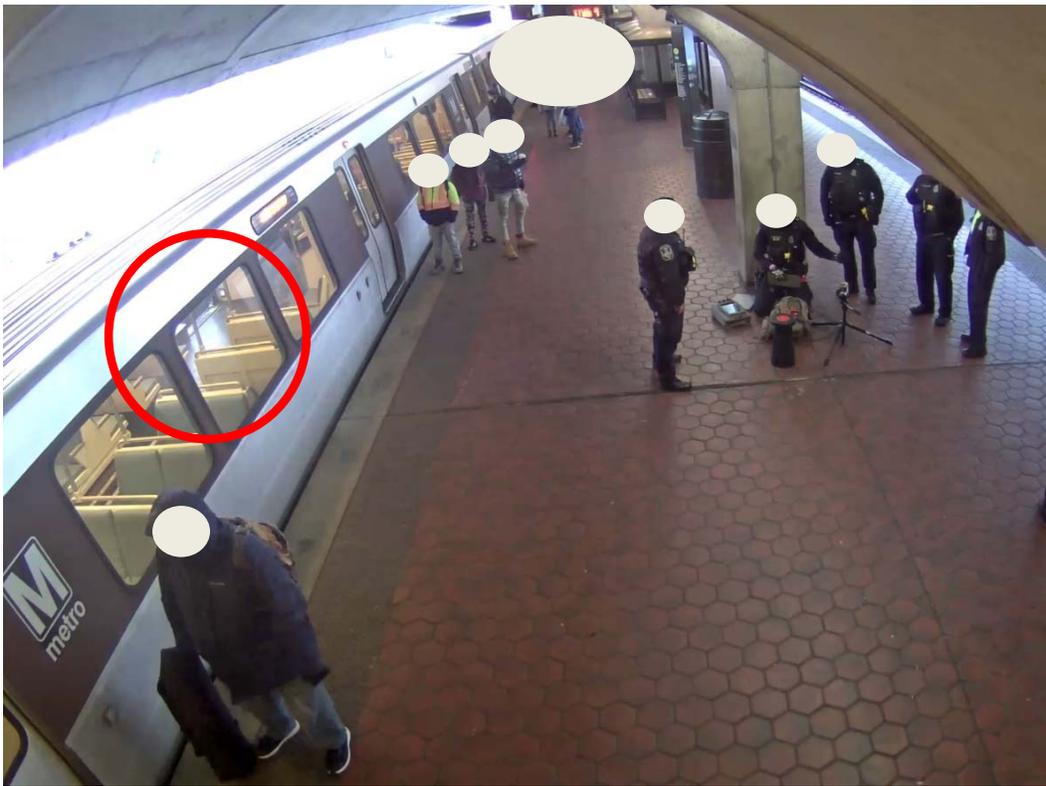
Image 3 – Train ID 304 right side doors on the non-platform side completely opened at approximately 16:24:22 hours.

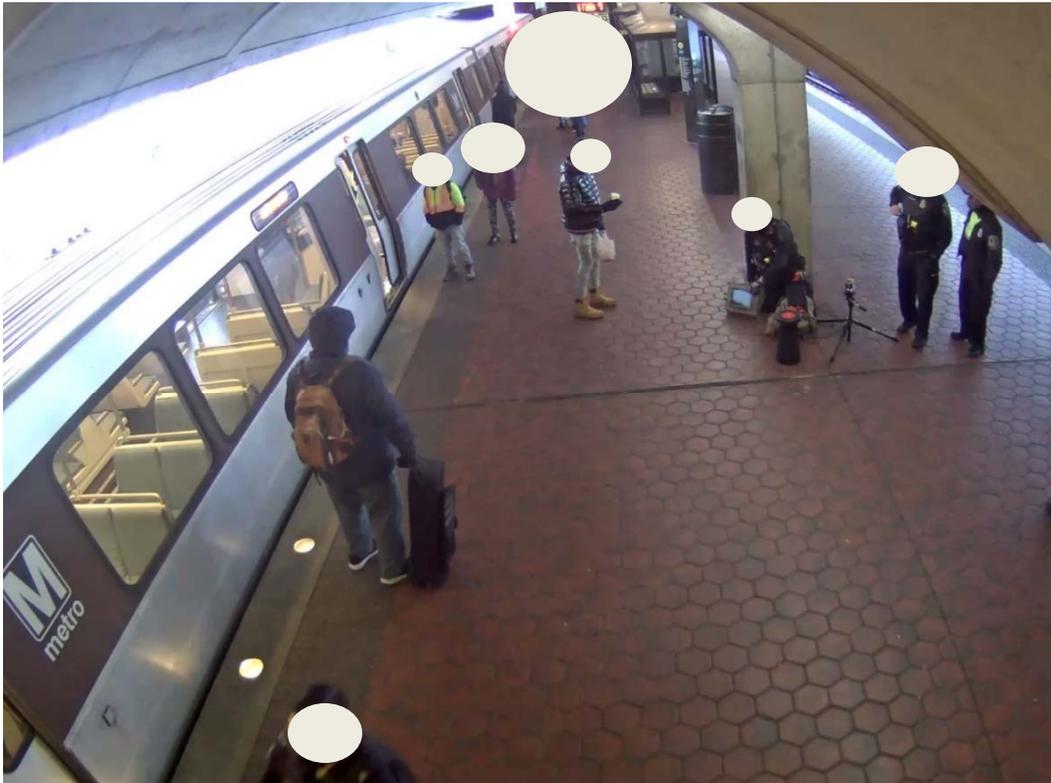
Image 4 – Train ID 304 left side doors on the platform side begin to open at Fort Totten Station, Track 2 at 16:24:40 hours.

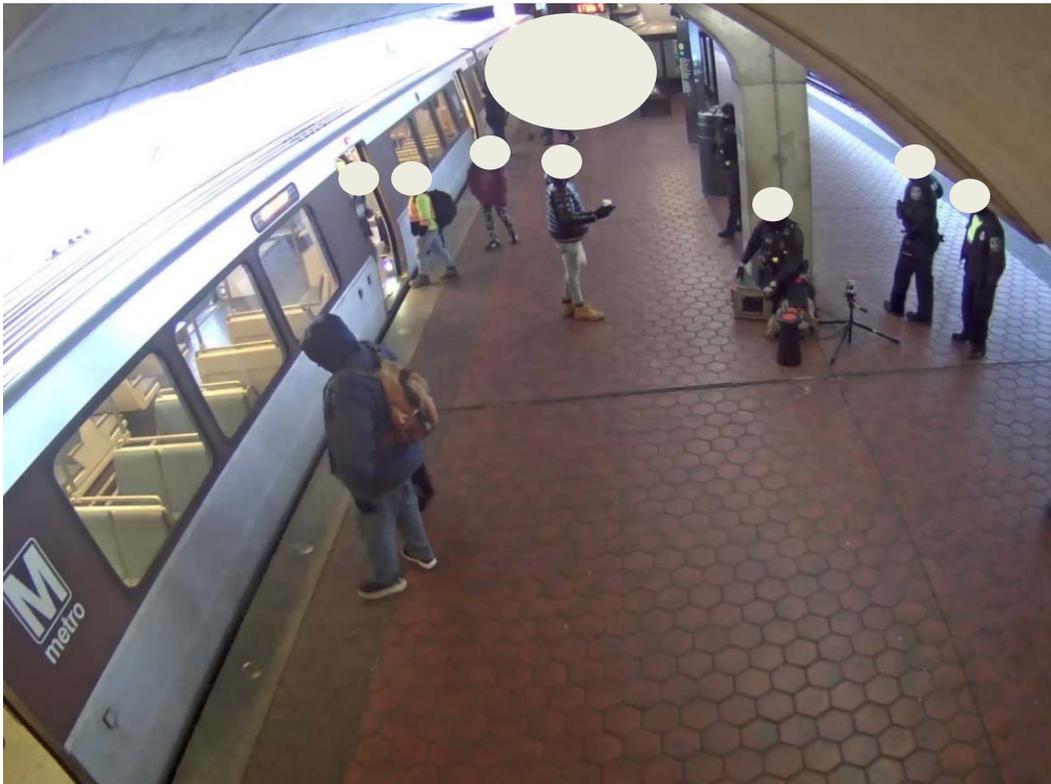
Image 5 – Train ID 304 left side doors on the platform side completely opened at Fort Totten Station, Track 2, at 16:24:42 hours.

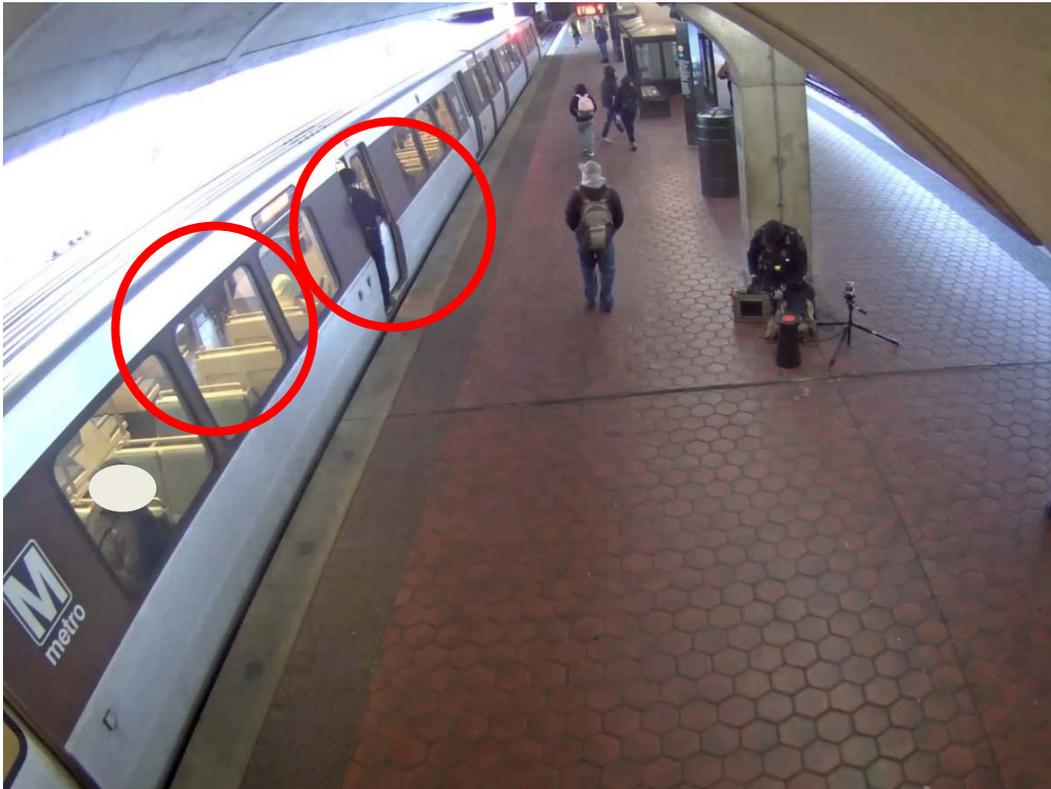
Image 6 – Train ID 304 left side doors (platform side) closed as MTPD personnel keep one door open. Doors on the non-platform side are completely opened at Fort Totten Station, Track 2, at 16:25:02 hours.

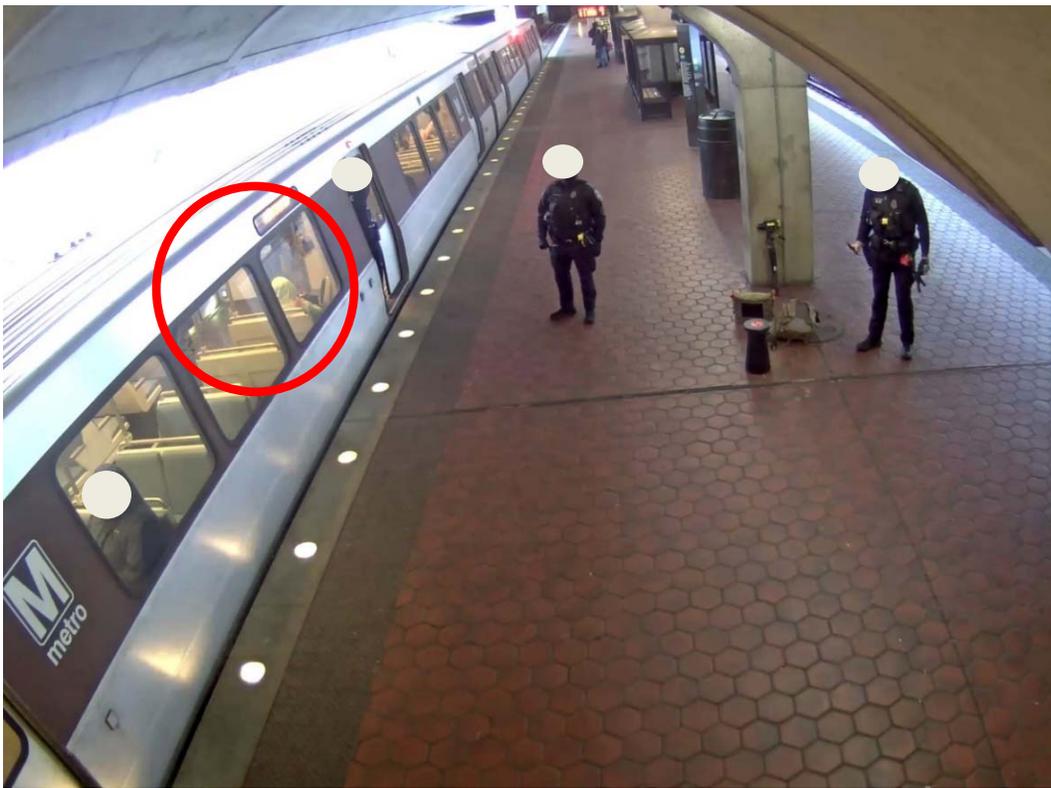
Image 7 – Train ID 304 right side doors (non-platform side) completely closed at Fort Totten Station, Track 2, at 16:26:08 hours.

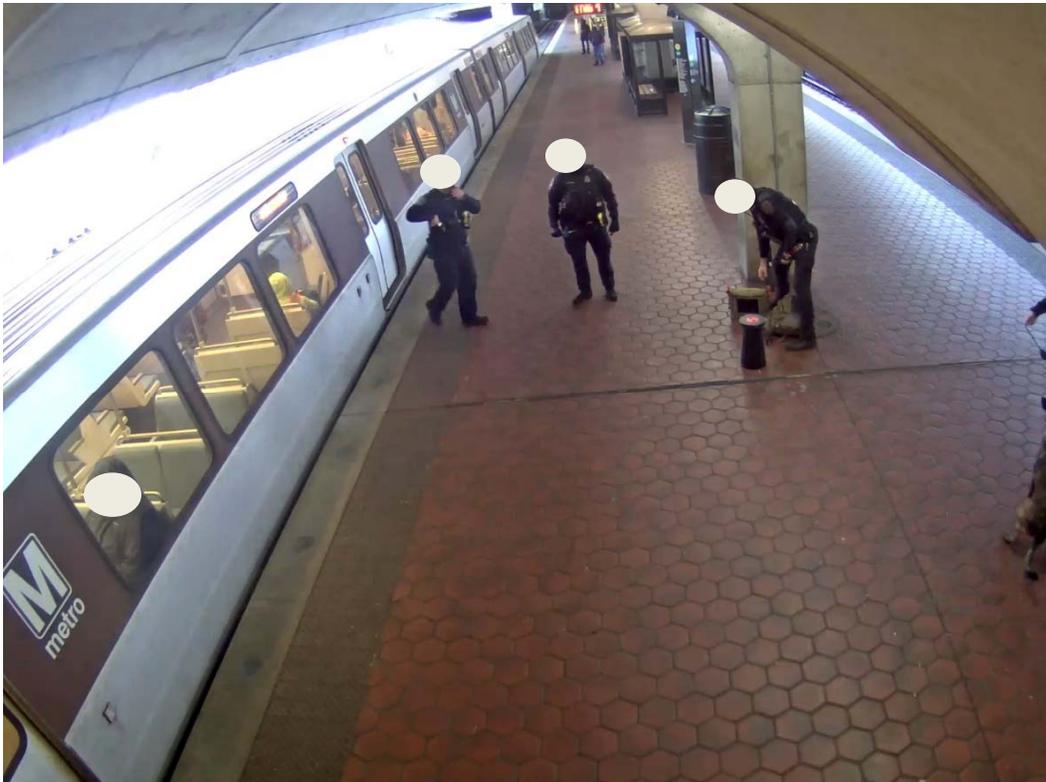
Image 8 – Train ID 304 right side doors (platform side) completely closed at Fort Totten Station, Track 2, at 16:26:16 hours.

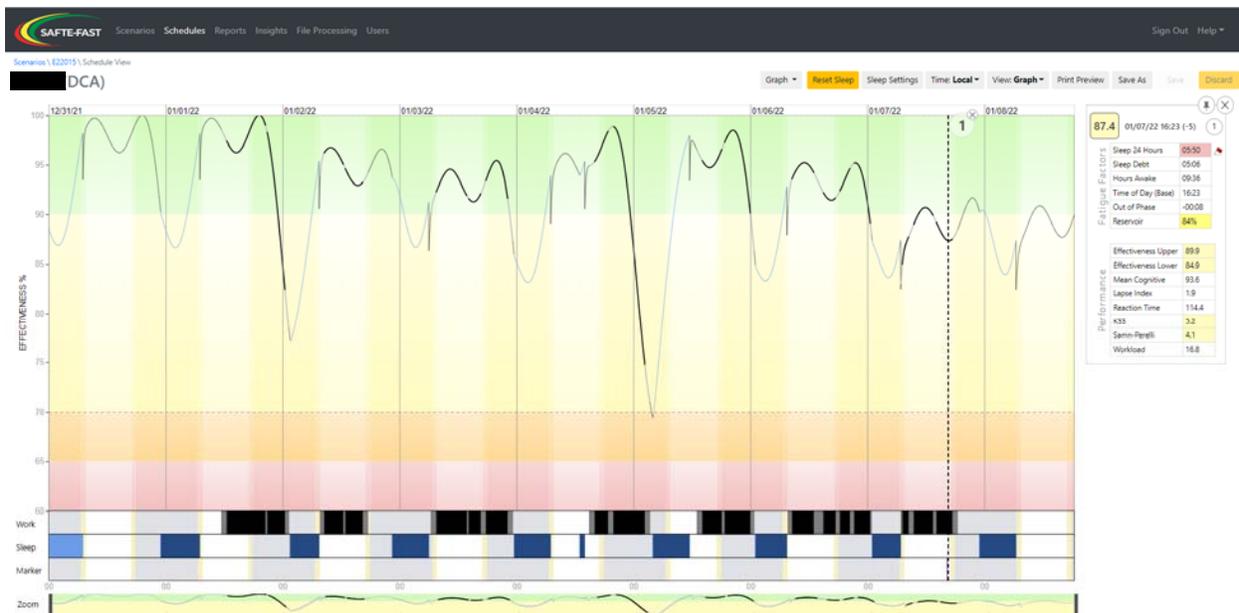
A biomathematical fatigue modelling application (SAFTE-FAST WebSFC) was used to further evaluate fatigue risk factors that may have been present in the Train Operator's schedule. The analysis was based on the Train Operator's work schedule, reported sleep from the day before the incident, and reported habitual sleep durations. Estimated performance effectiveness at the time of the incident was 87.4%. Specifically, the analysis identified short sleep duration in the last 24 hours as a factor contributing to an increased risk of fatigue at the time of the incident.

Modeling analysis output shows estimated performance effectiveness during the incident work shift and for the week leading up to the work shift, based on the employee work and reported sleep schedule. Estimates were based on the Train Operator's work schedule, reported sleep from the day preceding the incident, and reported habitual sleep durations (7.5 hours a day). Bold portions of the modeled curve show work (in black) and sleep times (in blue). Effectiveness is shown on the vertical axis, with colored fields in the chart background signifying ranges of effectiveness scores including high effectiveness (>90%) in green, and low effectiveness (<65%) in red. Time is shown on the horizontal axis. Markers for work and sleep times are shown in the lanes above the time of day on the horizontal axis.
