WMSC Commissioner Brief: W-0163 – Improper Movement – Suitland Station – December 7, 2021

FINAL REPORT OF INVESTIGATION A&I E21638

Suitland Station – Improper Vehicle Movement

FINAL REPORT OF INVESTIGATION E21638

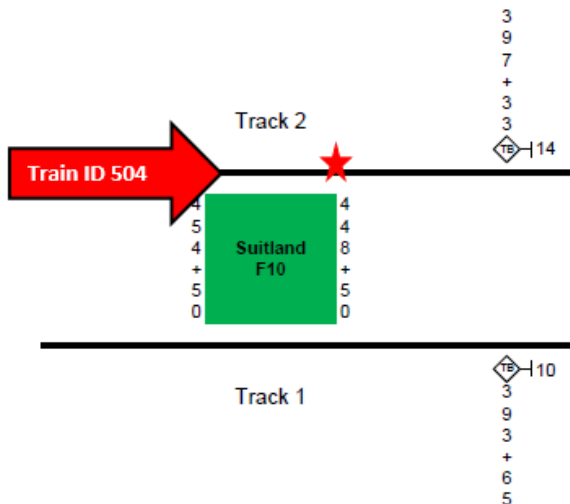
Field Sketch/Schematics*

Suitland Station, Track 2

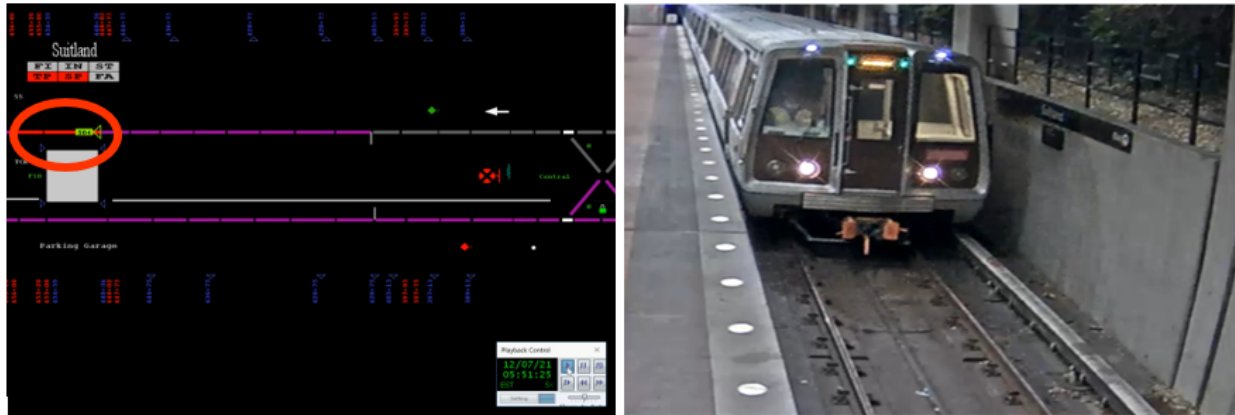
Image 1 – AIMS Display depicting Train ID 504 on the platform and The Train Operator of Train ID 504 moving the train in back on the platform at Suitland Station, Track 2 after the station overrun.

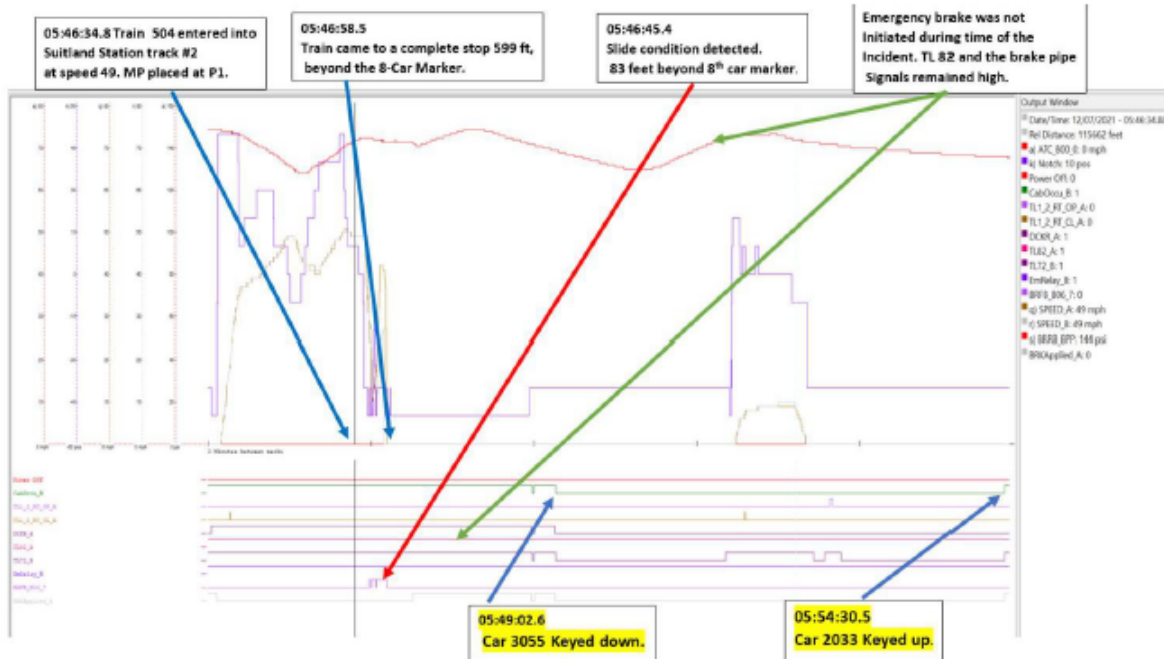
3055 VMS DATA:

"IIT has completed the analysis of data retrieved from the reported consist for a station overrun. Train ID 504, lead car 3055 entered Suitland Station, track 2 at a speed of 49 MPH with the master controller in the P1 mode. The regulated speed in approach to Suitland Station is 40 MPH and maximum authorized speed is 55 MPH. The Automatic Train Control (ATC) Subsystem was not communicating with the VMS at time of the incident, the trains speed commands were not available. The lead car experienced a slide condition³ after the train overran the station at approximately 83 feet after the 8-car marker. The slide was observed on all cars. While experiencing sliding conditions, the master controller was moving between B2 and B5 braking mode and the train eventually came to a complete stop 599 feet beyond the 8-car marker. Lead car 3055 keyed down then keyed up on the trailing car 2033. The consist moved back onto the platform at Suitland Station, track 2 and came to complete stop 495 feet into the platform. The

05:46:45.4 hours	Slide conditions were detected 83 feet beyond 8-car marker. The train speed was 26MPH, with the master controller in a B5 braking mode.

05:46:49.0 hours	The master controller moved to a B2 braking mode 167 feet beyond the 8-car marker. The train speed was 13MPH (with slide conditions).
05:46:50.0 hours	The master controller moved to a B5 braking mode 192 feet beyond the 8-car marker. The train speed was 18MPH (with slide conditions).

05:49:50.6 hours	The master controller moved to a B4 braking mode 207 feet beyond the 8-car marker. The train speed was 16MPH. (with slide condition)
05:46:57.5 hours	The master controller moved to a B5 braking mode 573 feet beyond 8-car marker. The train speed was 18MPH (with slide conditions).

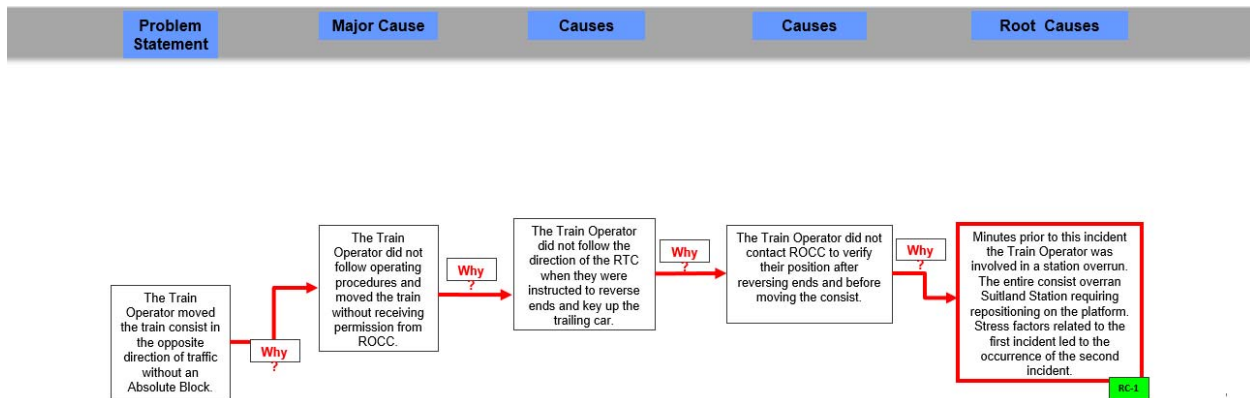
Appendix D - Root Cause Analysis

The probable cause of the Improper Vehicle Movement event was stress factors related to the station overrun incident that occurred minutes prior; the Train Operator was involved in a station overrun and the entire consist stopped outside of the platform limits. The Train Operator appears to have experienced performance pressure, taking action beyond what was authorized by the RTC. In addition, the probable cause of the AOM failing to report the Improper Vehicle Movement event to the Operations Manager (OM) and/or the Incident Management Official (IMO) is also likely attributed to performance pressure to maintain service and monitor several concurrent events, including a down track circuit and clamped switch.
