WMSC Commissioner Brief: W-0164 – Improper Roadway Worker Protection – Orange Line – January 29, 2022

Washington Metro Area Transit Authority
Department of Safety (SAFE)
FINAL REPORT OF INVESTIGATION A&I – E22053

Landover Station – Improper RWP

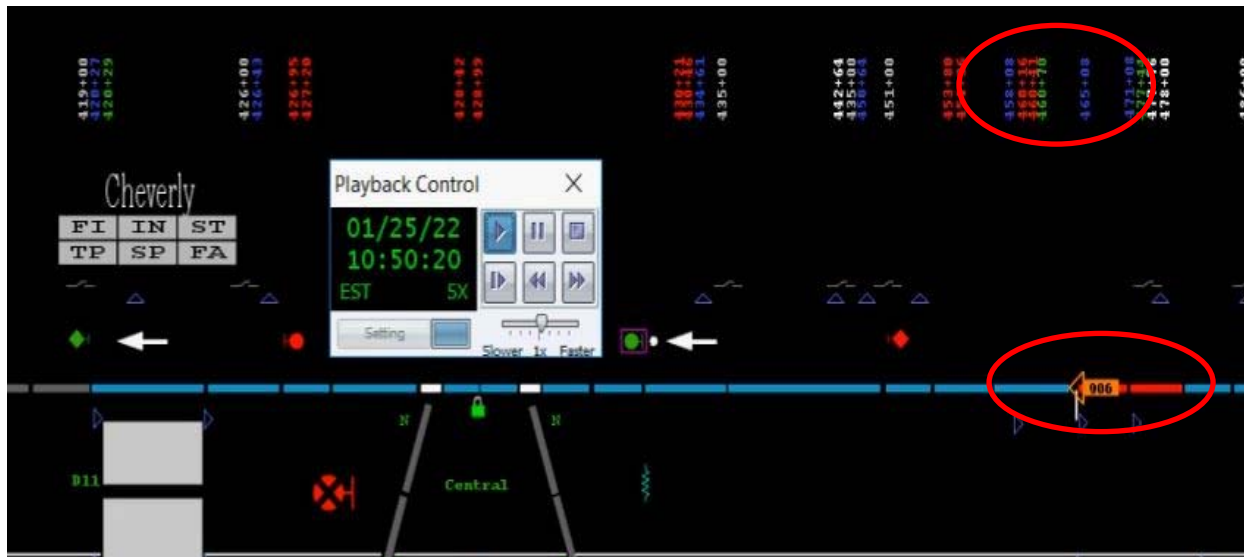
Data system playback shows that two trains passed the hot spot location during the time the crew was walking in this segment. The crew had sufficient time from receiving permission to enter the roadway to the time that the trains passed the hot spot to have reached the hot spot location. The RWIC reported in an interview that the crew was conducting their inspection while walking in the roadway. Neither train operator reported a near miss. The Watchman/Lookout and other members of the work crew also did not report any safety issues. There were no available Metrorail video or other systems that could confirm the location of the work crew when these trains passed them.

Figure 2: Shows the first train that passed the FT area after the RWIC requested permission to continue the fence inspection.

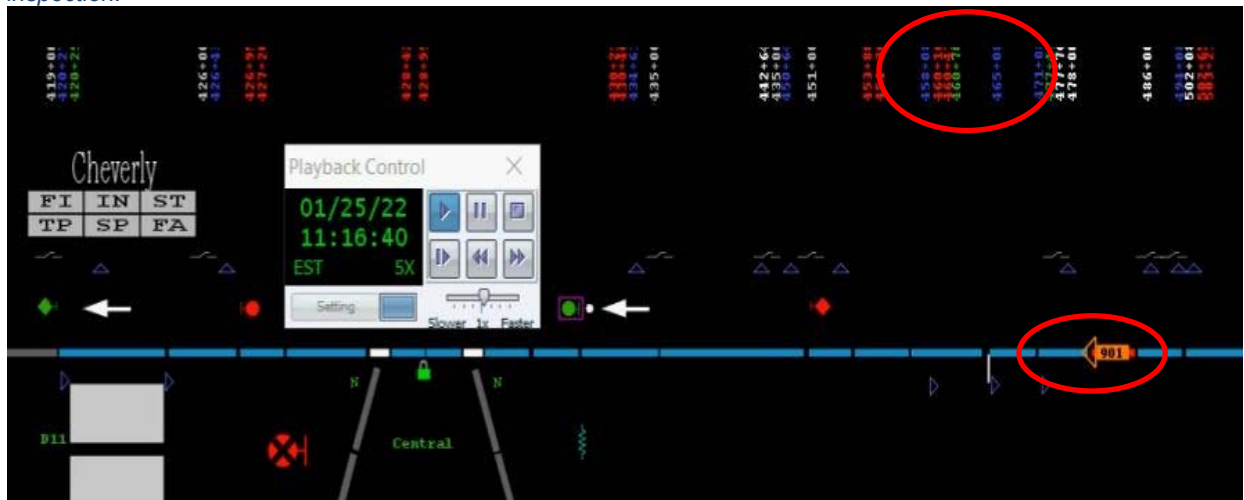
Figure 3: Shows the second train that passed the FT area after the RWIC requested permission to continue the fence inspection.

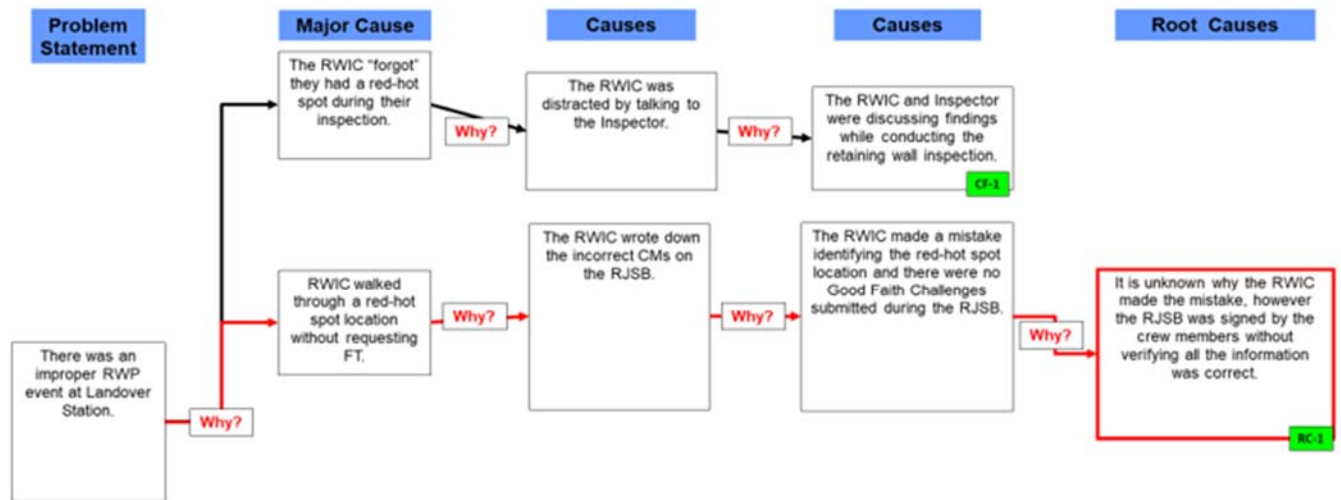
Root Cause Analysis

The probable cause of the Improper Roadway Worker Protection (RWP) event on January 25, 2022 was human factors error due to complacency. The RWIC failed to identify the correct red hot spot location during their RJSB before conducting the retaining wall inspection and then failed to request foul time protection at either area. In addition, no crew member raised a Good Faith Challenge at the RJSB or when traversing the roadway from Cheverly to Landover Station despite a red hot spot being noted on the RJSB form.

Corrective Action Code	Description	Responsible Party	Due Date
98071_SAFE CAPS_TRST_001	Develop and issue a safety bulletin to reiterate the importance of checking the information on the RJSB form against their own RWP Quick Access Guide (required of each member of the crew).	TRST SRC	6/1/2022
