WMSC Commissioner Brief: W-0165 – Collision at Potomac Avenue Station – January 9, 2022

FINAL REPORT OF INVESTIGATION A&I E22019

Date of Event:	01/09/2022
Type of Event:	Person Struck by Train
Incident Time:	19:51 hours
Location:	Potomac Avenue Station, Track 2
Time and how received by SAFE:	19:57 hours, SAFE MAC
WMSC Notification Time:	19:57 hours
Event Scene Release	21:52 hours, WMSC
Responding Safety Officers:	WMATA SAFE: No WMSC: No Other: N/A
Rail Vehicle:	Train ID 903 L3213-3212 x 2003-2002 x 3245-3244T
Injuries:	One transport for medical attention. Non-life-threatening injury. Right Leg Lacerations
Damage:	Train-to-Wayside Communication Antenna
Emergency Responders:	Office of Rail Transportation (RTRA), Metro Transit Police Department (MTPD), District of Columbia Fire and Emergency Services (DCFEMS), Office of Car Maintenance (CMNT), Emergency Response Team (ERT), and Office of Plant Maintenance (PLNT).
SMS I/A Incident Number:	20220109#97784MX

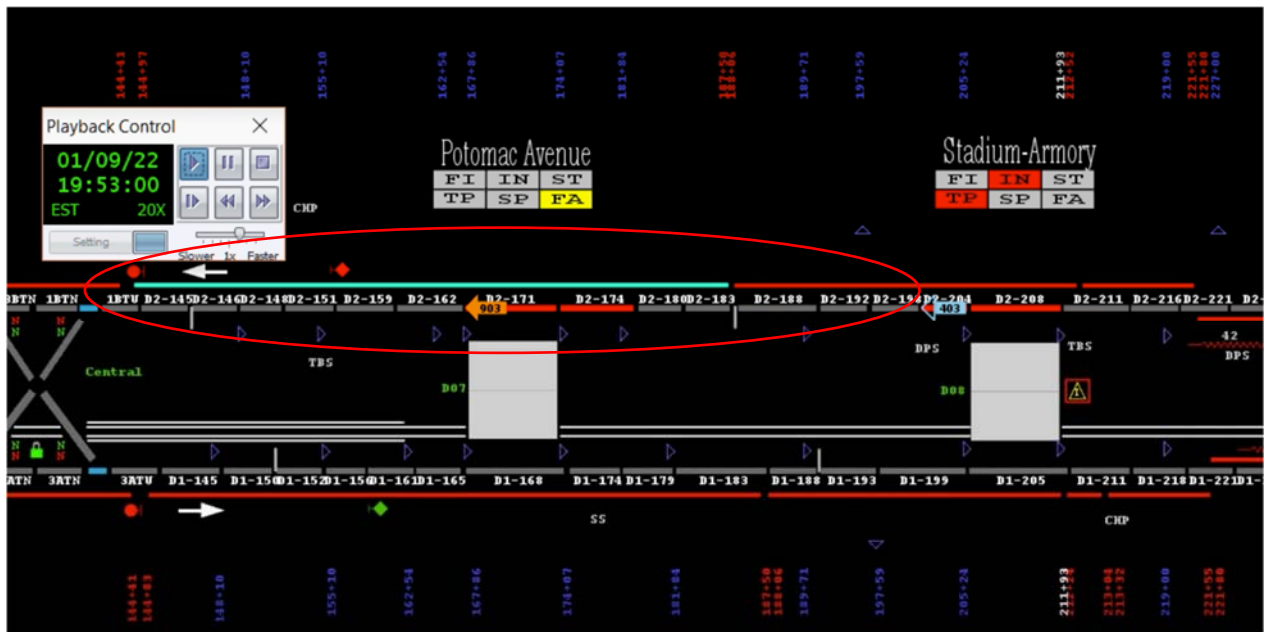
Figure 1- AIMS Playback showed third rail power de-energized

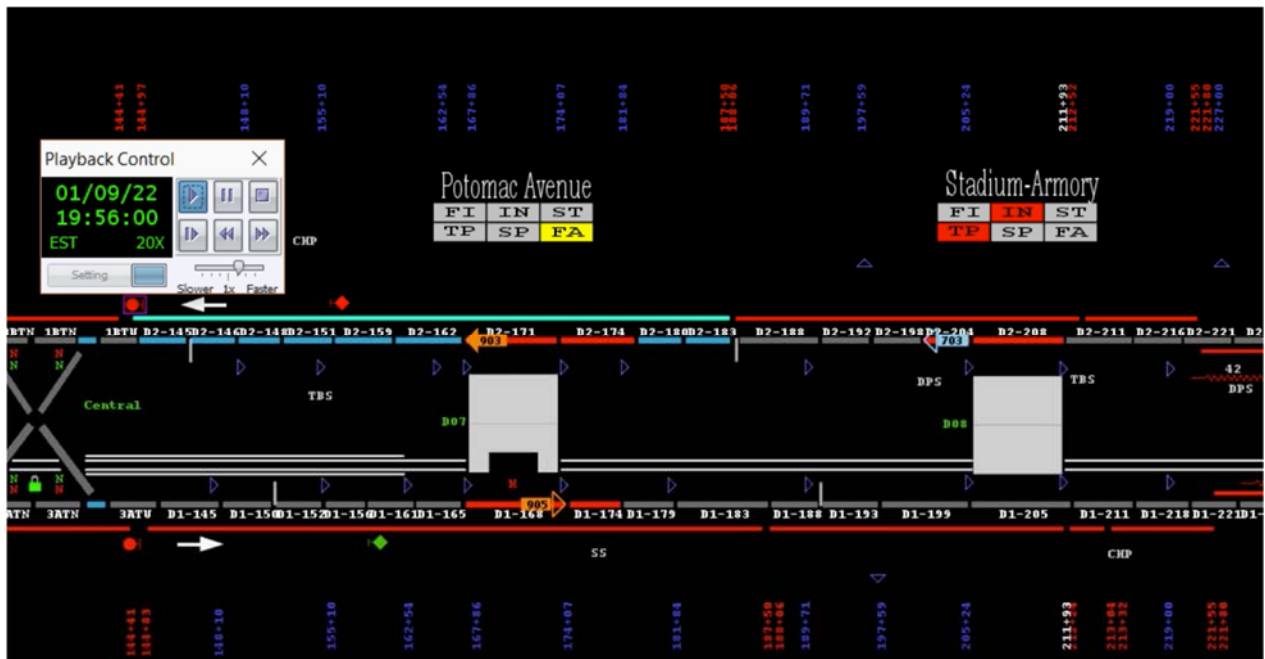
Figure 2 - Train ID 905 serviced Potomac Avenue Station at approximately 19:56 hours.

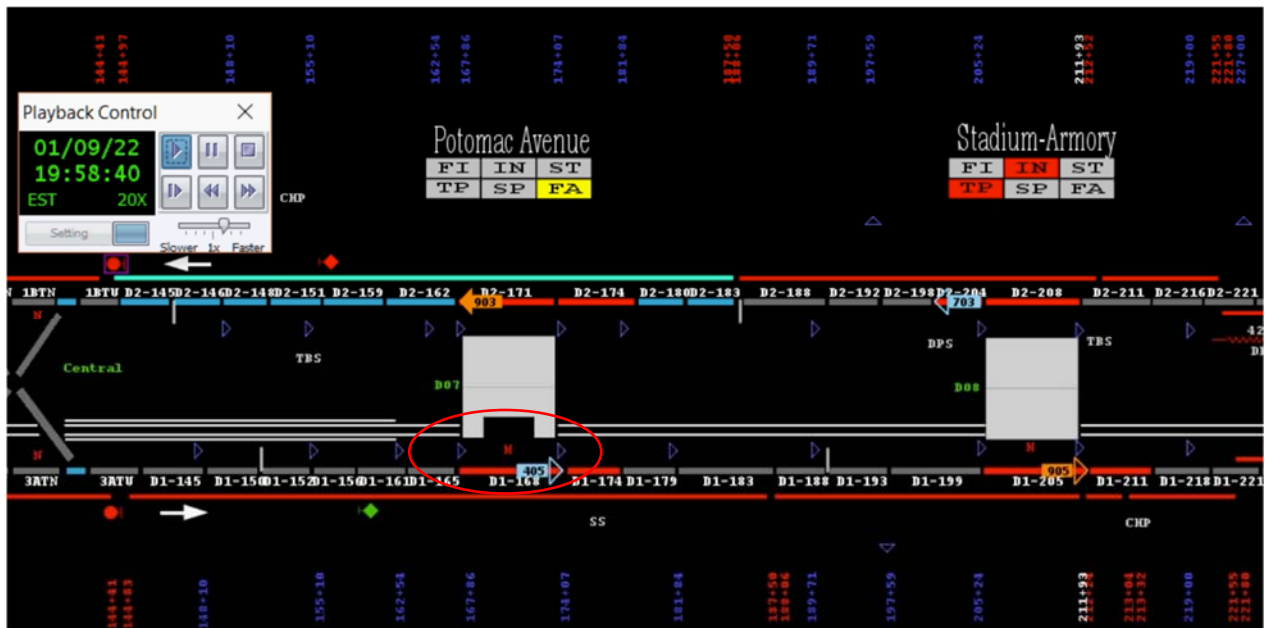
Figure 3 - Train ID 405 Serviced Track #1 Potomac Avenue Station.

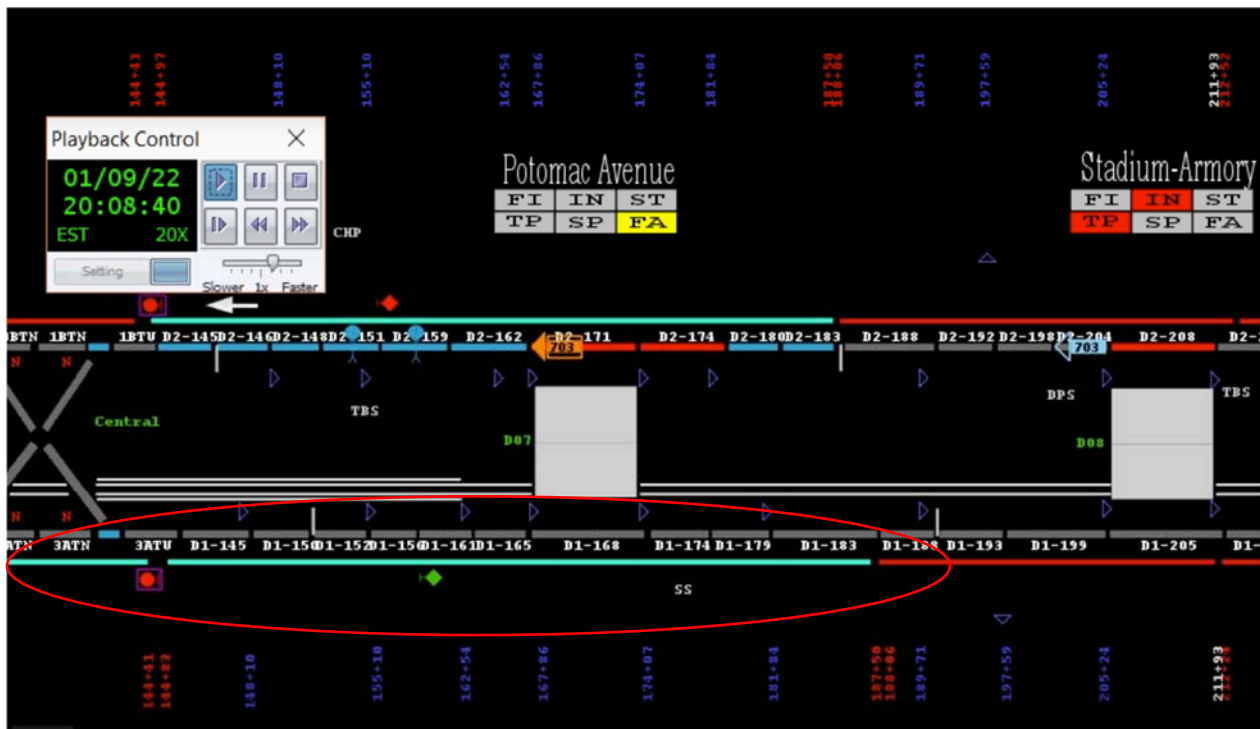
Figure 4 - Third rail power de-energized on Track #1 at 20:08:40 hours.

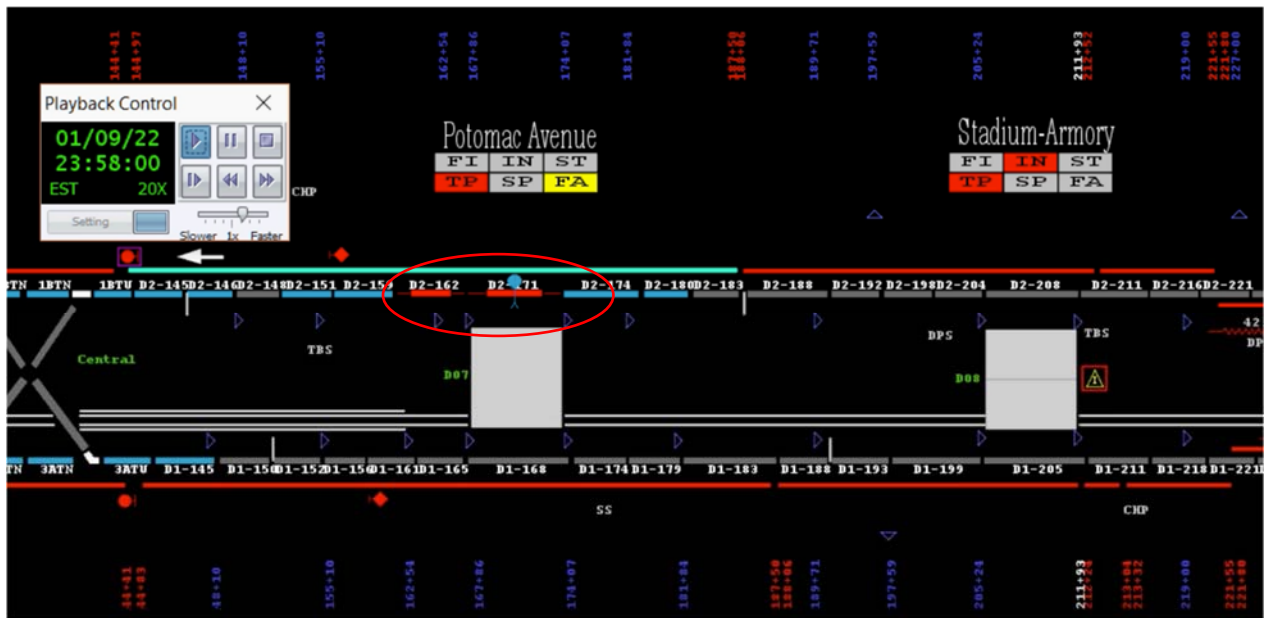
Figure 5 - Red Tag established with shunts placed at approximately 23:58 hours.

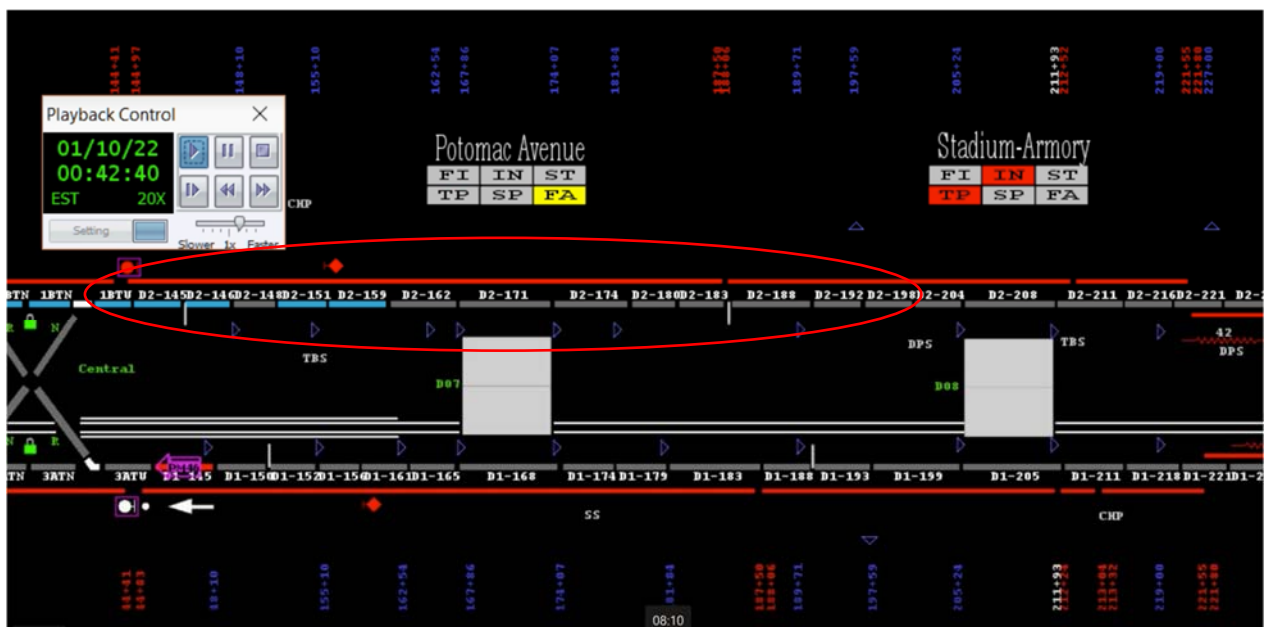
Figure 6 - Power Re-energized on Track #2 at approximately 00:42 hours.

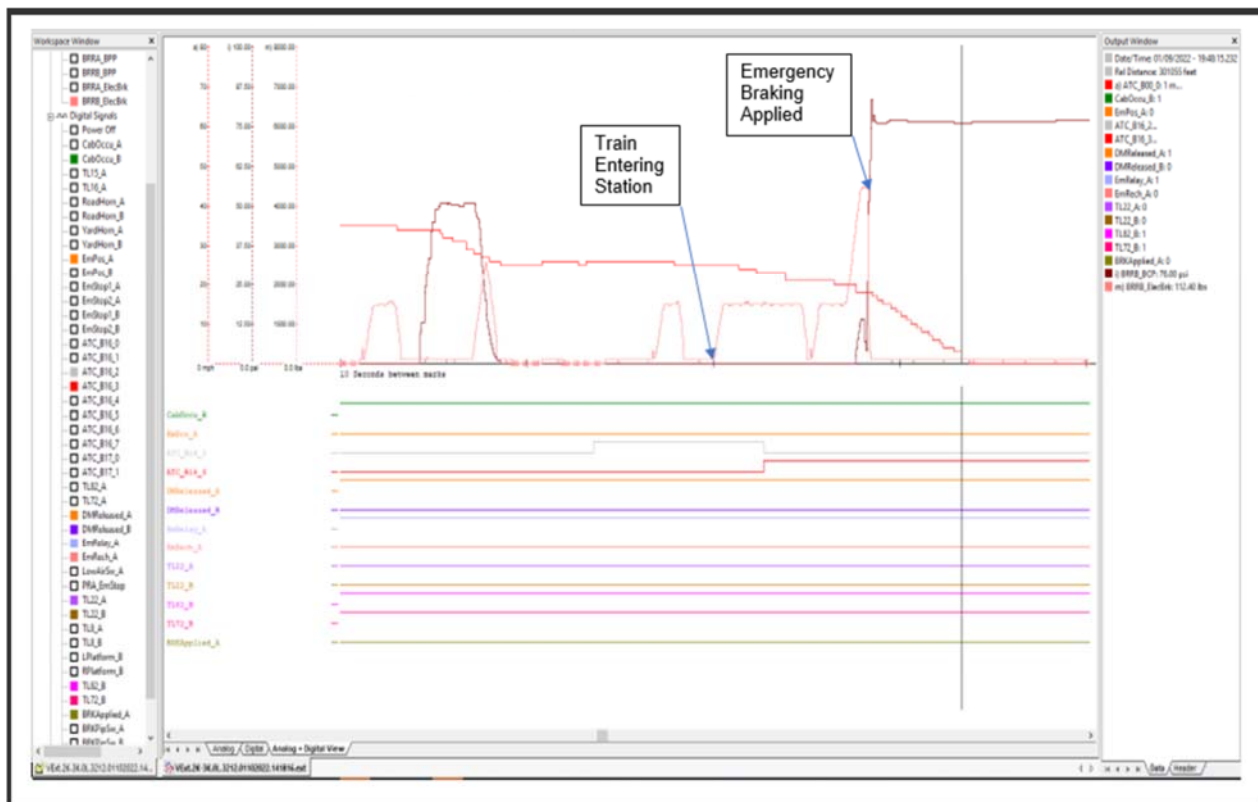
Diagram 1 - Event Recorder Graphical Analysis

Time	Description
19:48:01 hours	Train ID 903 entered Potomac Avenue Station, traveling at 25 mph.
19:48:10 hours	Train ID 903 speed reduced to 18 Mph when Emergency braking is activated and applied.
19:48:15 hours	The train recorded zero speed.

Based on the VMS and ER data, all the subsystems' safety components such as Automatic Train Control (ATC), brakes, and propulsion acted as designed. There were no faults with the train that contributed to this event.
