WMSC Commissioner Brief: W-0166 - Collision - Bethesda Station - January 29, 2022

Washington Metro Area Transit Authority Department of Safety (SAFE) FINAL REPORT OF INVESTIGATION A&I – E22060

Date of Event:	01/29/2022
Type of Event:	A-3 Collision
Incident Time:	13:58 hours
Location:	Bethesda Station, Track 1
Time and How received by SAFE:	13:59 hours MAC Desk
WMSC Notification Time:	14:07 hours (Event Scene Release issued)
Responding Safety Officers:	WMATA: No
	WMSC: No
	Other: No
Rail Vehicle:	L3112-3113x3211-3210x3075-3074
Injuries:	Yes
Damage:	Minor
Emergency Responders:	Metro Transit Police Department (MTPD), Office of Rail Transportation (RTRA), Office of Car Maintenance (CMNT), Montgomery County Police Department (MCPD), Montgomery County Fire and Rescue Service (MCFRS), Emergency Response Team (ERT), Mission Assurance Coordinator (MAC)
SMS I/A Number	20220129#98115

Bethesda Station - Collision

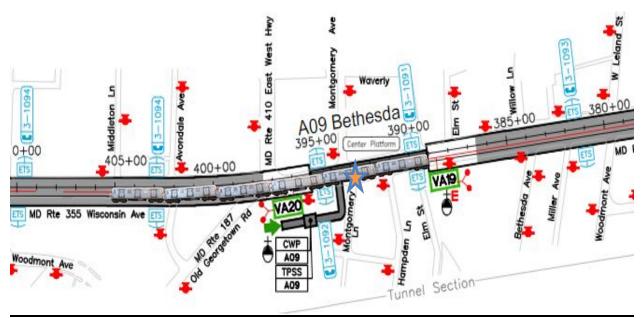
Figure 1: This image shows the approximate location where the customer was removed from underneath the second car, 3113.

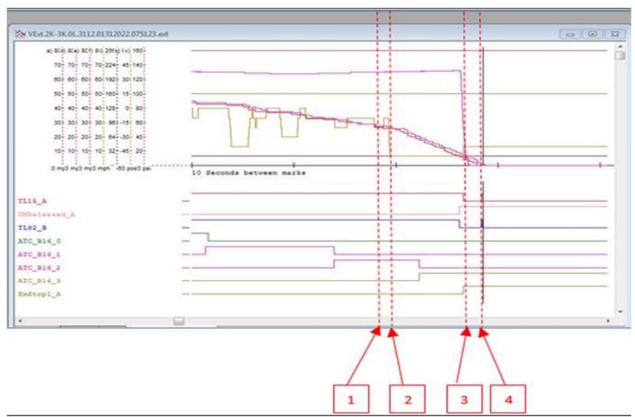
- 1 13:49:02 Train entered the A10-01 platform (Bethesda) with 26mph, MP in B2 position
- 2 13:49:03 After traveled for around 35-40 feet master controller was moved to B5 position.
- 3 13:49:09 After 165 feet, train slowed down to 5mph, dead man was released and Emergency push button was depressed, emergency brake applied.
- 4 Train come to full stop after 2.1sec. (time 13:49:11)

Figure 2: According to the data analysis train reacted as it is designed to do. No train anomalies related to the incident shown.

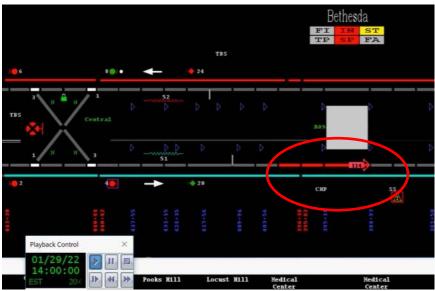
Figure 3: This image shows when third power was initially deenergized.

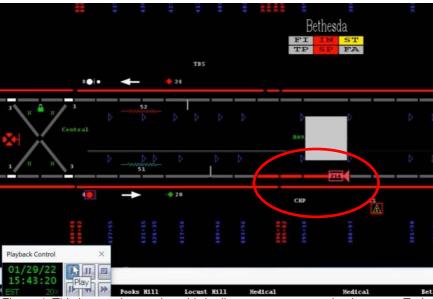
Figure 4: This image shows when third rail power was reenergized to move Train ID 714 so ERT could complete their inspection.

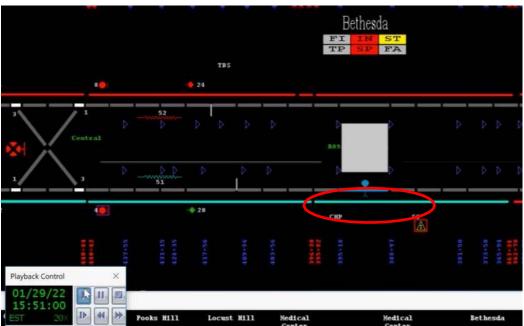
Figure 5: This image shows when third rail power was deenergized so the ERT could complete their inspection.

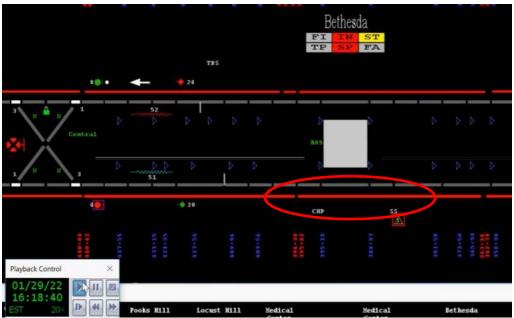
Figure 6: This image shows when third rail power was reenergized at the conclusion of the event.
