## **WMSC Commissioner Brief: W-0168 – Collision – Fort Totten Station – February 25, 2022**

**FINAL REPORT OF INVESTIGATION A&I E22124**

<b>Date of Event:</b>	02/25/2022
<b>Type of Event:</b>	Person Struck by Train
<b>Incident Time:</b>	15:22 hours
<b>Location:</b>	Fort Totten Station, Track 2 Lower Level
<b>Time and how received by SAFE:</b>	15:25 hours, SAFE MAC
<b>WMSC Notification Time:</b>	16:43 hours
<b>Event Scene Release</b>	16:39 hours, WMSC
<b>Responding Safety Officers:</b>	WMATA SAFE: No WMSC: No Other: N/A
<b>Rail Vehicle:</b>	Train ID 301 L2065-2064.2060-2061.3000-3001T
<b>Injuries:</b>	One transport for medical attention, minor injury.
<b>Damage:</b>	None
<b>Emergency Responders:</b>	Office of Rail Transportation (RTRA), Metro Transit Police Department (MTPD), District of Columbia Fire and Emergency Services (DCFEMS), and Office of Car Maintenance (CMNT).
<b>SMS I/A Incident Number:</b>	20220225#8655MX

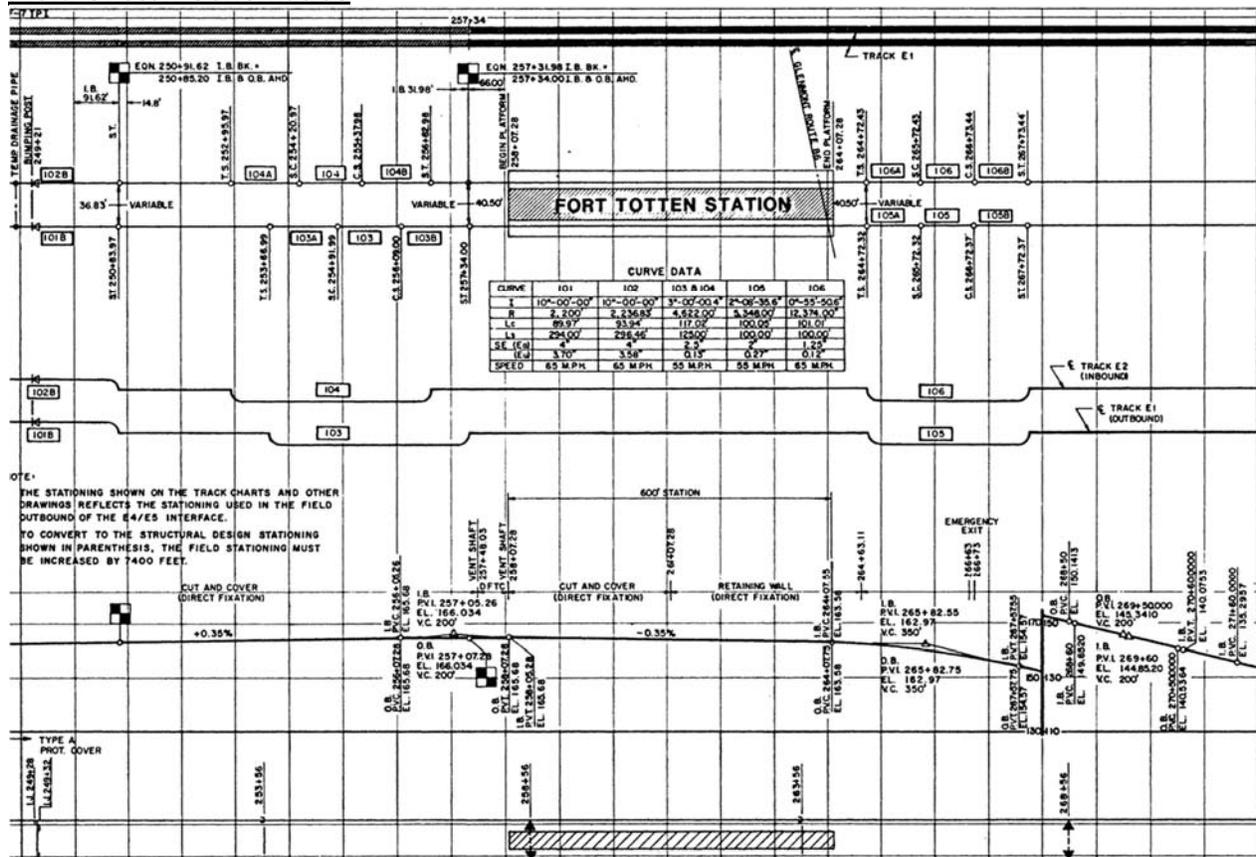
## Field Sketch/Schematics

Fort Totten Station, Track 2  
 Direct Fixation Track  
 Length of Curve – 100.05'  
 The Radius of Curve – 5.348'  
 Elevation – 163.5  
 Point of Vertical Intersect – E2 - 265+82  
 Point of Vertical Curve – E2 - 264+07 Beginning of Platform Limits  
 Point of Vertical Tangent – E2 - 267+57

The WMATA Quick Access Guide shows a restricted view curve on the Fort Totten station [approach end] platform limits near E2-264+00. The vertical curve ends within the Fort Totten Station platform limits. Based on the system of record data, the Train Operator had a limited view of Fort Totten Station, Track 2, while on approach. Train ID 301 Train Operator traveled at 31 mph when they entered Fort Totten Station. At 31 mph, Train ID 301 traveled at a rate of 44 feet per second, which minimized the opportunity to prevent the collision.

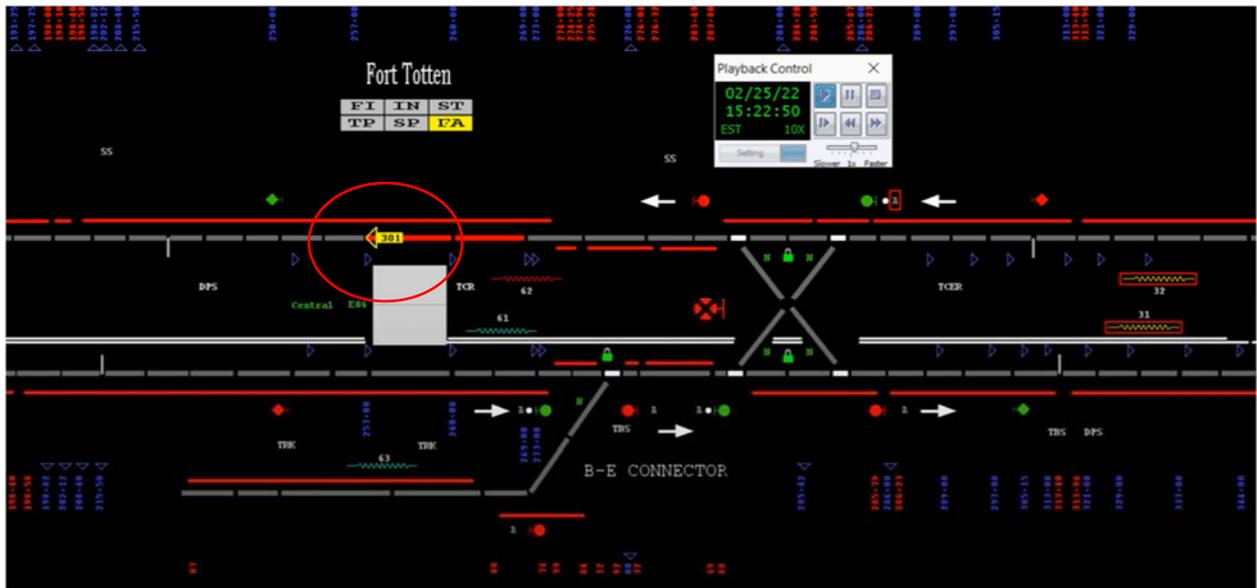
At approximately 15:22 hours on February 25, 2022, a Yellow Line train [Train ID 301] on Track 2, traveling inbound in Huntington Station's direction, entered Fort Totten Station platform limits at approximately 31mph and the Train Operator properly berthed their train at the 8-car marker.

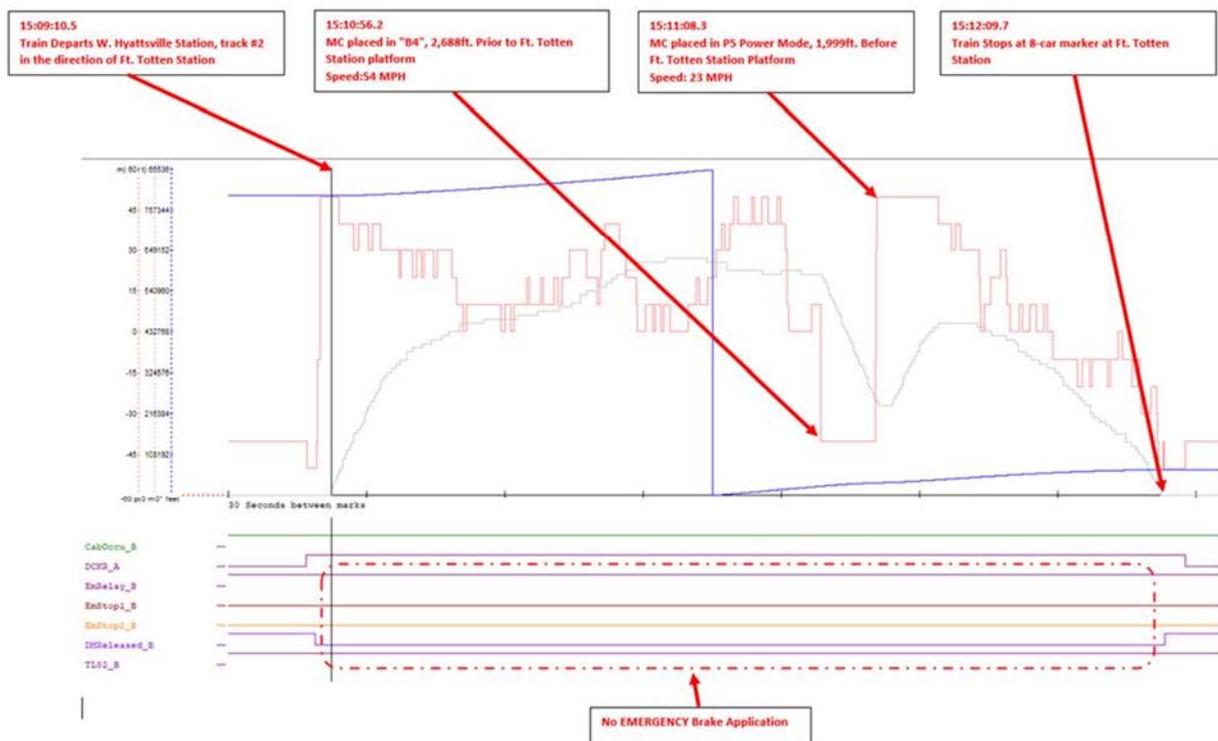
## Event Recorder (ER) Data Graph/Sequence of Events

Time	Description
15:09:10 hours	Train ID 301 departed West Hyattsville, Track #2, in the direction of Fort Totten
15:10:56 hours	Master Controller placed in "B4" Braking mode; Train was traveling at a speed of 54 MPH, 2,688 feet. prior to the Fort Totten Station platform

15:11:08 hours	After slowing to a speed of 21 MPH, the Master Controller is placed in "P5" Power Mode, 1,999 feet before Fort Totten Station Platform
15:11:46 hours	The train entered Fort Totten Station at a speed of 31 MPH with the Master Controller in the " <b>Coast</b> " Position

15:11:46 hours	Master Controller moved to "B1" Braking Mode, speed of 31 MPH, 9 feet onto Fort Totten station platform
15:11:51 hours	Master Controller moved to " <b>Coast</b> ," traveling at a speed of 15 MPH, 122 feet. from the 8-Car Marker

15:11:51 hours	Master Controller alternated between "B2" Braking and "B1" Braking Modes.
15:12:05 hours	Master Controller placed in a "B3" Braking Mode, Train speed of 10 MPH, 36 feet from the 8-car marker

15:12:09 hours	Master Controller moved to "B5" Braking mode, Train speed of 3 MPH.
15:12:09 hours	The train came to a complete stop at the 8-Car marker at Fort Totten station.
