WMSC Commissioner Brief: W-0172 – Improper Roadway Worker Protection – Shaw-Howard U Station – February 17, 2022

Washington Metro Area Transit Authority
Department of Safety and Environmental
Management (SAFE)
FINAL REPORT OF INVESTIGATION A&I – E22105

Shaw – Howard U Station – Improper RWP

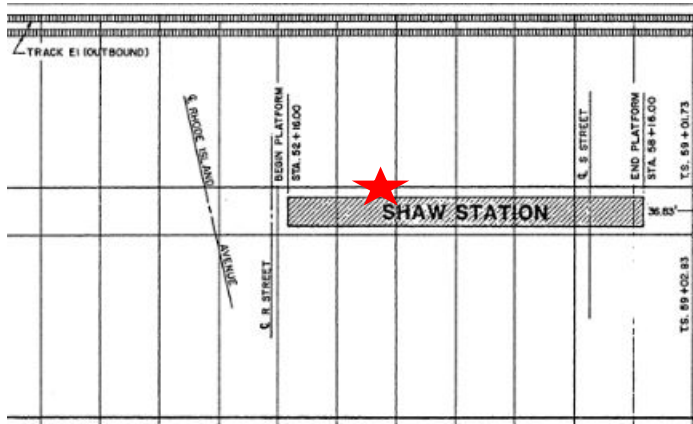
Field Sketch/Schematics

The red stars indicate the approximate location where the customer dropped their cellphone into the roadway.

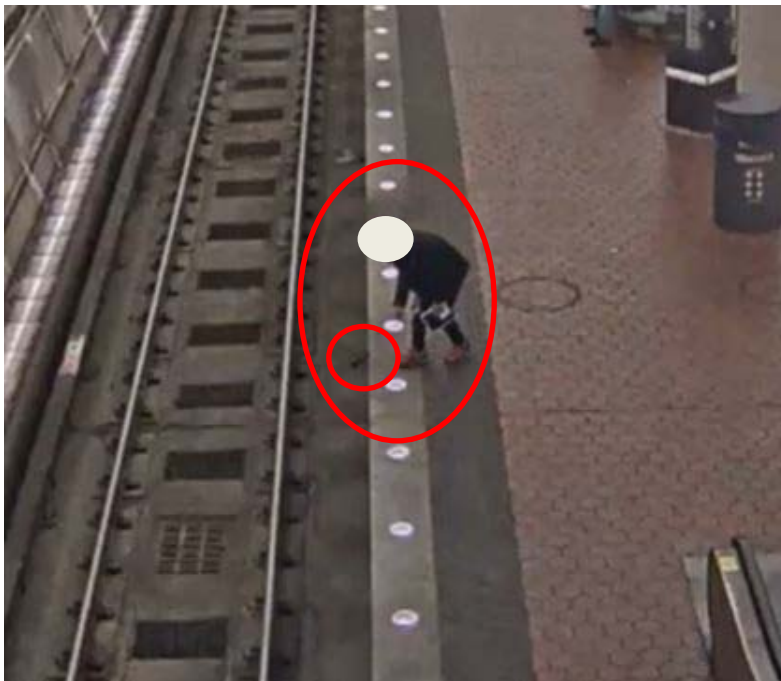
This image shows the customer's cellphone falling into the roadway, Track 1.

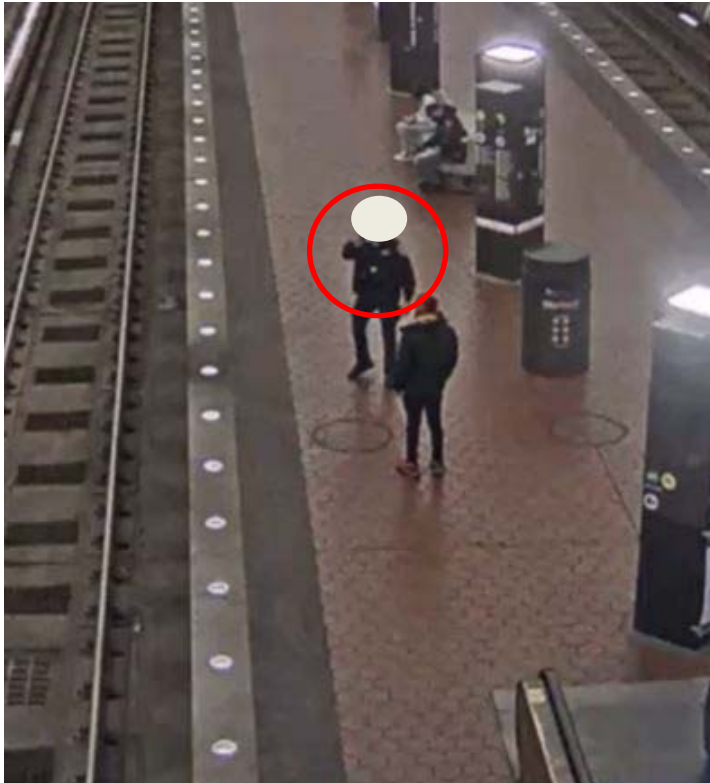
This image shows MTPD Officer #1 contacting the ROCC about the customer dropping their phone in the roadway.

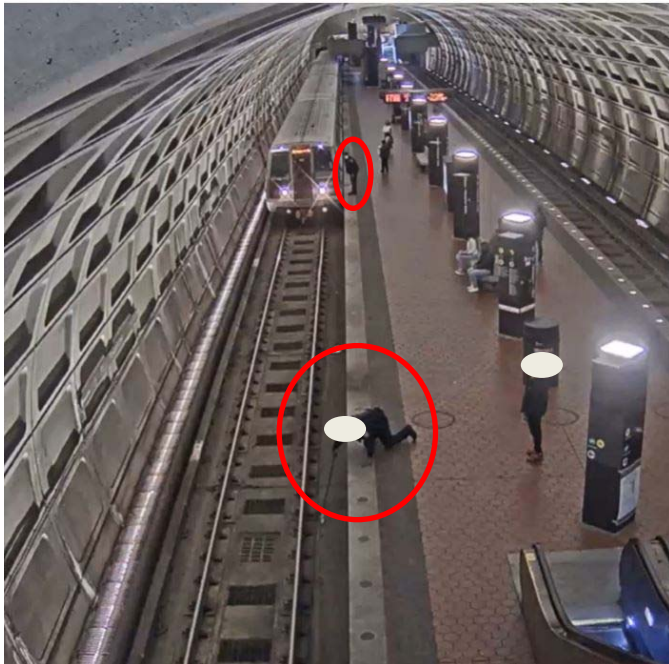
This image shows MTPD Officer #1 talking to the Train Operator while MTPD Officer #2 attempted to retrieve the customer's cellphone using the non-conductive grabber.

- MTPD Officer #1 contacted the ROCC to inform them of the situation but never requested foul time to retrieve the cellphone.
- MTPD Officers fouled the roadway after contacting the Security Operations Control Center and the Station Manager.
- MTPD Officers failed to verify train movement was halted before attempting to retrieve the cellphone from the roadway.
- MTPD Officers violated RWP Cardinal Rule #5: There shall be no fouling of the Authority's Roadway unless it is ABSOLUTELY necessary to perform your job.
- As Train ID 306 stopped mid-platform, MTPD Officer #2 attempted to retrieve the cellphone.
- MTPD Officers do not request FT to enter the roadway unless an Incident Command is established.

The probable cause of the Improper Roadway Worker Protection event was lack of awareness on behalf of the MTPD officers which resulted in non-compliance with established MTPD RWP Roadway Safety procedures. The MTPD Officer reported the dropped property in the roadway but failed to establish the required protections before retrieving the property from the roadway.

Corrective Action Code	Description	Responsible Party	Estimated Completion Date
90755_SAFE CAPS_ SAFE_004	MTPD RWP training materials shall be reviewed at least annually by OPMS, to ensure process changes and rule updates are reflected in the material.	SAFE SRC	6/30/2022
90755_SAFE CAPS_ SAFE_005	OEM instructors shall be evaluated and approved by OPMS training leadership. The approval process would mirror that followed by SAFE's contractor RWP instructors. Approval would ensure RWP material is presented consistently regardless of instructor group	SAFE SRC	6/30/2022
90755_SAFE CAPS_MTPD _007	Annual MIRs shall include reviews of the ROCC emergency SOPs (including use of Foul Time), which are covered during new recruit training.	MTPD SRC	6/30/2022
90755_SAFE CAPS_MTPD 008	Roll Call notes discussing roadway access violations and reporting (From E22104).	MTPD	Completed
90755_SAFE CAPS_MTPD 009	Continue to work towards addressing open CAPs related to RWP.	MTPD	8/30/2022

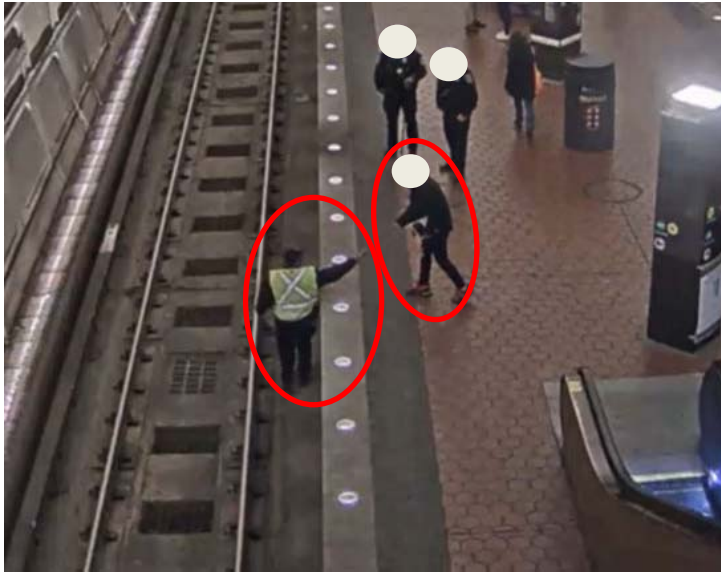
This image shows the RTRA Supervisor handing the customer their cellphone after retrieving it from the roadway under Foul Time Protection.
