WMSC Commissioner Brief: W-0173 – Serious Injury – L’Enfant Plaza Station – February 21, 2022

FINAL REPORT OF INVESTIGATION A&I E22114

L'Enfant Plaza Station – Serious Injury

February 21, 2022

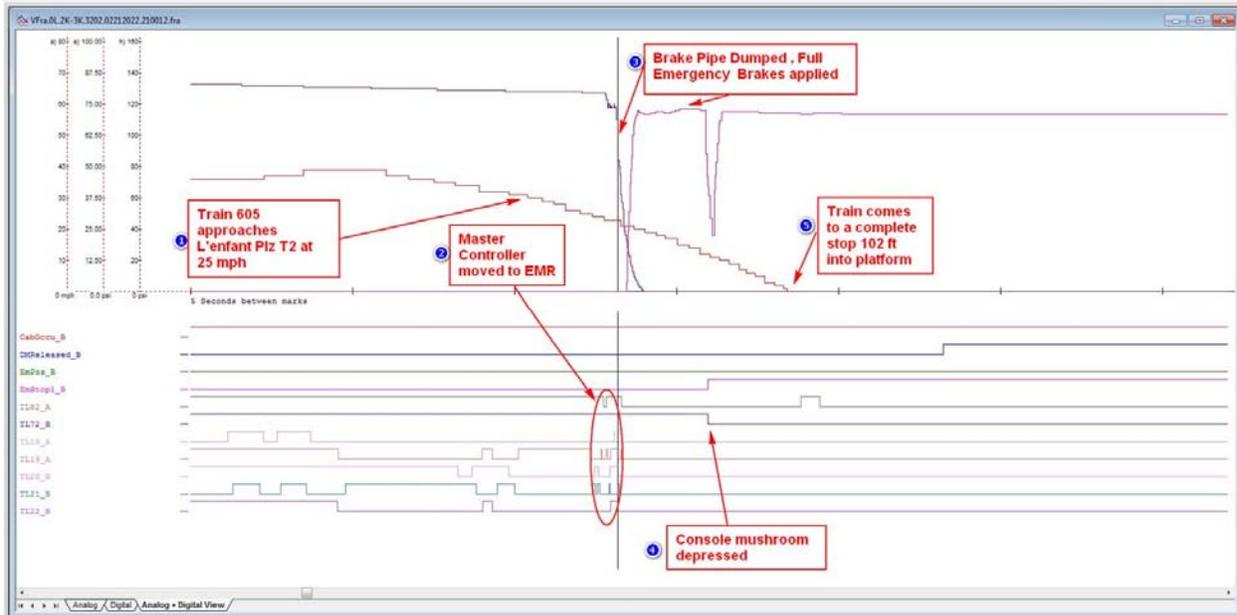
Figure 1 – IIT CMOR VMS analysis showing Train Operator's actions.

IIT CMOR analysis of the VMS data found that at approximately 11:16 hours, Car 3203 was headed inbound on the D line Track 2 in approach to L'Enfant Plaza Station. At approximately 6 feet prior to the station, the VMS data is consistent with the Master Controller (MC) being moved into the Emergency (EMER) Position, with a speed of 25 mph. This initiated the brake pipe to dump and full emergency brake cylinder pressure was applied. Approximately 1.5 seconds later, the Emergency Mushroom 1 (on Operator's console) was depressed at 15 mph and at 78 feet into the platform. The train travelled an additional 24 ft before coming to a stop 102 feet into the platform. This corresponds to a deceleration rate of 3.026 Mphps in Emergency. The train performed within design specifications. There is no activation of the road horn.

“Based on the VMS data, there was no faults observed with the train that contributed to the cause of this incident.”

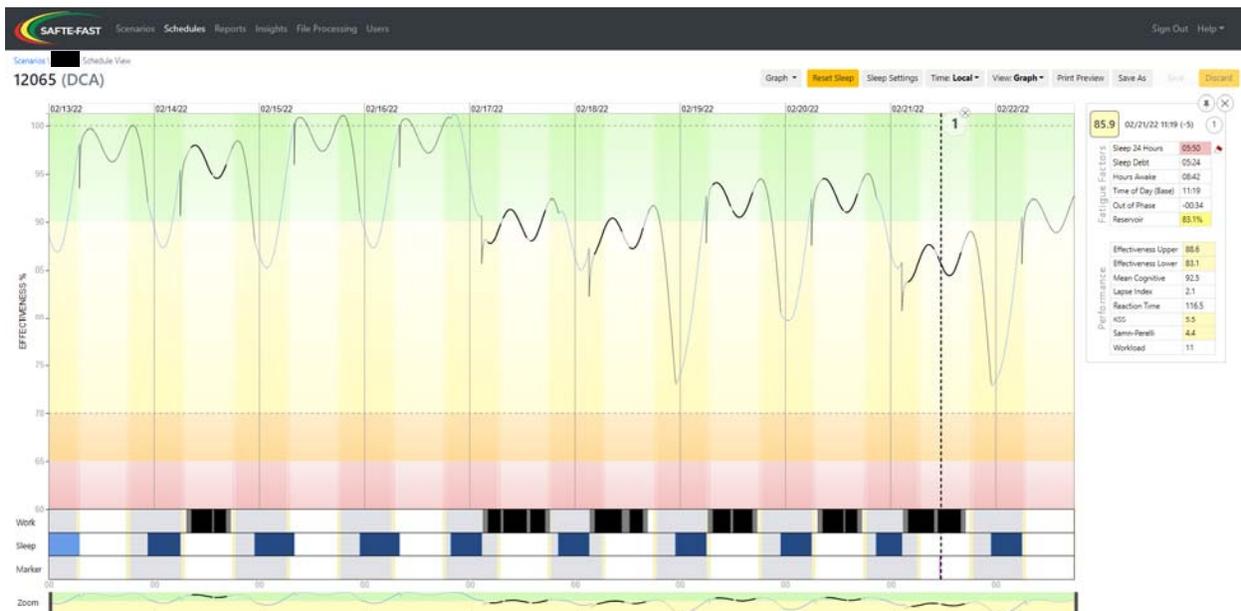
A biomathematical fatigue modelling application (SAFTE-FAST WebSFC) was used to further evaluate fatigue risk factors that may have been present in the Train Operator's schedule. The analysis was based on the Train Operator's work schedule, reported sleep from the day before the incident, and reported habitual sleep durations. Estimated performance effectiveness at the time of the incident was 85.9%. Specifically, the analysis identified short sleep duration in the last 24 hours as a factor contributing to an increased risk of fatigue at the time of the incident.

Modeling analysis output shows estimated performance effectiveness during the incident work shift and for the week leading up to the work shift, based on the employee work and reported sleep schedule. Estimates were based on the Train Operator's work schedule, reported sleep from the day preceding the incident, and reported habitual sleep durations (7 hours a day). Bold portions of the modeled curve show work (in black) and sleep times (in blue). Effectiveness is shown on the vertical axis, with colored fields.
