WMSC Commissioner Brief: W-0174 – Improper Worker Protection – near Greenbelt Station – April 3, 2022

FINAL REPORT OF INVESTIGATION A&I E22193

Date of Event:	04/03/2022
Type of Event:	Improper Roadway Worker Protection (RWP)
Incident Time:	02:31 hours
Location:	Near Greenbelt Station, Track 1 and 2, Chain Marker (CM) 607+00 and 609+00
Time and How received by SAFE:	02:44 hours via MAC Notification
WMSC Notification Time:	03:40 hours
Responding Safety Officers:	WMATA: No WMSC: No Other: No
Rail Vehicle:	N/A
Injuries:	None
Damage:	None
SMS I/A Incident Number:	20220403#99360

Greenbelt Station – Improper Roadway Worker Protection (RWP)

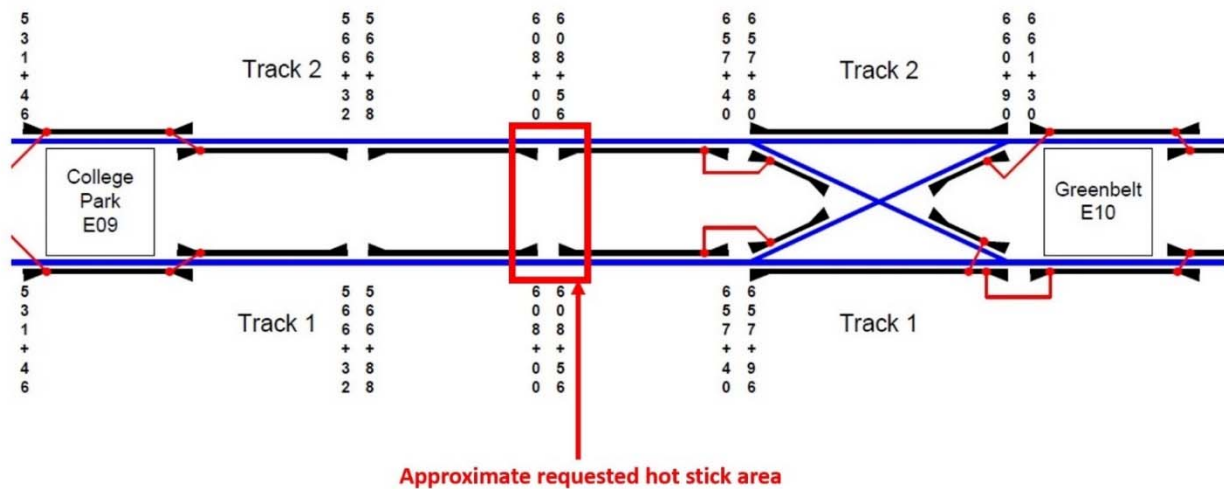
Field Sketch/Schematics

Near Greenbelt Station, Tracks 1 and 2, Chain Markers (CMs) E1-E2 607+00 and E1-E2 609+00.

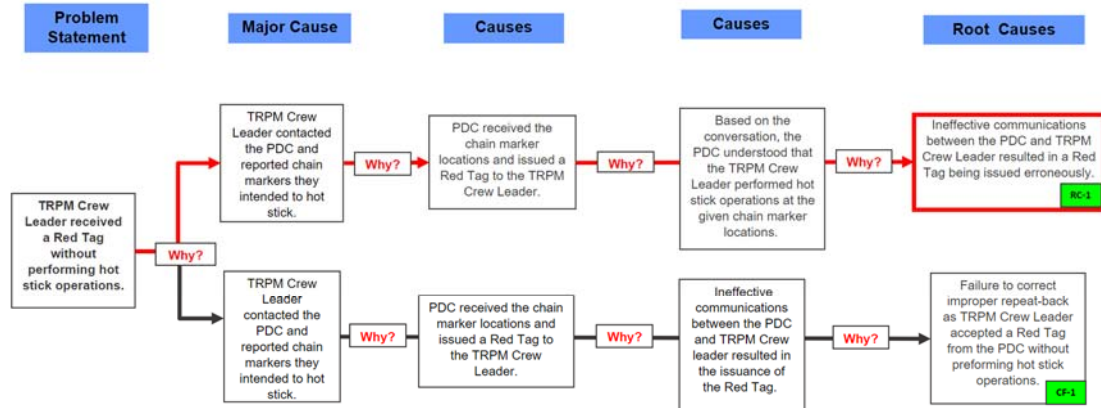
Appendix F – Root Cause Analysis

The investigation concluded that an improper roadway worker protection event did not occur. However, a noteworthy action occurred related to SOP 2. The PDC issued a Red Tag to the TRPM Crew Leader before performing hot stick operations to confirm if third rail power was deenergized due to a miscommunication. The probable cause for this occurrence was inadequate communications between the PDC and the TRPM Crew Leader. The TRPM Crew Leader reportedly gave the PDC chain marker locations they intended to check by performing hot stick operations. The PDC understood that the TRPM Crew Leader had conducted hot stick operations and issued the Red Tag in error. Contributing to the incident was the acceptance of the Red Tag by the TRPM Crew Leader despite not performing hot stick operations.

Corrective Action Code	Description	Responsible Party	Estimated Completion Date
99360_SAFE CAPS_TRPM _001	(RC-1, CF-1) TRPM management will conduct a safety stand down focusing on effective communications and following regulated procedures throughout the department related to the proper issuance and acceptance of a Red Tag.	TRPM SRC	Completed
99360_SAFE CAPS_TRPM _002	(RC-1, CF-1) TRPM RWIC will conduct refresher RWP training with the emphasis on effective communications and procedures for Red Tag Operations.	TRPM SRC	Completed
99360_SAFE CAPS_TRPM _003	(RC-1, CF-1) TRPM management will ensure pre-shift safety talks are conducted for all PDCs regarding 100% repeat backs when issuing Red Tags.	TRPM SRC	Completed
