WMSC Commissioner Brief: W-0175 – Improper Roadway Worker Protection – near Stadium-Armory Station – April 25, 2022

FINAL REPORT OF INVESTIGATION A&I E22255

Date of Event:	April 25, 2022
Type of Event:	Improper RWP – Entering the Roadway without Permission
Incident Time:	09:48 Hours
Location:	Stadium-Armory Station - Chain Marker D1 197+00
Time and How received by SAFE:	10:00 Hours – SAFE/MAC
WMSC Notification Time:	10:30 Hours
Responding Safety Officers:	WMATA: N/A WMSC: M/A Other: N/A
Rail Vehicle:	L3149/48.3229/28.3274/75T
Injuries:	None
Damage:	None
Emergency Responders:	None
SMS I/A Incident Number:	20220503#10029

Stadium-Armory Station - Improper RWP

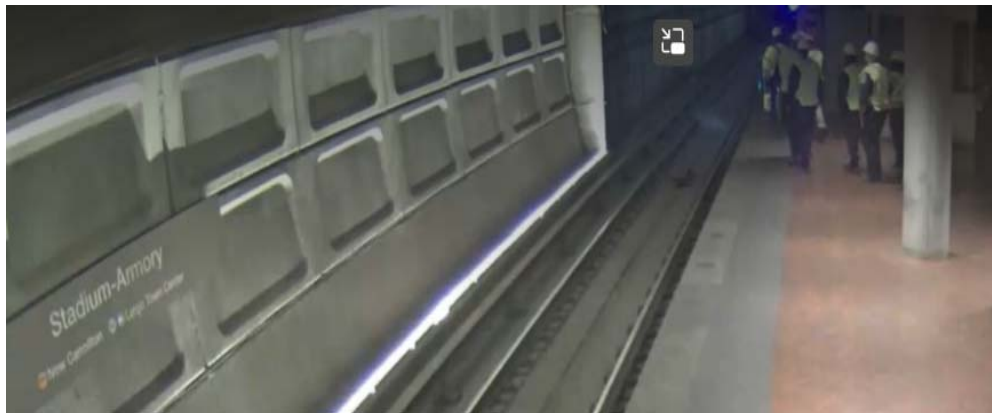
At approximately 09:48 hours, the MTPD Training Group is observed entering the roadway to commence the Roadway Familiarization Training.

Image 1 – MTPD Training Group entering the roadway at approximately 09:48 hours.

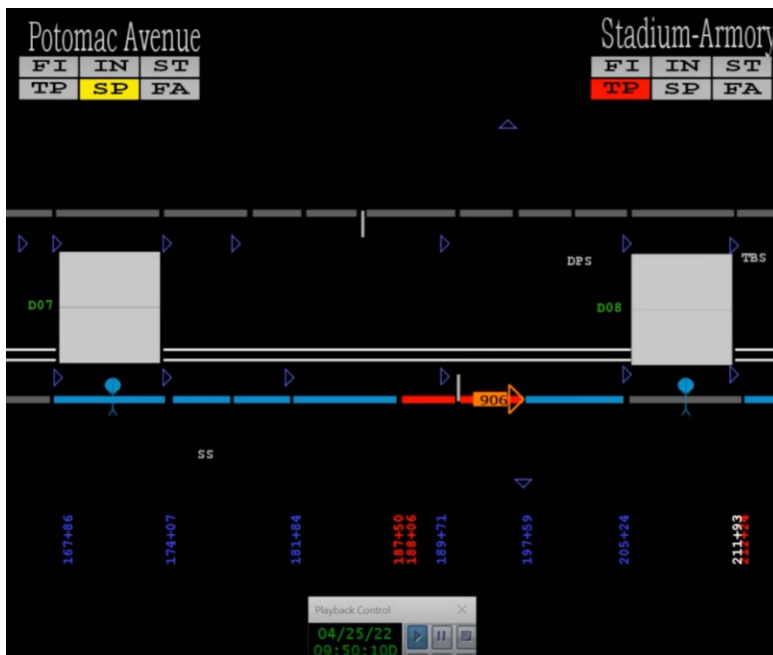
Image 2 - Train ID 906 approaching Stadium-Armory Station, track 1 at 09:50 hours.

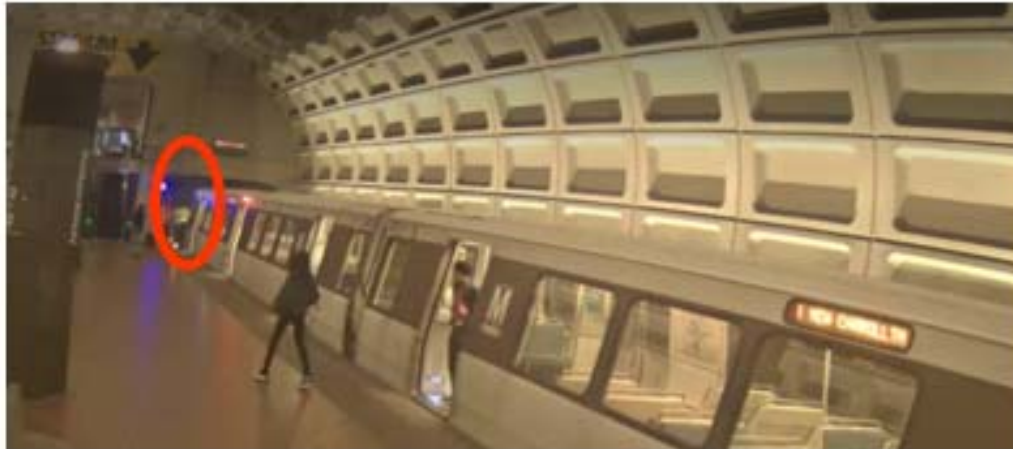
Image 3 – Train Operator disembarked the train to contact ROCC via the ETS Box at approximately 09:52 hours.

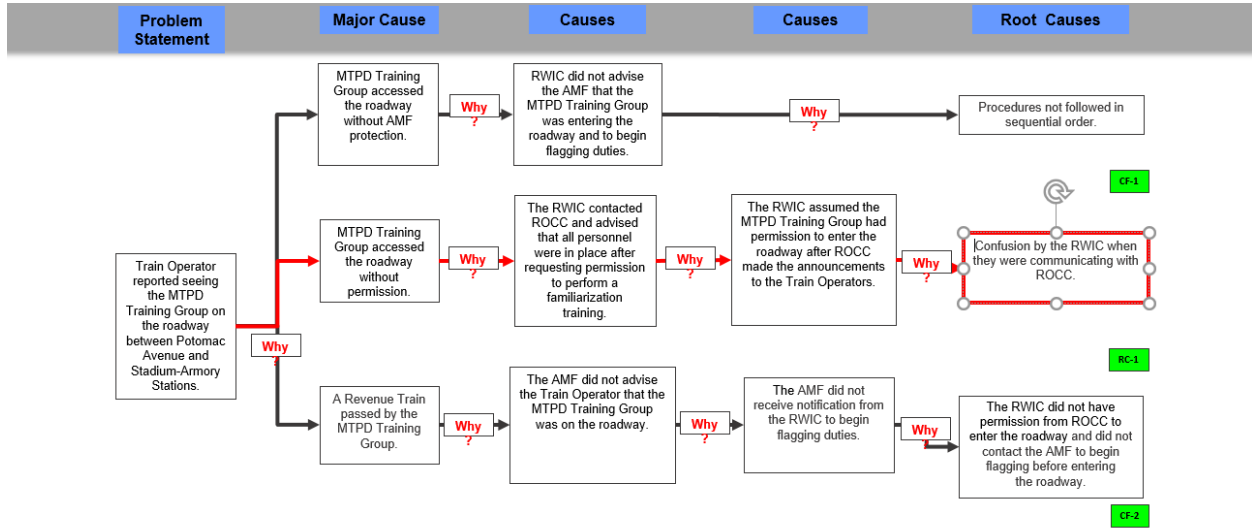
Appendix C - Root Cause Analysis

The probable cause of the Improper RWP event was a failure to complete all steps of an established procedure by the RWIC. During their last transmission prior to entering the roadway, background noise of a train departing the station was overheard and may have contributed to the RWIC inferring that permission was granted to enter the roadway. This action was not in accordance with MSRPH Section 5 – 5.13.6 (emphasis added to relevant section) Advanced Mobile Flagging – Mobile Work Crew, *the RWIC will contact ROCC and perform a radio check establishing positive communication. After receiving confirmation that the AMF is in position, the RWIC will request permission from ROCC to enter the Roadway. **Once ROCC gives permission, and before the Mobile Work Crew enters the Roadway, the RWIC will notify the AMF to begin AMF operations.***

Corrective Action Code	Description	Responsible Party	Estimated Completion Date
100029_SAFECAPS_MTPD_001	RWIC to complete requalification training for the RWIC on MSRPH Section 5 – Roadway Worker Protection with an emphasis on Radio Communication	MTPD	Completed
100029_SAFECAPS_RTRA_001	RTRA to provide documented discussions with Train Operators regarding MSRPH Sec. 1 – GR 1.32.	RTRA SRC	08/01/2022
100029_SAFECAPS_RTRA_002	RTRA to provide documented discussions with Train Operators regarding MSRPH Sec. 3 – OR 3.124.	RTRA SRC	08/01/2022
