WMSC Commissioner Brief: W-0176 – Serious Injury – Queenstown Road Repair and Maintenance Supply Storage Facility – April 25, 2022

Prepared for Washington Metrorail Safety Commission meeting on August 9, 2022

On Friday, April 25, 2022, at approximately 09:10 hours, a Contractor with Patuxent Roofing was working on Building T-36 (Queenstown Road Repair and Maintenance Supply Storage Facility), in West Hyattsville, MD, and fell through the roof approximately 28 feet, landing inside the building on a solid concrete floor.

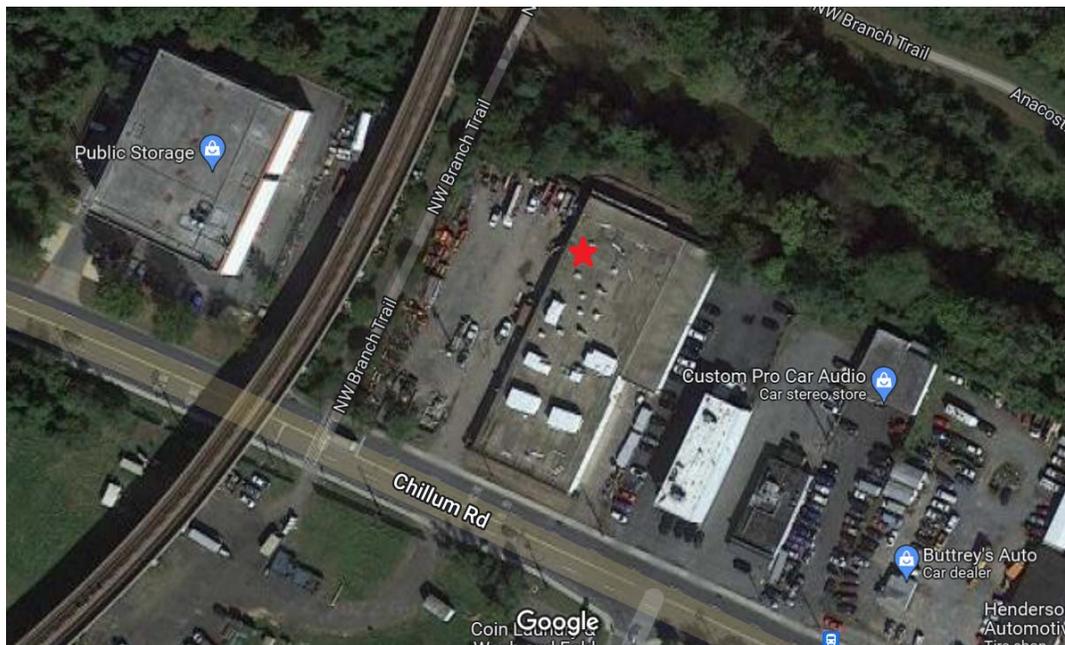
Figure 1: Incident Location. Red star marks approximately where Contractor fell through the roof.
*Not to scale. Oriented North.

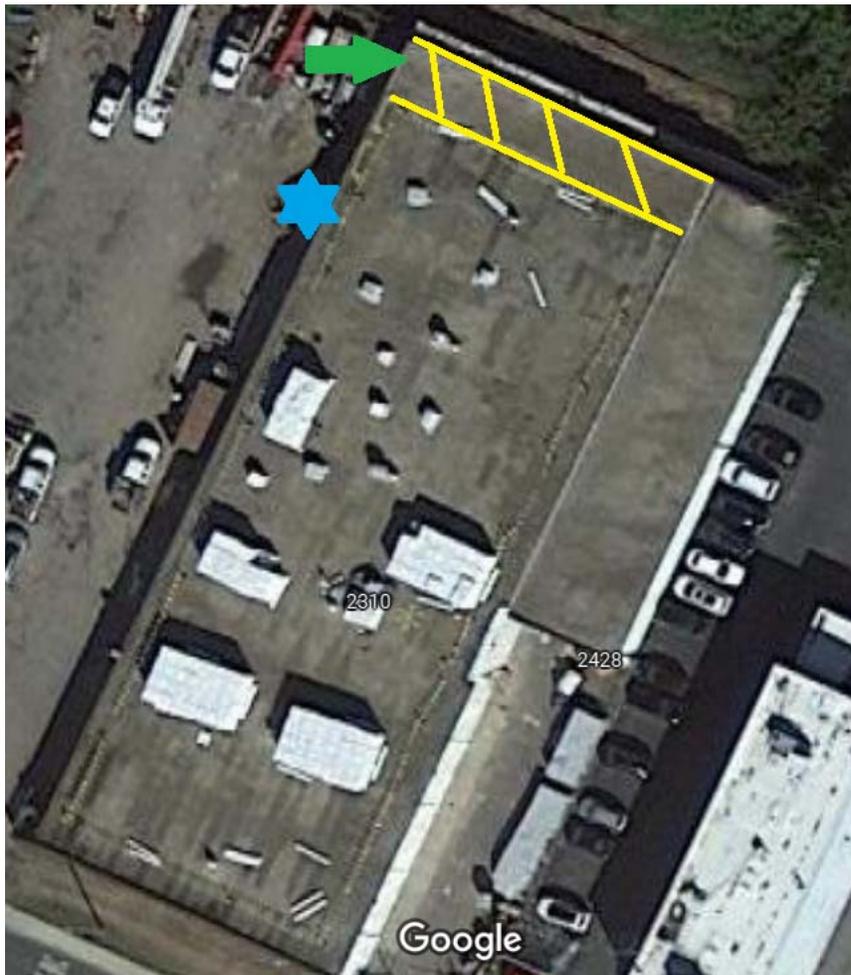
The egress point of the roof was established at the west-facing wall of the north corner via the ladder. This ladder led directly to the staging area allocated for demolition and construction. Multiple tie-down points were observed for safety-tethering workers; however, the retrieval point for new building materials lacked a tie-down point.

Figure 2: The egress point on to the roof, designated safety area at height and forklift are indicated by the green arrow, yellow lines, and blue star, respectively.

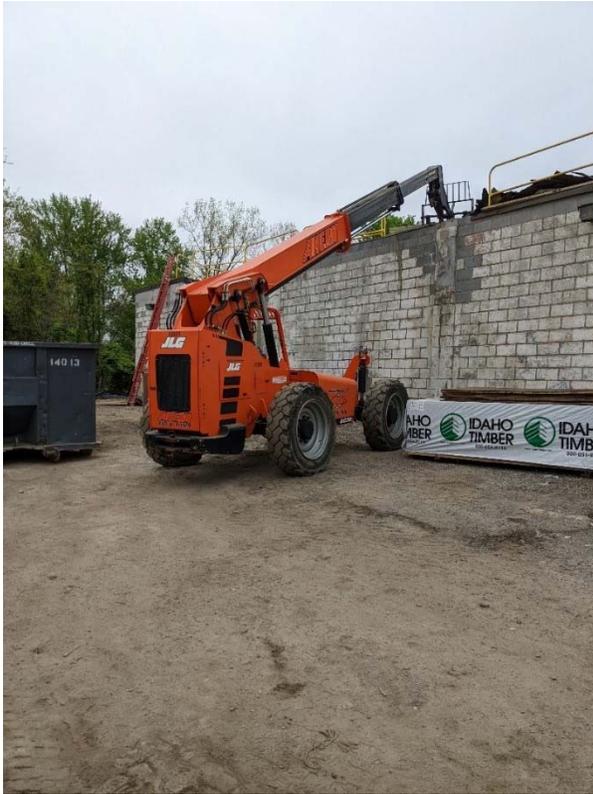
The retrieval point was positioned on the west wall to provide new materials for repairing the roof. It consisted of a forklift positioned on the ground, using its lift to overhang the roof and provide materials, as necessary. Before the fall, the Contractor was assigned to retrieve these materials from the forklift.

Figure 5: Forklift stationed on the ground with fork overhanging the roof to provide supplies.

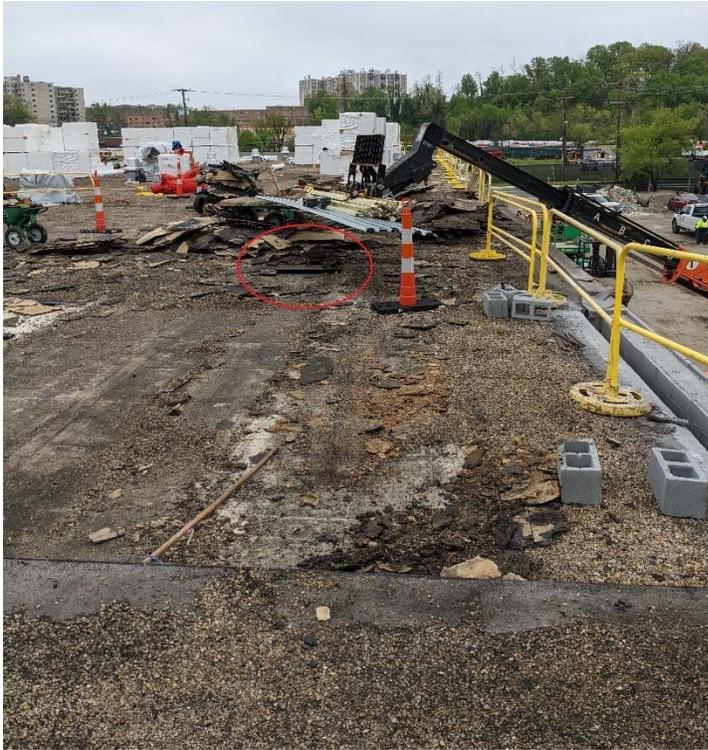
Figure 6: Northwest Corner orientated to the South, missing tile creating the hole can be observed from the safe area. Forklift can be observed to the right of the hole.

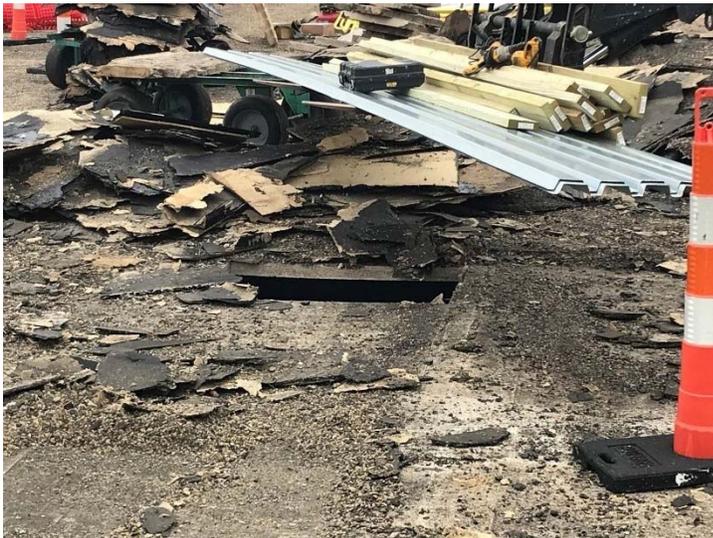
Figure 7: Close-up of the hole.

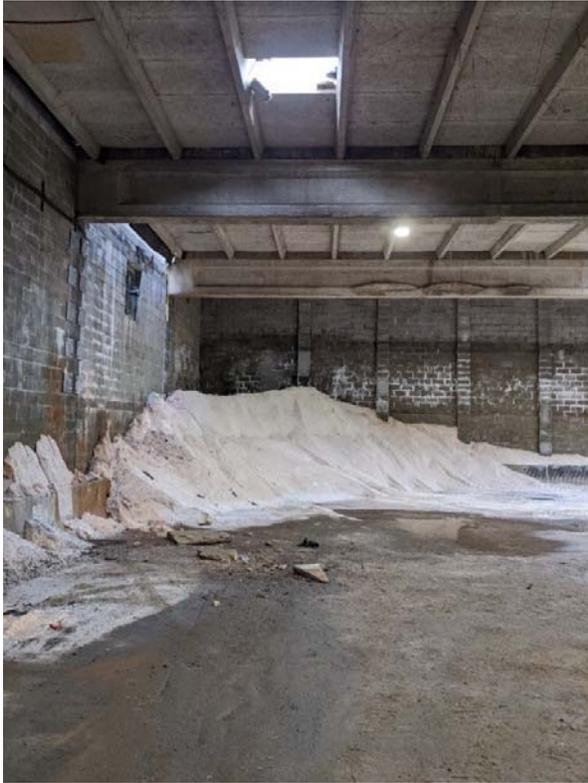
Inspection from the ground floor revealed the tile that broke out from underneath the Contractor was damaged prior to applying the Contractor's body weight.

Figure 8: View of the hole from inside the structure, orientated North

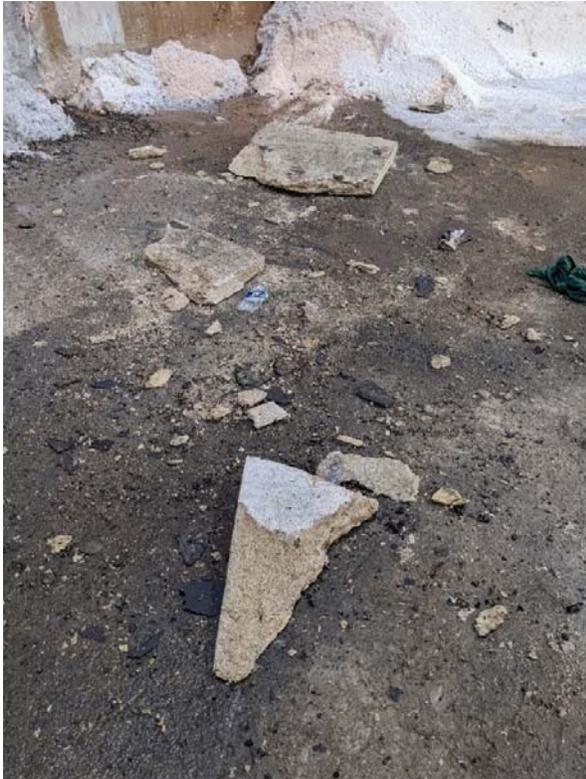
Inspection of the area where the contractor fell through the roof demonstrates that that section of the roof (panel/tile) was damaged before the contractor stepped on top of it. This is an example of the weak panel integrity that posed a hazard for this work. Additional inspection demonstrated other tiles with similar damage.

Figure 9: Close up of the shattered tile. Note the pre-existing damage.

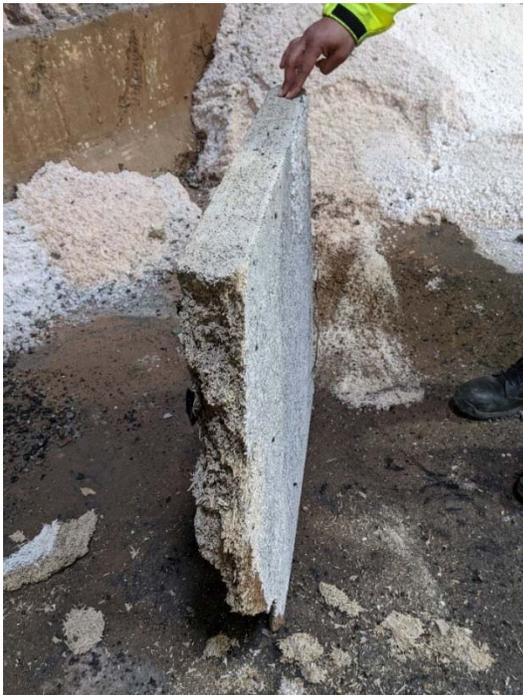
Figure 10: The largest piece of the tile with visible discoloration at the weak point. This piece was estimated to be in excess of 45 lbs.

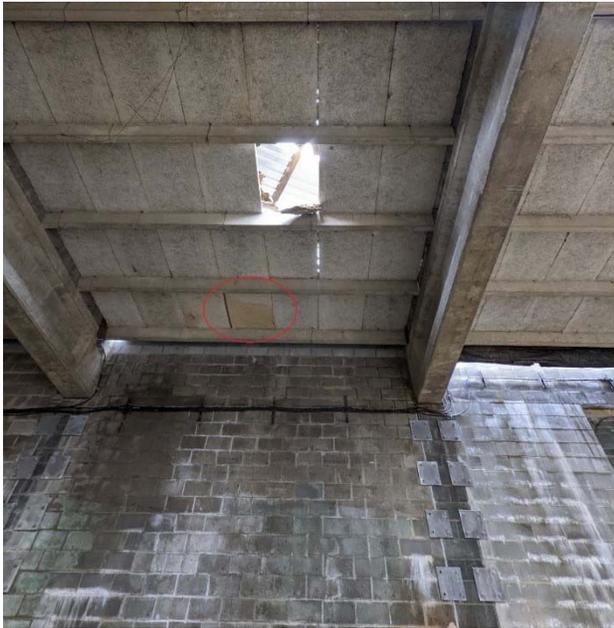
Further inspection of the roof from the ground floor revealed several visibly damaged tiles.

Figure 11: Water-damaged tile within the vicinity of the incident site.

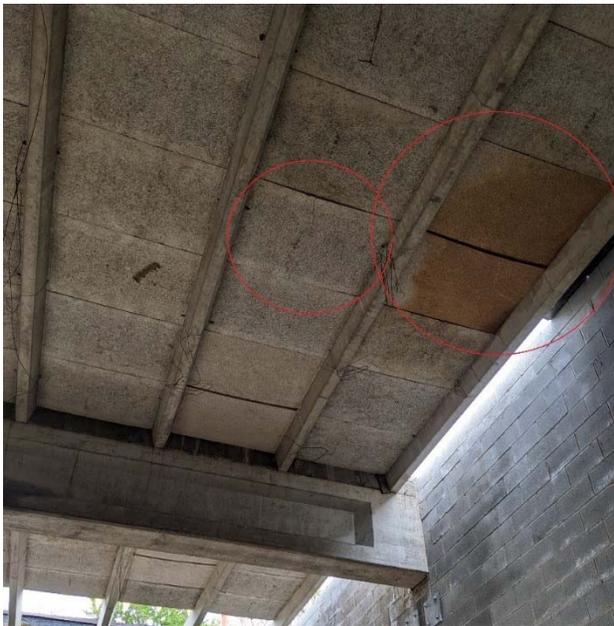
Figure 12: Two water-damaged tiles and a structurally compromised tile near the East wall.

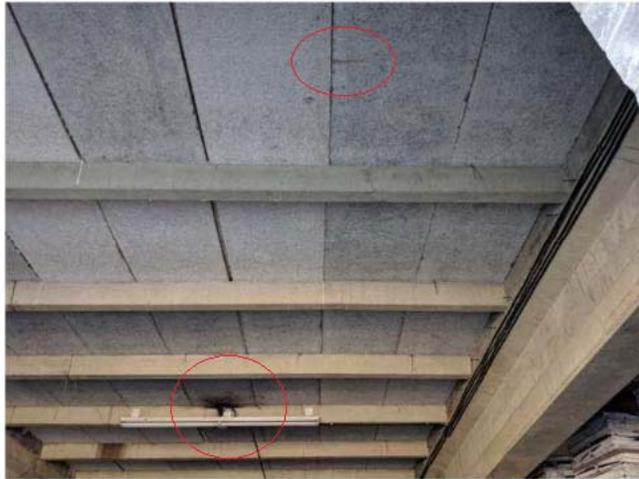
The report also showed multiple photographs taken inside T-36, showing the underside of the roofing, including at least one photograph clearly demonstrating structural damage to multiple pieces of the Tectum decking.

Figure 15: Photo retrieved from the Gannett Fleming/Parsons Report (2019)

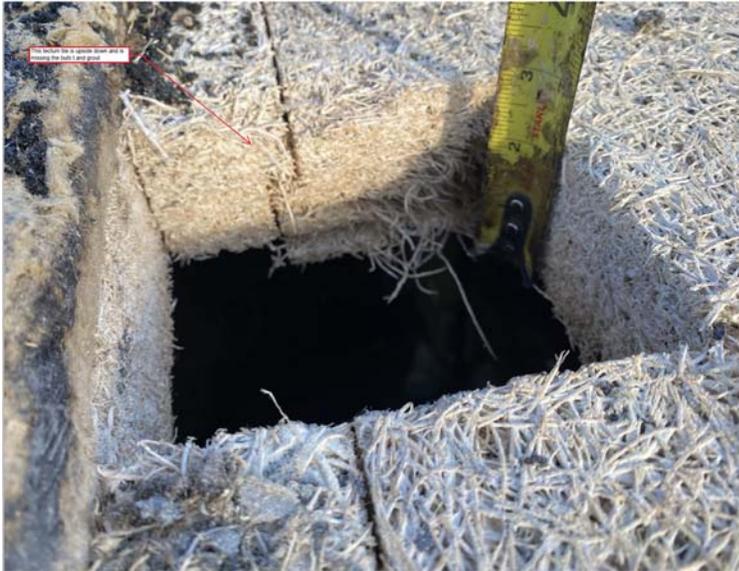
A follow-up conversation with The Mid Atlantic Sales Representative confirmed he stood by their original statement pertaining to the installation of the Tectum decking. Further, the Mid Atlantic Sales Representative stated he believed he recalled seeing and taking photographs of water damage observed on the underside of the panels, viewable from inside the building.

The Mid Atlantic Sales Representative stated the upside-down tiles were only discoverable after the bituminous layer was removed from the top of the Tectum decking.

Figure 15: Cutting of tectum from the roof of T-36.
Caption reads: "This Tectum tile is upside down and is missing the bulb t and grout."

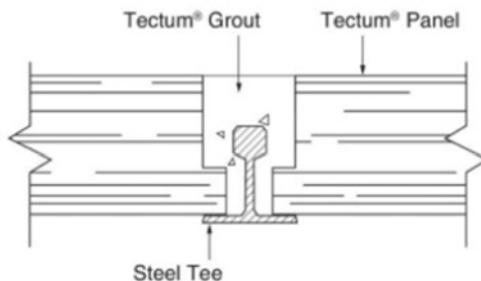
Figure 16: Diagram of how tectum should have been installed.

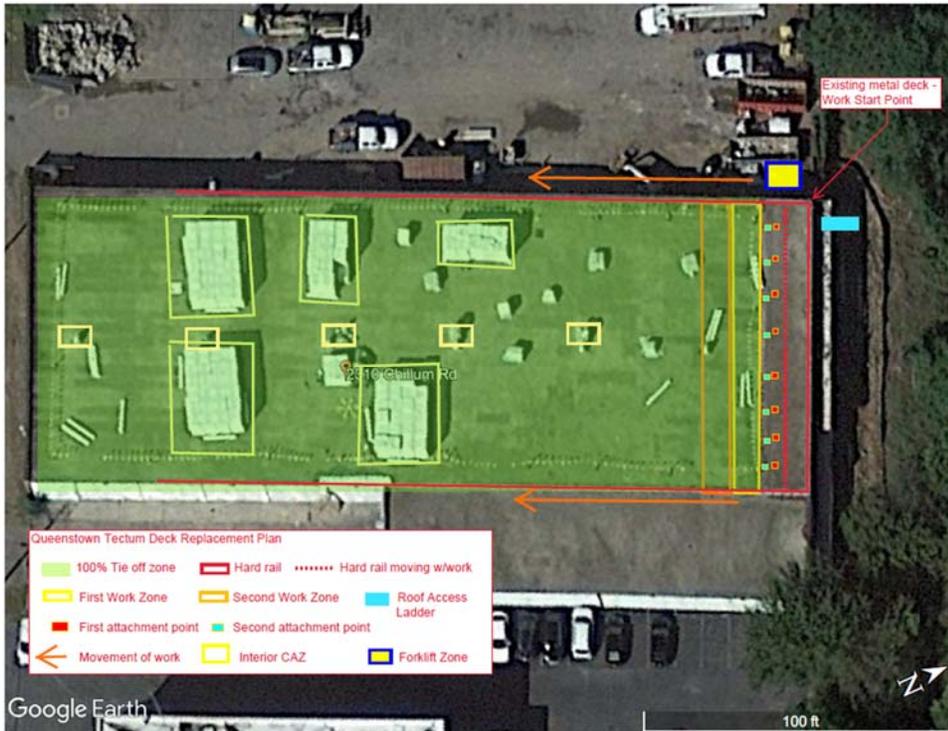
Figure 17: Diagram of Patuxent Roofing’s Safety Plan and Hazard Mitigation for the site. The Arrow indicates incremental movements of 9 ft, if safe to do so.

- Work will resume from the established safe zones, and be done so by hand without the aid of machines that will increase weight bearing on the roof
- 100% of employees will be required to wear all appropriate personal protective equipment to include the appropriate safety harness with a retractable strap as the primary means of fall protection and an additional 3/8" steel cable rigging strap as a fail-safe.

- Workers on the roof will move forward to the next section of roofing only when attachment points are made available by secured workers designated for that role, who are secured during the moving of secure points.

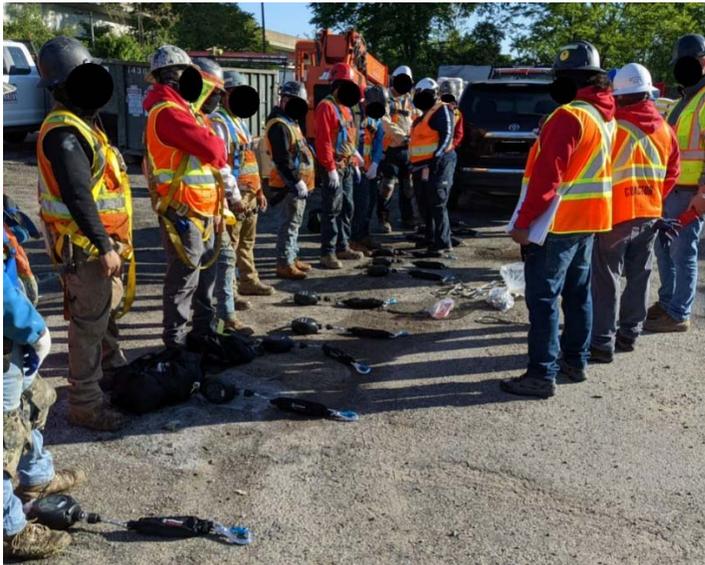
Figure 18: Patuxent Roofing Employees being instructed on the use of personal fall arrest systems as part of the rehearsal.

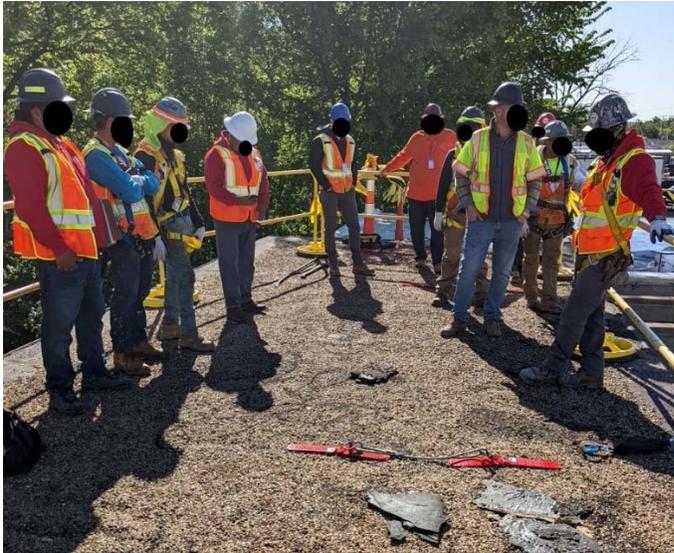
Figure 19: Patuxent Roofing Employees being instructed on the mounting point system.
