WMSC Commissioner Brief: W-0177 – Evacuation for Life-Safety Reasons – West Falls Church Yard (Building F) – April 4, 2022

FINAL REPORT OF INVESTIGATION A&I E22206

West Falls Church Yard – Evacuation for Life Safety Reasons

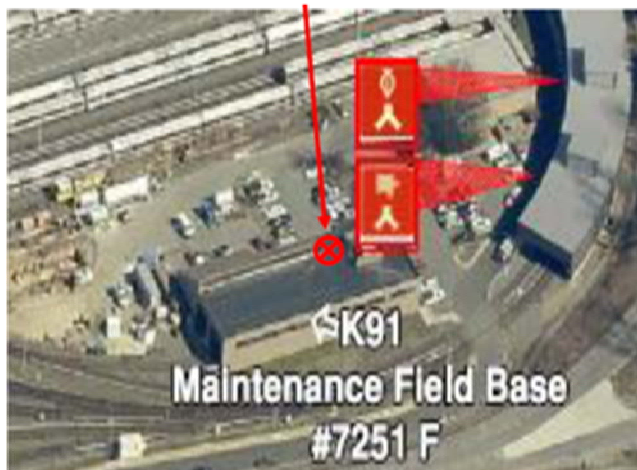
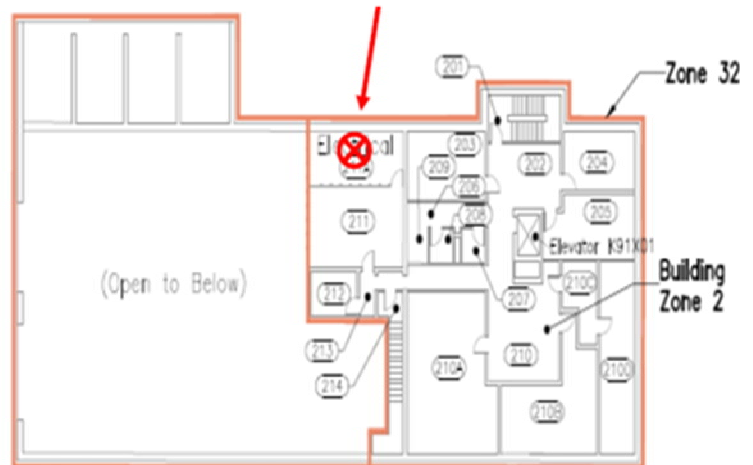
Field Sketch/Schematics

West Falls Church Yard – Building F, Room 211-A
