WMSC Commissioner Brief: W-0178 – Evacuation for Life-Safety Reasons – Pentagon City Station – April 13, 2022

Washington Metro Area Transit Authority
Department of Safety and Environmental
Management (SAFE)
FINAL REPORT OF INVESTIGATION A&I

Date of Event:	April 13, 2022
Type of Event:	Evacuation for Life Safety Reasons – (Fire/Smoke)
Incident Time:	22:04 Hours
Location:	Pentagon City Station, Track 1
Time and how received by SAFE:	22:11 Hours – Mission Assurance Coordinator (MAC)
WMSC Notification Time:	23:45 Hours
Responding Safety Officers:	WMATA: N/A WMSC: N/A Other: N/A
Rail Vehicle:	Train 306 (L2024/25x2073/72x3166/67T)
Injuries:	None
Damage:	None
Emergency Responders:	Arlington County Fire Department
SMS (Safety Management System) I/A Number	20220414#99607MX

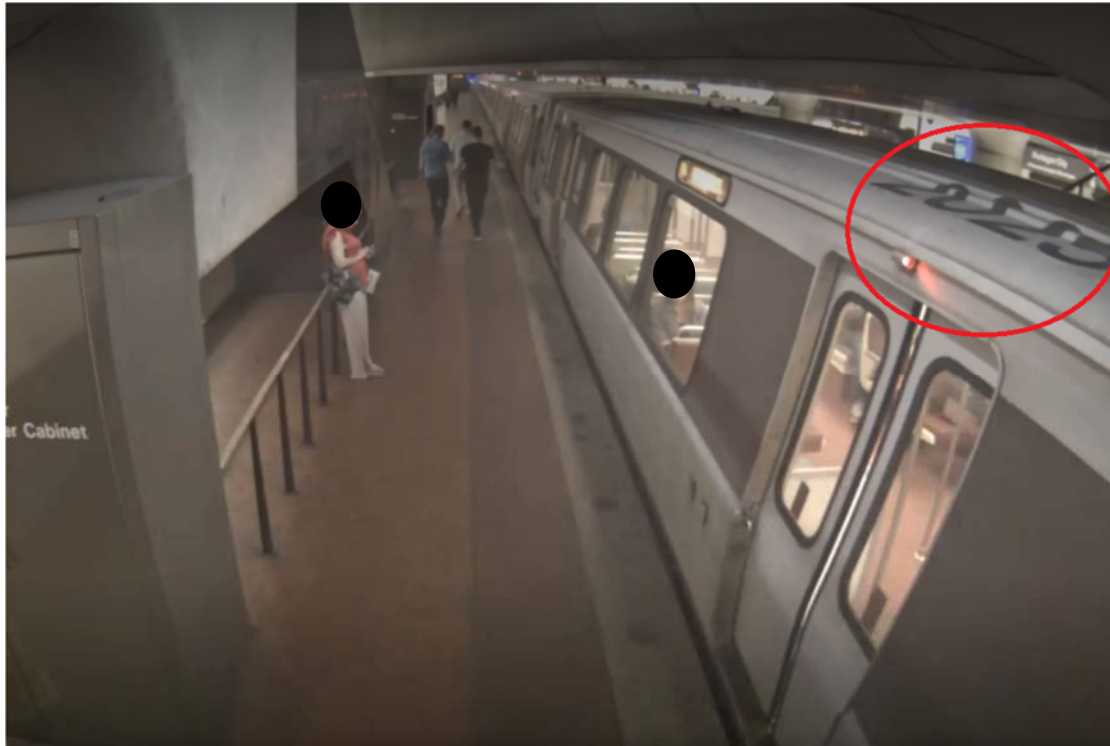
Upon receiving the report, the ROCC AOM, ROIC, SAFE, OM, MTPD, PLNT and other concerned personnel were notified. A review of the CCTV playback around the time of the report revealed a puff of white smoke emanating from Train 306, Car 2025. Later investigation identified the source of the smoke as a fire extinguisher discharged in between the rail cars.

Figure 1: Train 306, Car 2025 after alighting passengers, just prior to departing towards Pentagon Station, Track 1, from Pentagon City Station.

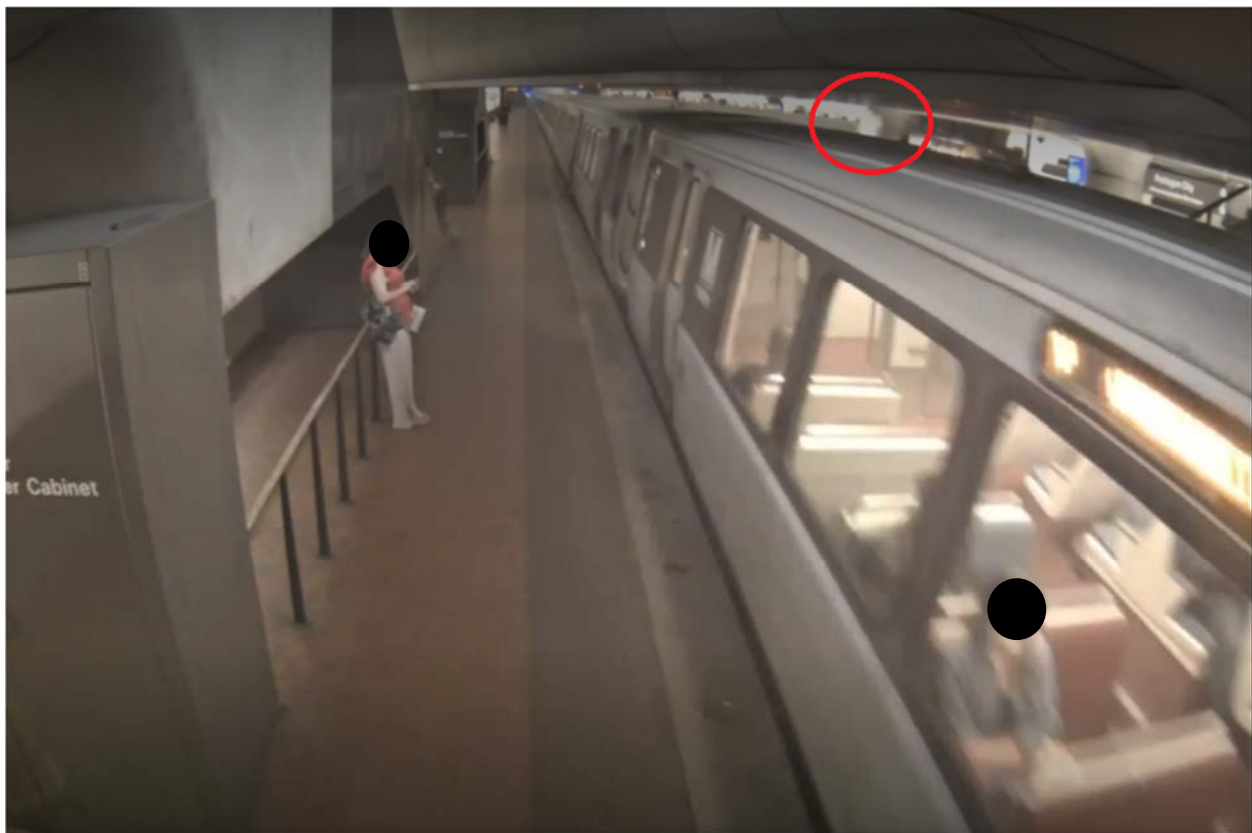
Figure 2: Train 302 departing Pentagon Station on opposite track. view obstructed by Train 306. A cloud of white smoke visible between cars 2025 and 2073.

The ARS playback and the ROIC report revealed the Station Manager observed no smoke in the Station, however, they could observe smoke in the tunnel, towards Crystal City. This was likely due to the departure of Train ID 302, pulling the fire extinguisher discharge towards portal. Both the Station Manager and Train Operator of Train 306 did not detect an odor consistent with hot brakes, electrical or regular combustible events.

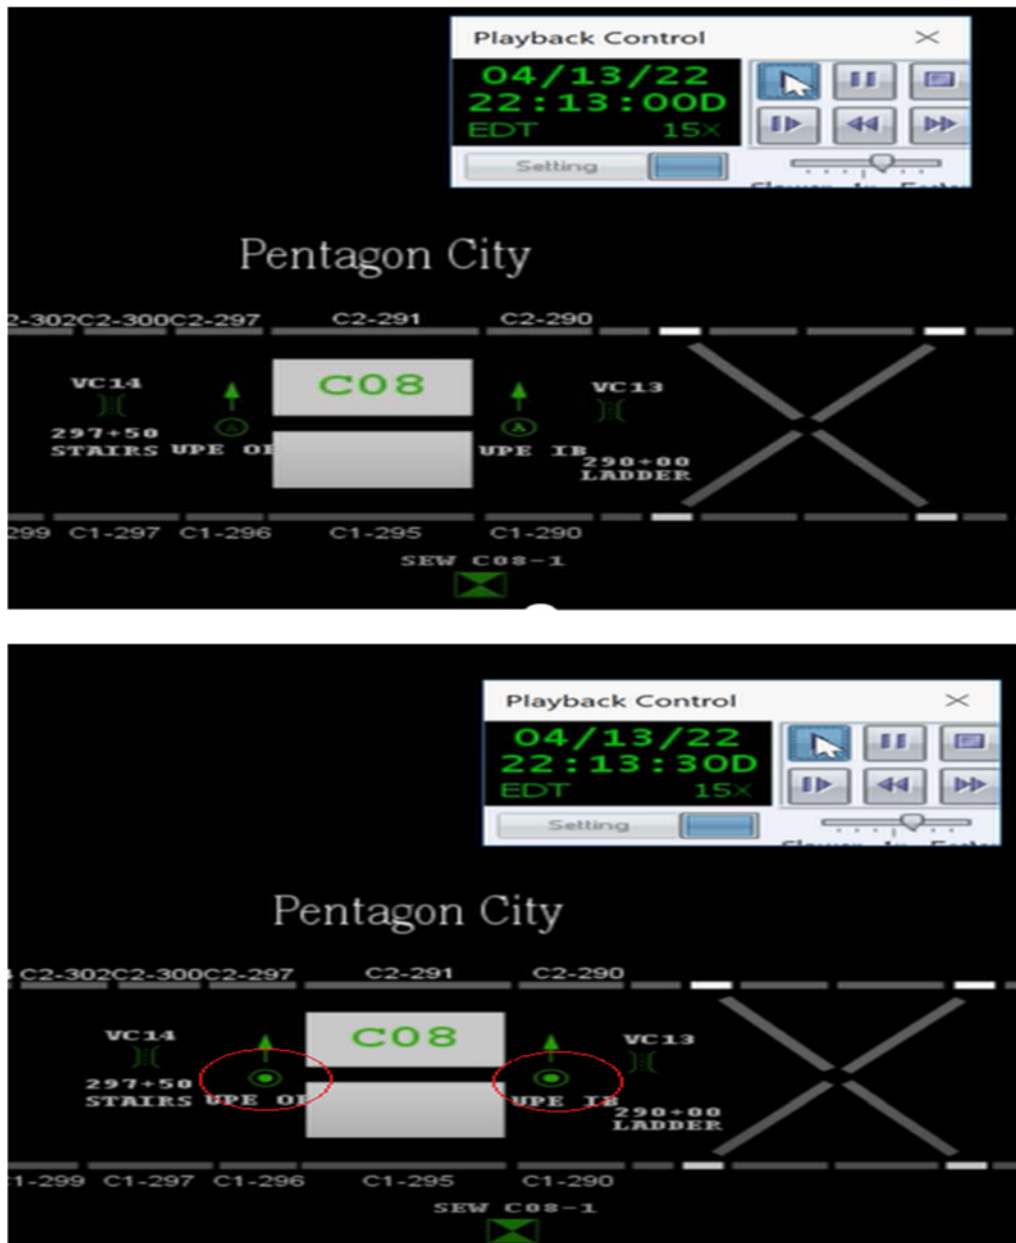
At approximately 22:12 hours, Train 404 was instructed to alight passengers at Ronald Reagan National Airport Station to perform a track inspection. Train 407 was instructed to alight all passengers at Arlington Cemetery, Track 2 for the same purpose. At approximately 22:13 hours, the ventilation fans were activated inside the tunnel of Pentagon City Station.

Figure 3: AIMS Playback indicating Fan activation at approximately 22:13 hours.

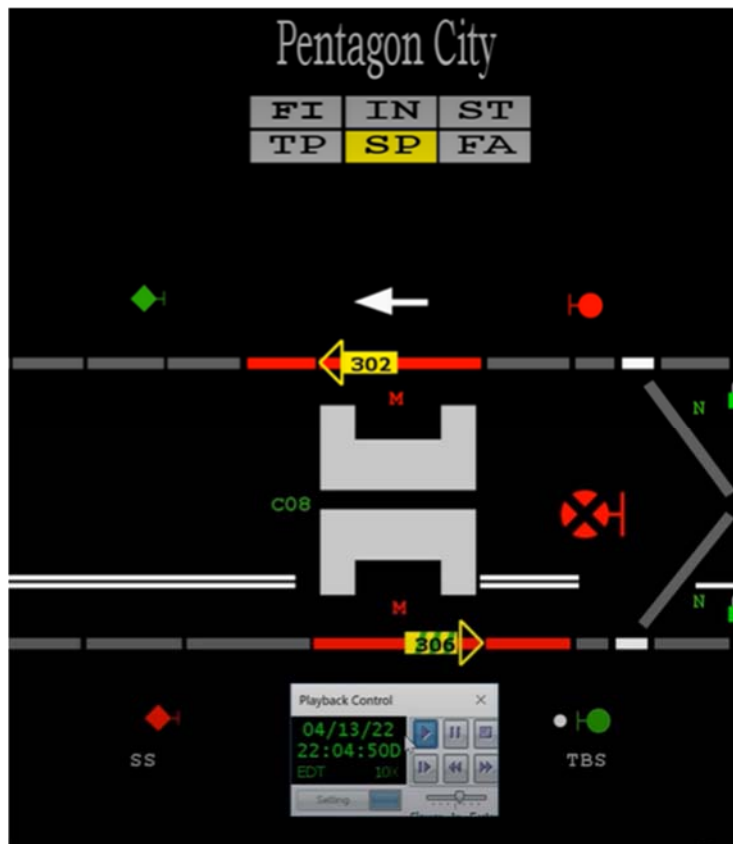
Figure 4: AIMS Playback incident train ID 306 servicing Pentagon City Station at approximately 22:04 hours.
