The Washington Metrorail Safety Commission

Safety Audit of the Washington Metropolitan Area Transit Authority

Audit of Communications Systems

Final Report:
September 29, 2022

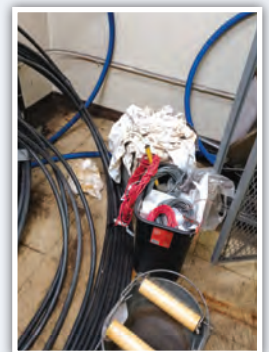
Despite these requirements, the WMSC observed a panel cover on the floor, a locker ajar with outdated equipment and various documents covered in dirt, and wires on the ground, with some near water that had accumulated at Fort Totten Station. Similar conditions with

Minimum Corrective Action: WMATA must conduct a special inspection of all communications rooms to check for water intrusion or signs of water intrusion. Metrorail must prioritize and address all identified hazards and safety deficiencies in a timely fashion. Metrorail must provide the records of these inspections and this prioritization and schedule for addressing each issue on at least a quarterly basis along with documentation of all implemented mitigations. Metrorail must then institute a process that ensures water intrusion is identified and addressed on an ongoing basis going forward. WMATA must develop processes to ensure all equipment and documents in communications rooms are kept clean, organized and protected, including routine verification inspections conducted and documented by supervisors.
