**WMSC Commissioner Brief: W-0180 – Improper Door Operation – Stadium-Armory Station – May 6, 2022**

**FINAL REPORT OF INVESTIGATION A&I E22278**

# Stadium-Armory Station – Improper Door Operation

May 6, 2022

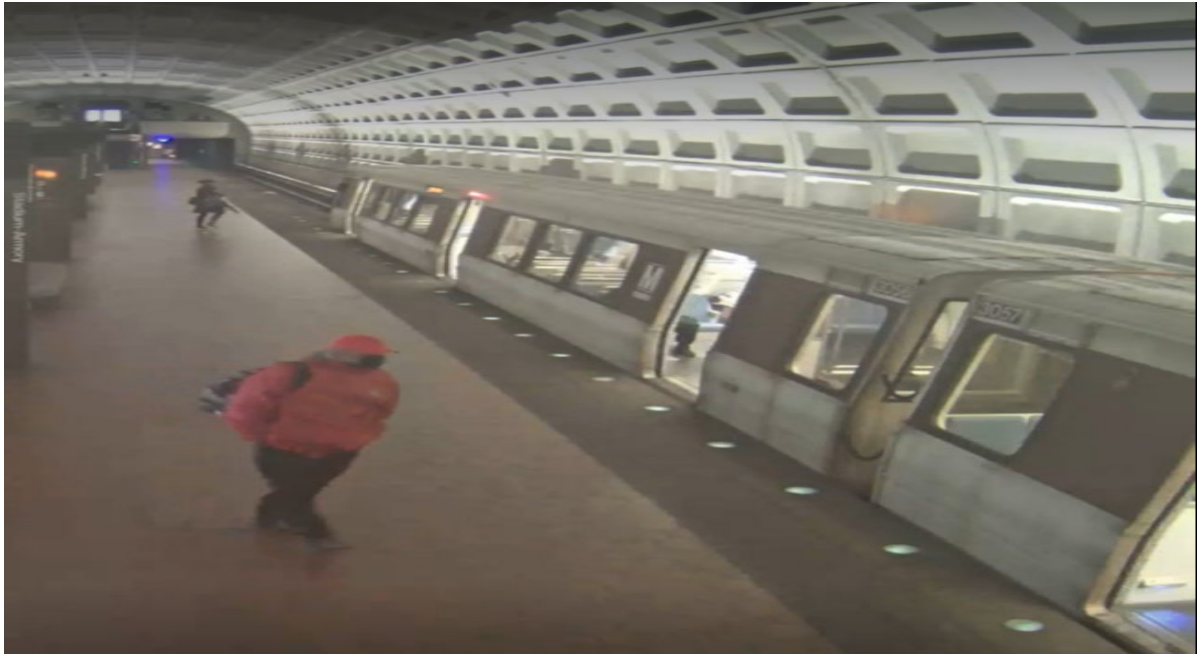
The Closed-Circuit Television (CCTV) confirmed that Train ID 607 entered the platform at Stadium-Armory Station, track 2 and stopped with four rail cars on the platform with two rail cars remaining in the tunnel. The Train Operator looked out of the window in the operator's cab and opened the doors on the platform side, closed the doors, then opened and closed the doors again. The Train Operator adjusted the train to the 8-car marker, then opened and closed the doors, then departed the station.

On Friday, May 6, 2022, at approximately 06:02 hours, Train ID 607, a six-car train consist, entered the platform limits at Stadium-Armory Station, track 2. The train stopped at the four-car platform marker leaving two rail cars outside of the platform limits in the tunnel area on track two of Stadium-Armory Station. This action was not in accordance with, MSRPH SOP #40.5.1.5.1 which states, “Make eight-car stops will all trains unless otherwise directed by ROCC (Ensure the train is properly berthed on the platform for the number of cars in the consist).” Within the same minute, the Train Operator depressed the left doors open pushbutton, causing all doors on the left side of the train consist to open, including the two rail cars that were located outside of the platform limits. This action was not in accordance with MSRPH SOP #40.5.1 Door Opening Procedures.

At approximately 06:03 hours, the left doors closed pushbutton was activated and all doors closed. Within the same minute, the left doors open pushbutton was activated again and all doors on the left side of the train consist opened, including the two rail cars that were located outside of the platform limits. Seconds later, the left doors closed pushbutton was activated and all doors closed. The Train Operator did not immediately report the incident to ROCC. This action was not in accordance with MSRPH, General Rule 1.32, *Employees involved in, witnessing, or informed of an accident or incident, to include near misses, on the Metrorail System shall inform their supervisor, Transit Police, ROCC and/or other appropriate authority as soon as possible, and shall file a written report.*

*Image 1 – Train ID 607, a 6-car train consist at Stadium-Armory Station with doors open without being fully berthed on the platform.*
