WMSC Commissioner Brief: W-0181 – Improper Door Operation – Judiciary Square Station – May 17, 2022

Washington Metro Area Transit Authority
Department of Safety and Environmental
Management (SAFE)
FINAL REPORT OF INVESTIGATION A&I E22303

Judiciary Square Station – Improper Door Operation

May 17, 2022

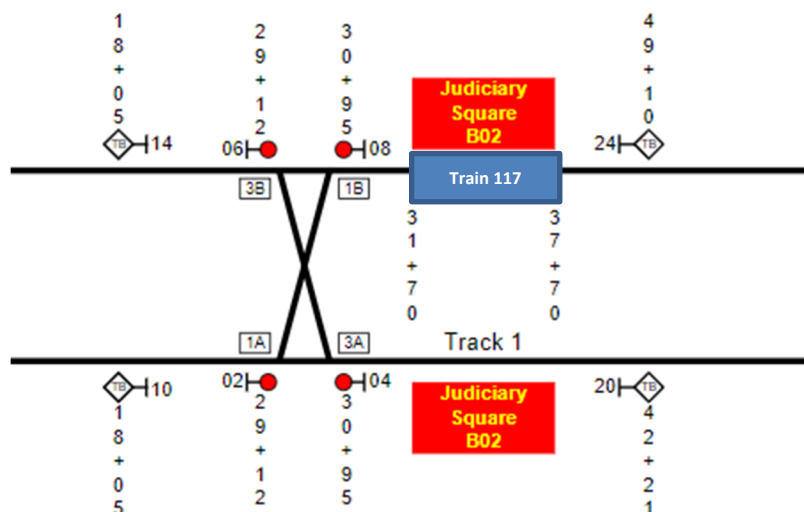
Figure 1: Shows the location of Train ID 117 when the improper door operation occurred.

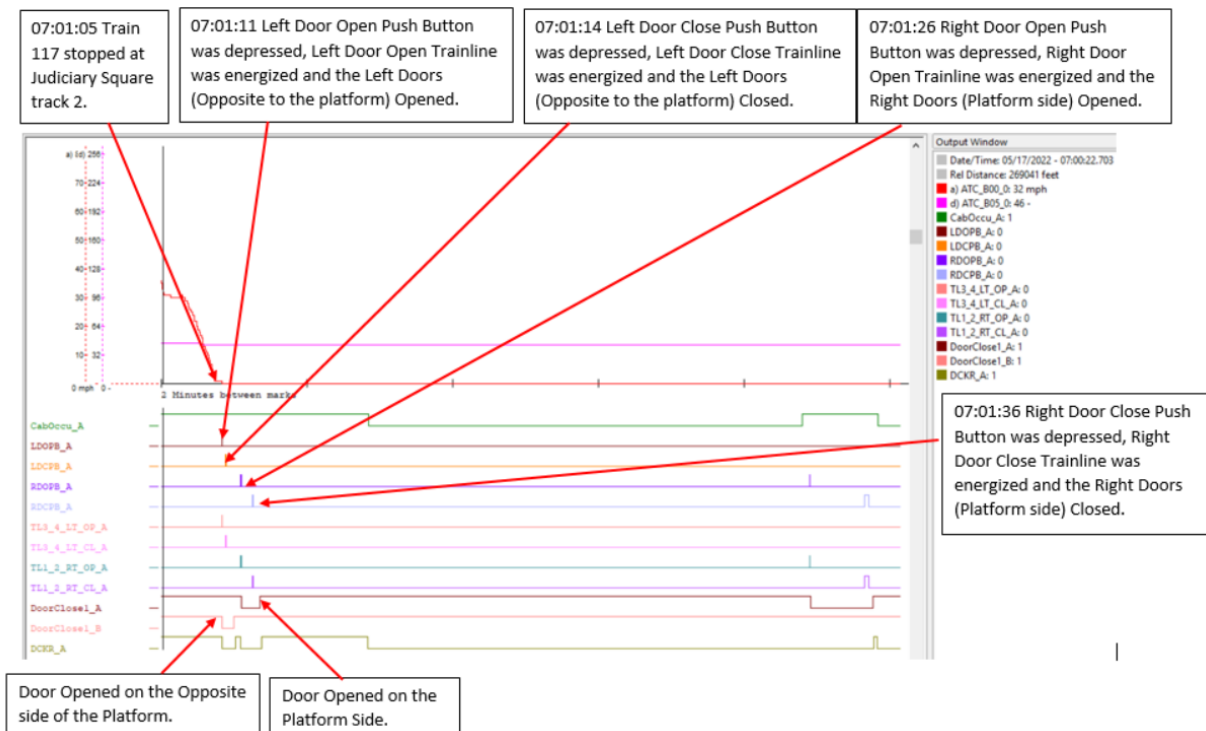
The VMS and SPOTS data provide evidence of an improper door Operation from Train ID 117 (L3222-23x3128-29x3248-29) at Judiciary Square Track 2 at 7:01:11 am 5/17/2022. Train ID 117 was berthed at Judiciary Square Station when the Left Door Open Push Button was depressed; as a result, the doors on the opposite side of the platform opened. The Left Door Close Push Button was depressed three seconds later, and the doors on the Opposite side of the platform closed. Doors on the opposite side of the platform were opened for a total of approximately 10 seconds. A door cycle on the platform side was performed later to service the station. Subsequently, the train was keyed down. During data analysis, no defects were observed; the doors responded as designed and opened due to commands entered through the door push buttons on Lead Car 3222.

Figure 5: Shows the detailed timeline of the door operations for Train ID 117.

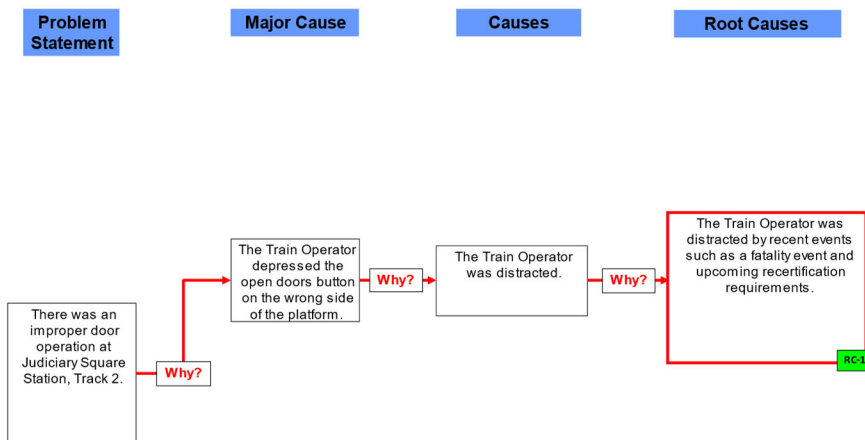
Appendix B - Root Cause Analysis

The root cause of this Improper Door Operation was a human factors error due to distractions. The Train Operator's focus was on a recent fatality at Brookland Station, issues with recertification, and the thought of jumpers while they were operating the train. The Train Operator experienced a cognitive lapse that resulted in the unintentional activation of the left side door open push button at a split station platform, which requires a right-side door operation. This action caused the doors to open on the non-platform side.

Corrective Action Code	Description	Responsible Party	Estimated Due Date
100376_SAFECAPS_RTRA_001	Train Operator will complete refresher training.	RTRA	Completed
100376_SAFECAPS_RTRA_002	Conducted RTRA wide safety blitz focused on increased improper door operations events.	RTRA	Completed
100376_SAFECAPS_RTRA_003	Increased RTRA Management daily interactions with front line employees to discuss recent safety concerns.	RTRA	12/31/22
