**WMSC Commissioner Brief: W-0184 – Improper Roadway Worker Protection – King Street Station – June 15, 2022**

Washington Metropolitan Area Transit Authority  
Department of Safety (SAFE)  
Office of Safety Investigations  
**FINAL REPORT OF INVESTIGATION A&I E22365**

# King Street Station - Improper RWP

June 15, 2022

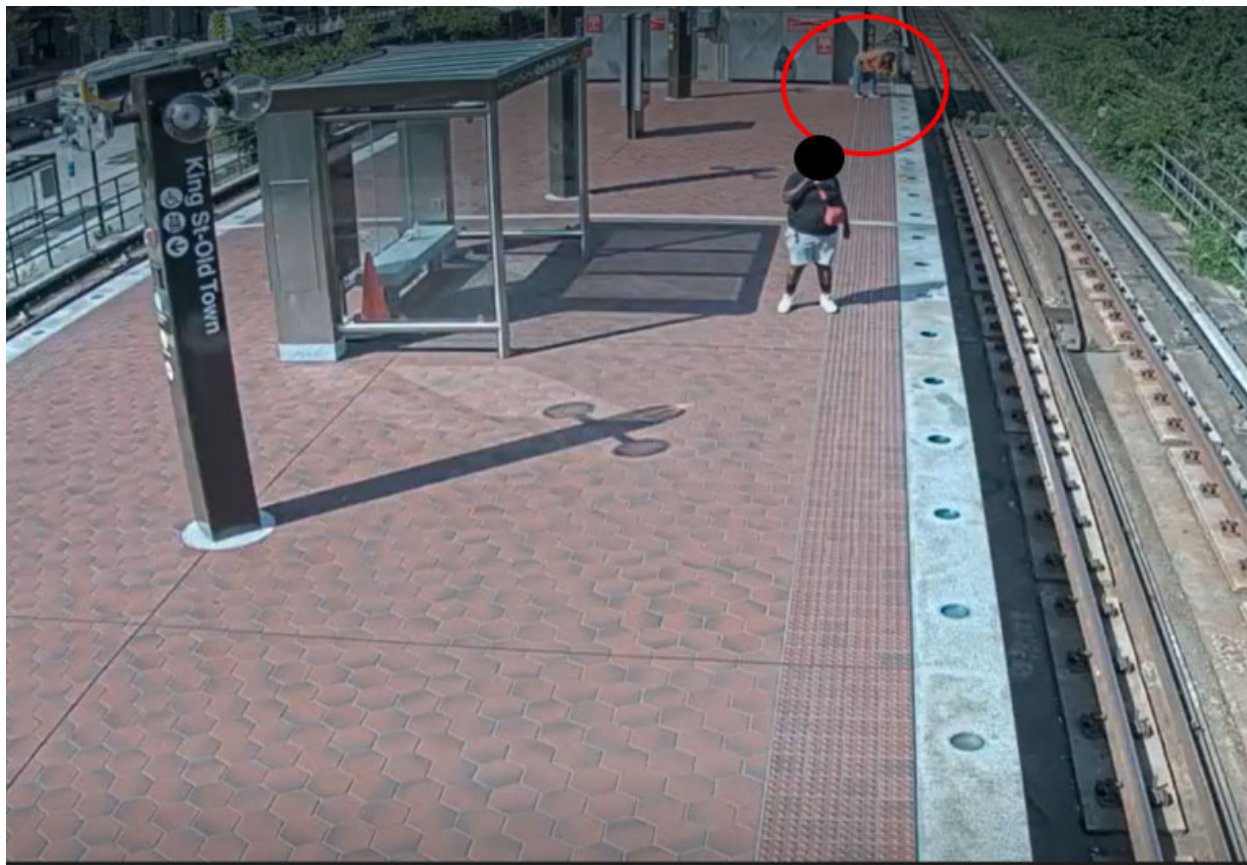
The AMF then spoke with a customer who approached them, turned off their lantern, and walked away from their work location at approximately 09:56 hours.

*Figure 1 - AMF turning off PPE equipment at approximately 09:56 hours.*

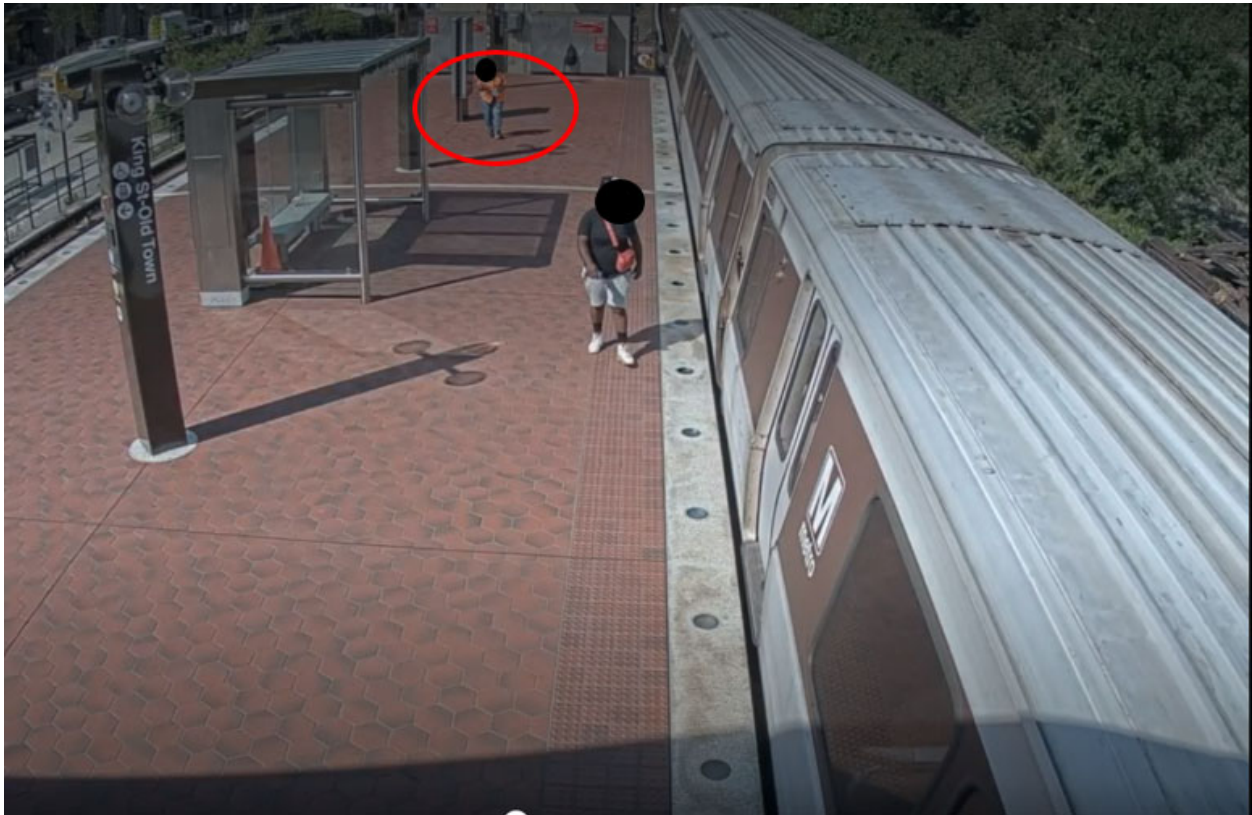
As the AMF walked away from the lantern, yellow line Train ID 301 entered the platform limits and the AMF failed to brief the Train Operator.

*Figure 2 - AMF walking away from the 8-car marker at approximately 09:56:31 hours*

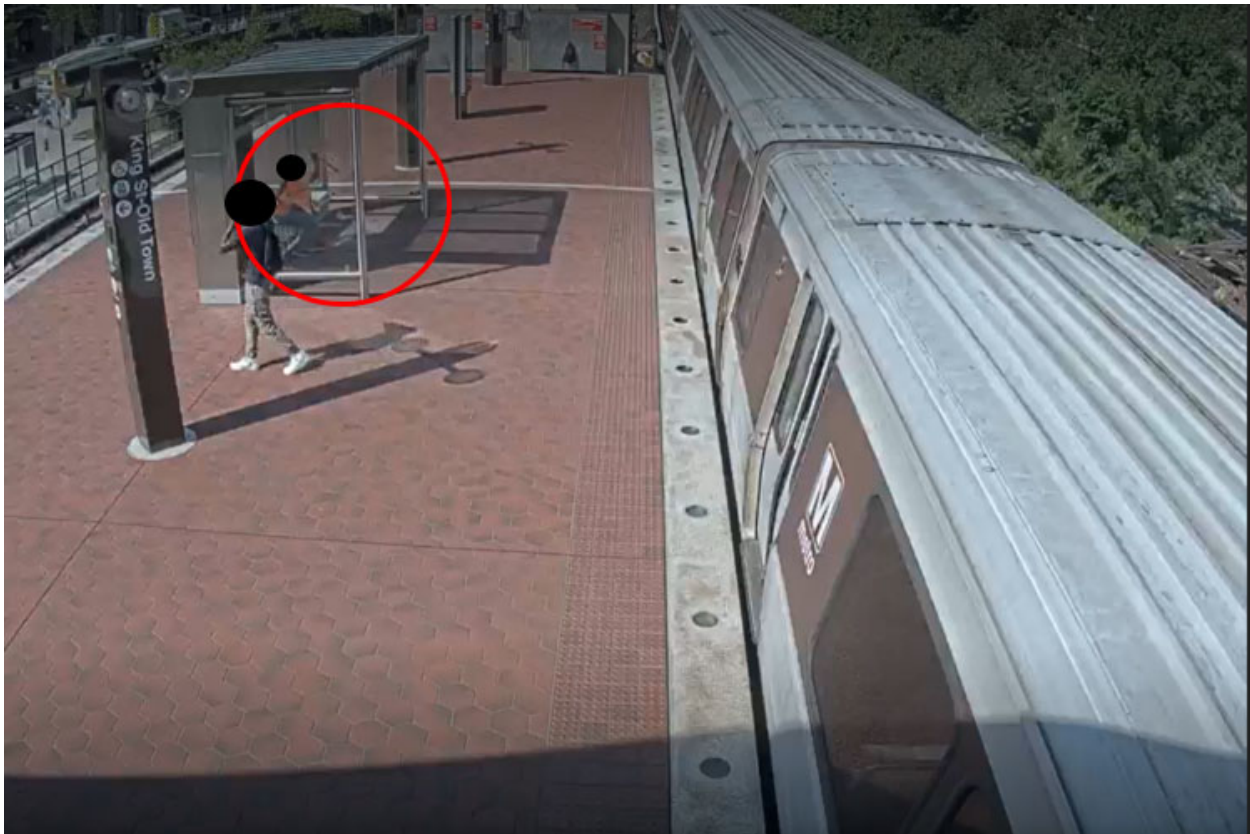
CCTV footage showed the AMF acknowledged Yellow Line Train ID 301 Train Operator and waved at them from the station platform shelter.

*Figure 3 - AMF waved at Yellow Line Train ID 301 Train Operator and acknowledged their presence.*

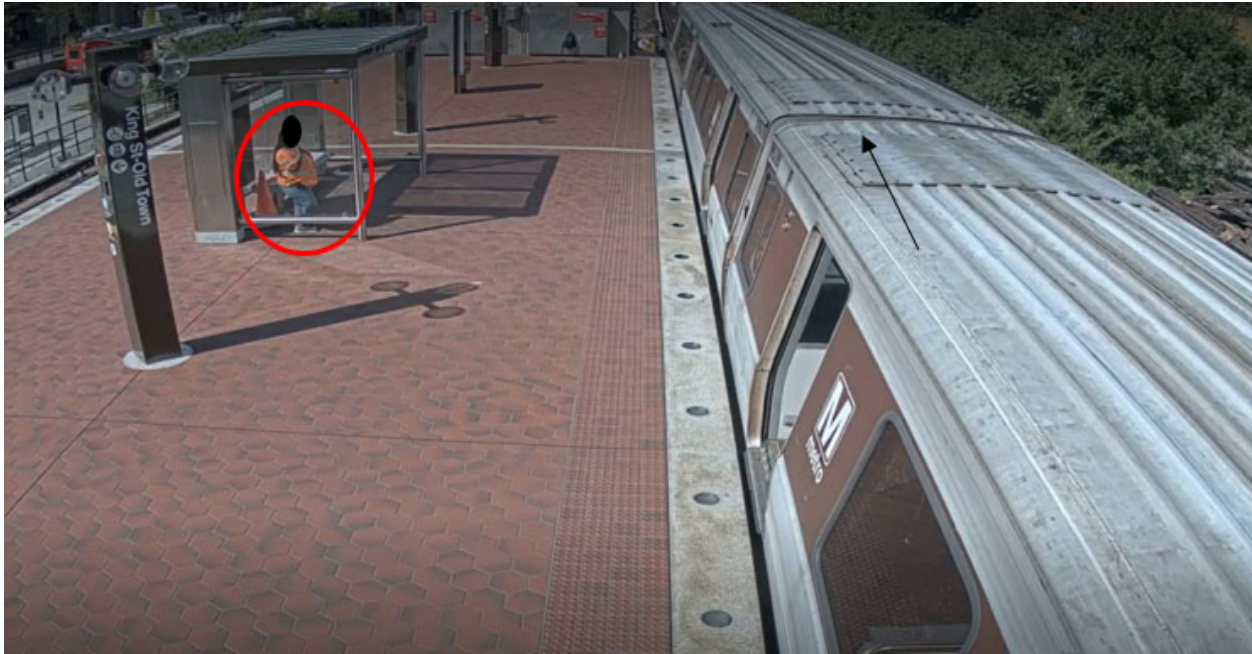
*Figure 4 - Train ID 402 operating in the direction of the Mobile Work Crew located at King Street Station at approximately 10:13 hours.*

Blue Line Train ID 402 departed King Street Station towards Franconia-Springfield at regulated speeds. CMOR IIT data determined Train ID 402 Train Operator was operating at 51 mph upon approaching the Mobile Work Crew. Train ID 402 observed personnel on the roadway and applied braking as they approached the work crew but did not enter emergency braking, according to the train's event recorder. The road horn was activated once during the reported incident time, 419 feet before coming to a complete stop at Van Dorn Street Station. At approximately 10:16 hours, Yellow Line Train ID 302 arrived at King Street Station and was not briefed by the AMF.

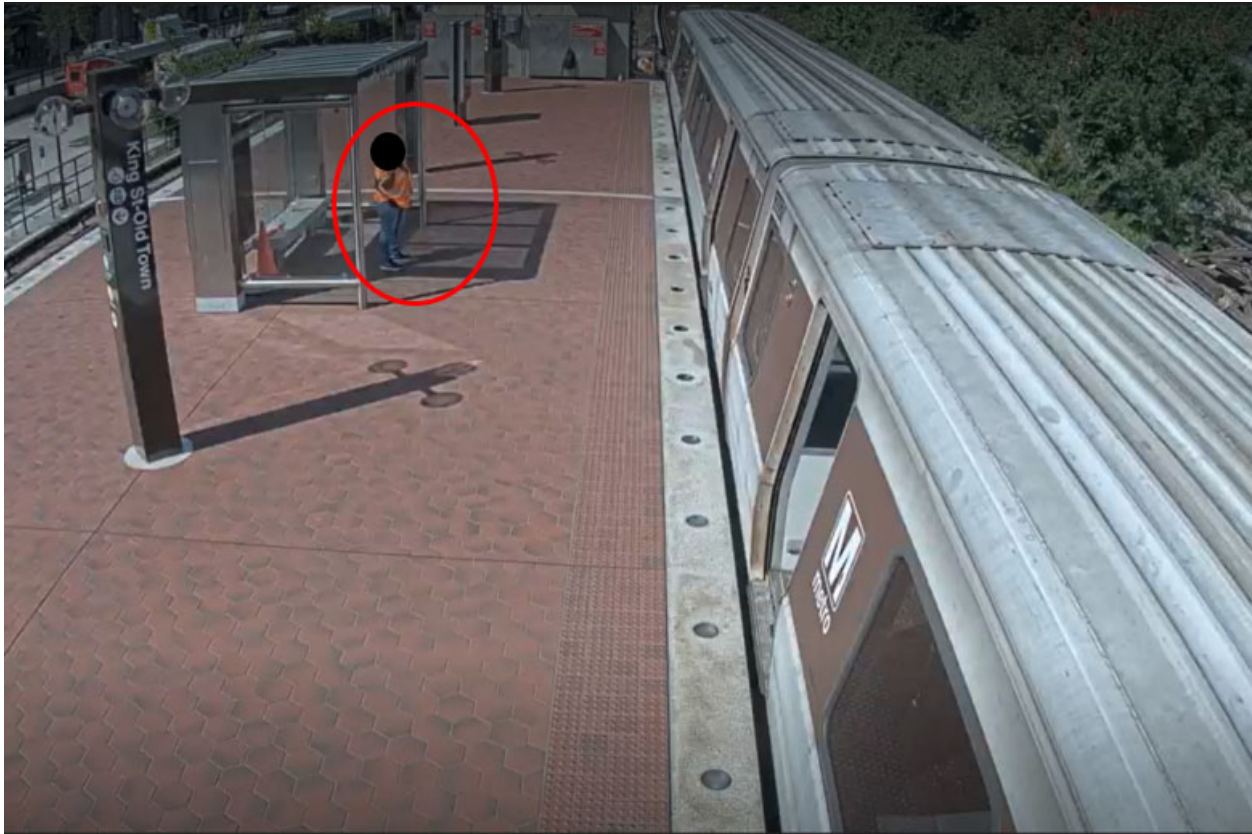
*Figure 5 - Train ID 302 headed toward Huntington Station located at King Street Station at approximately 10:16 hours.*

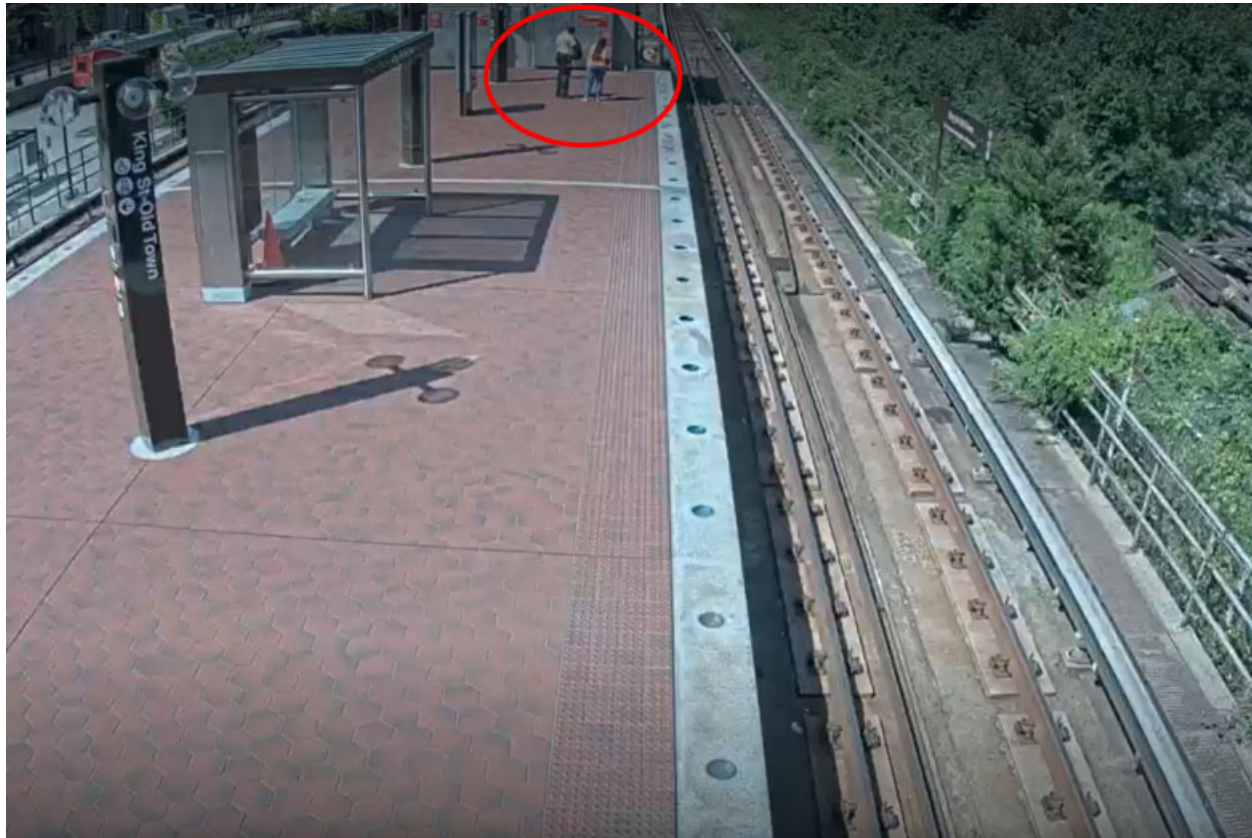
After the report by Train ID 402, ROCC verified the RWIC's location and dispatched a Station Manager to check on the status of the AMF. CCTV showed Station Manager communicating with the AMF at approximately 10:23 hours.

Figure 6 - Station Manager communicating with AMF.

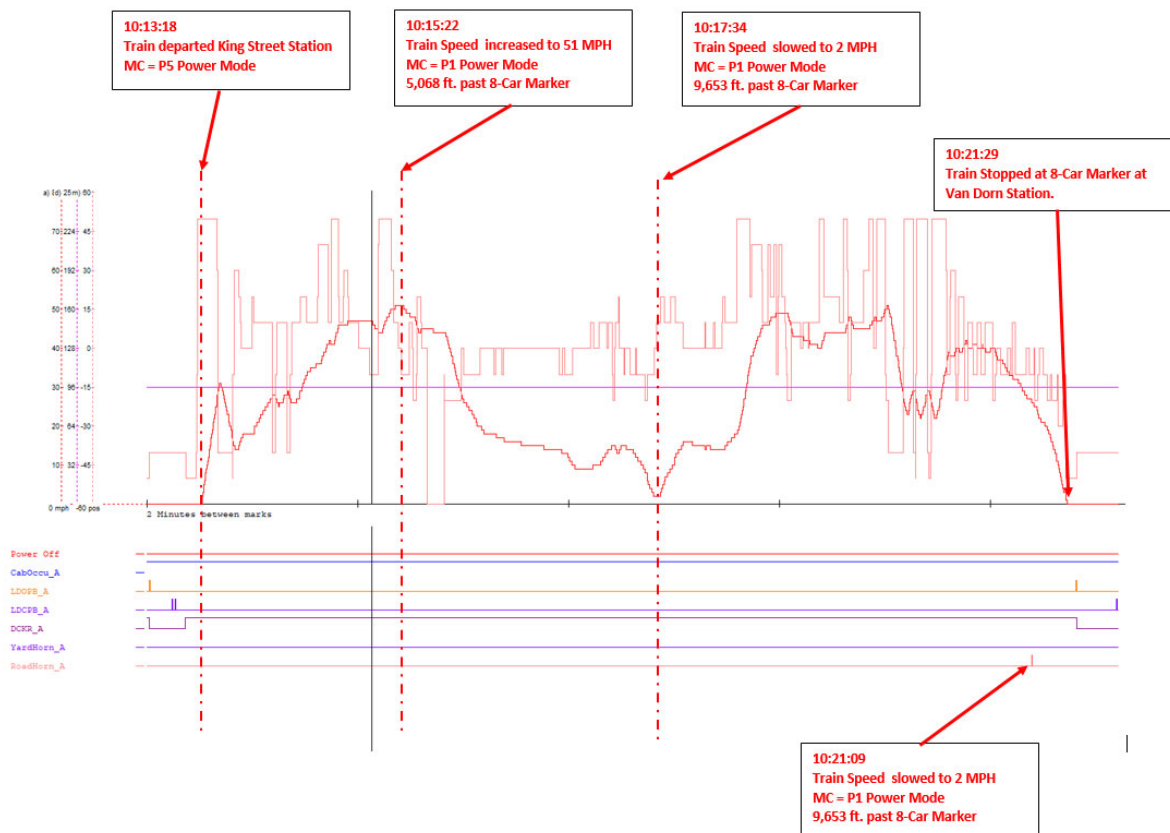
Figure 7 - CMOR IIT Data Graph

CMOR IIT completed an analysis of data retrieved from the consist. According to the VMS data analysis for the unusual occurrence, CMOR IIT determined Train ID 402, Lead Car 3192, serviced King Street Station, Track 2, and departed towards Van Dorn Street Station. The Master Controller cycled back and forth between several Braking and Power modes, increasing speed up to 51 MPH, about 5,068 feet past King Street station.

While traveling between King Street Station and Van Dorn Street Station, emergency braking was not initiated.

Based on the VMS data, no faults with the train may have contributed to the cause of this incident.

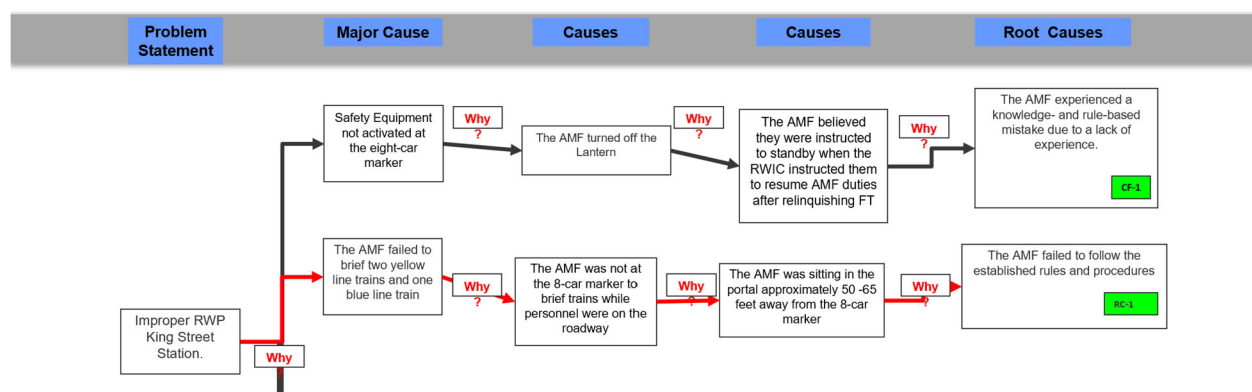
Attachment 1 – Root Cause Analysis page 1 of 1.

The probable cause of the King Street Station Improper RWP event was a failure by the AMF to perform duties in accordance with established rules and procedures. Available video and audio evidence indicated that the AMF was aware of their responsibility to perform their duties, and their training certification was current. Contributing to the event, the AMF experienced an unintentional mental error resulting in a knowledge-based and rule-based mistake due to a lack of experience.

<b>Corrective Action Code</b>	<b>Description</b>	<b>Responsible Party</b>	<b>Target Completion Date</b>
101092_SAFECAPS_TRST_001	(RC-1, CF-1) The Rail Pro contractor terminated the AMF, effective June 27, 2022.	TRST/SRC	Completed
101092_SAFECAPS_SAFE_001	(RC-1, FC-1) Evaluate AMF procedures, training, experience, and oversight requirements for areas of improvement.	OPMS/SRC SAFE/OOP	12/1/2022
